CAMELBACK CANYON ESTATES BLOCK WALL EVALUATION

Number: 23-0433

Final Submittal: January 31, 2024

SERVICE: 23-0433 – BLOCK WALL STRUCTURAL EVALUATION

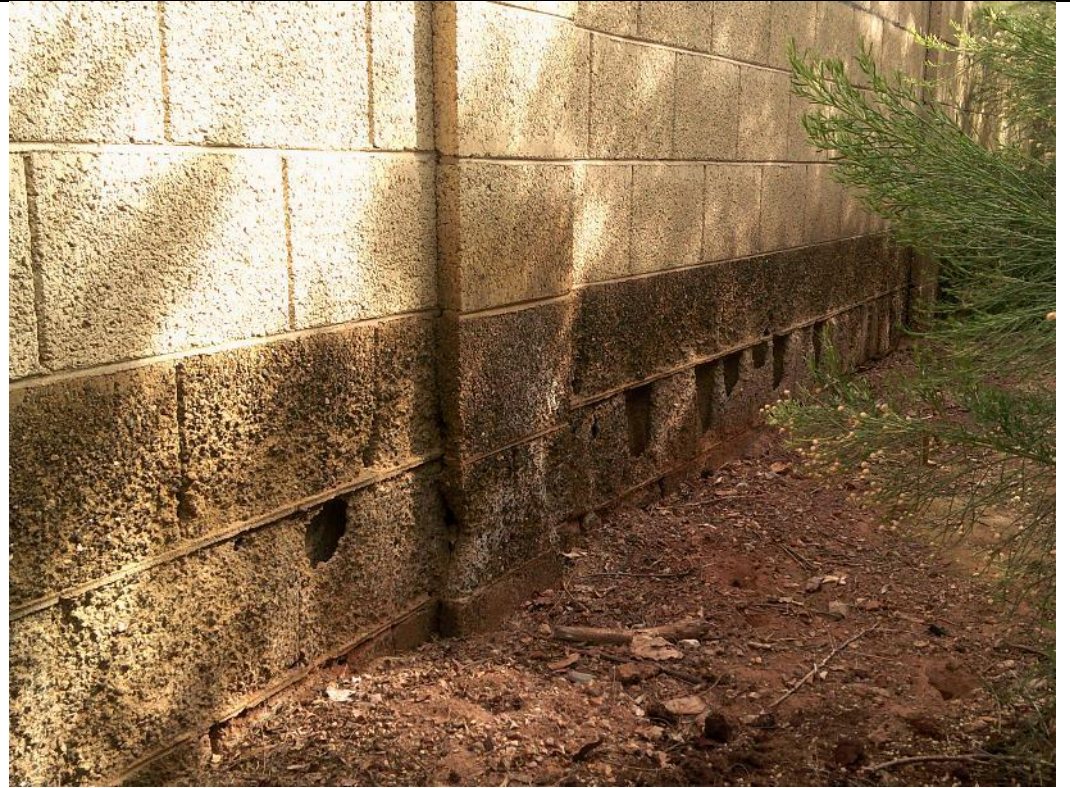
- ✓ Water intrusion leading to block delamination

Water intrusion is sometimes visibly observed by the presence of efflorescence and may result in the delamination and block degradation, eventually leading to structural failure.

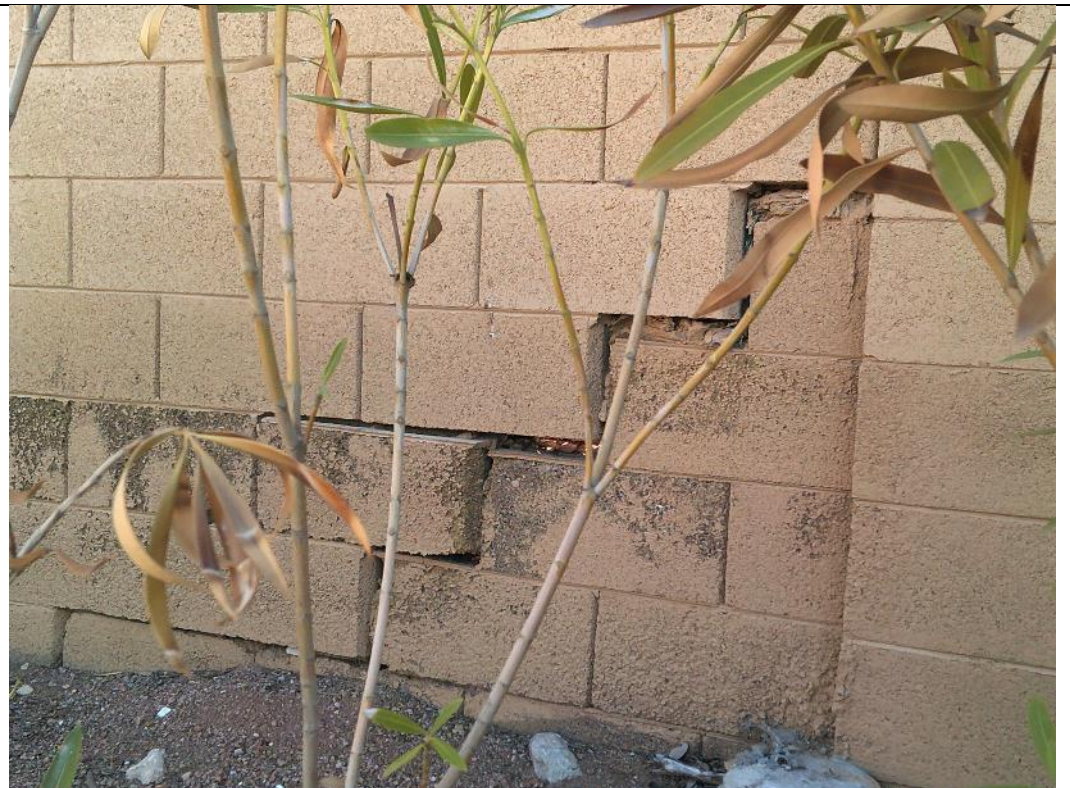
- ✓ Stair step cracking

Stair step cracking is typically a result of movement in the block wall foundation, tree roots, and/or the wall experiencing a permanent lean or "tilting". The condition becomes exacerbated when moisture intrusion exists in addition to the movements described above.

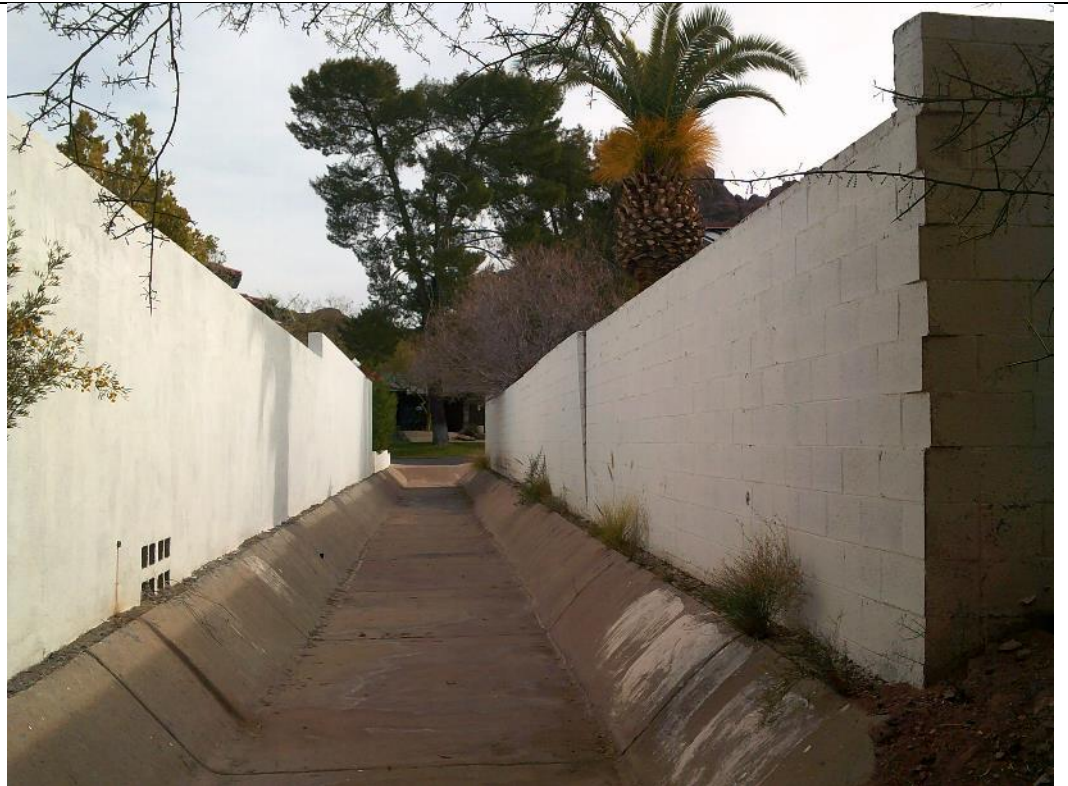
✓ Leaning or "tilting" wall segments and view fence

Leaning or "tilting" wall segments typically occur due to missing vertical reinforcement, insufficient footings, or structural failure of the internal wall elements (such as at the bond beam).

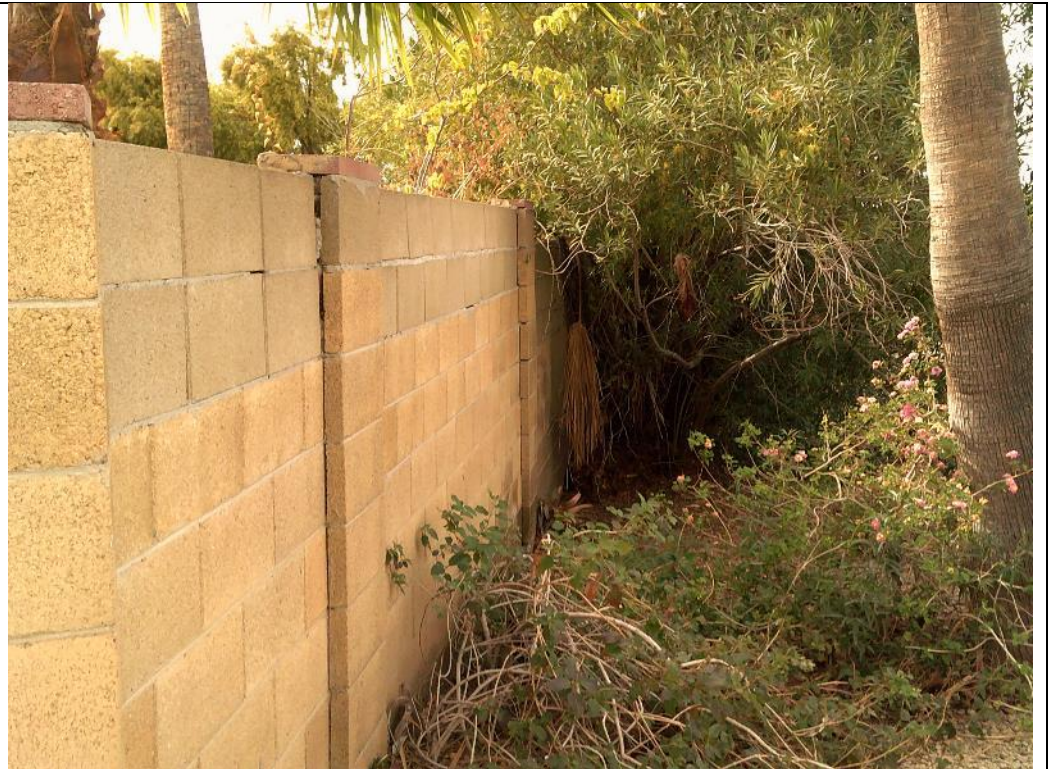
✓ Landscape Overgrowth and Irrigation Systems

Landscape planters, shrubs, and tree overgrowth can allow moisture penetration into the wall and in the case of trees, the roots can undermine the footing system causing failure. In addition, many times irrigation systems will be a source for masonry walls to be constantly soaked leading to delamination and ultimate failure.

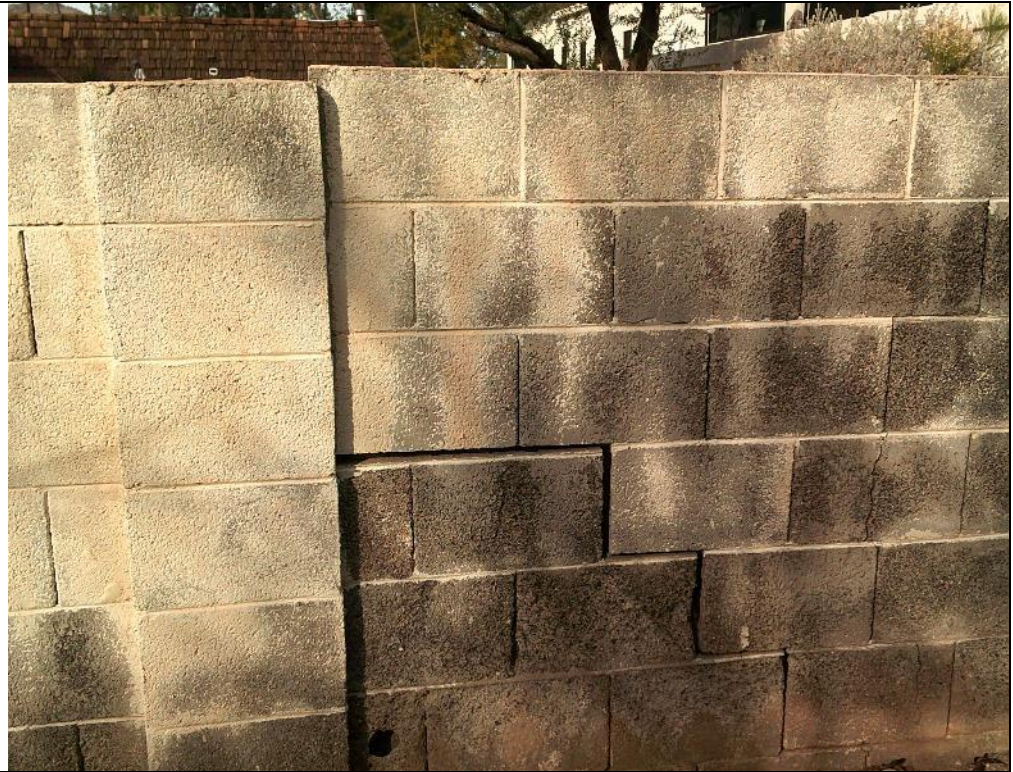
✓ Uplift

Roots from vegetation and settlement of the wall can cause uplifting conditions for a portion or all of the wall. Portions of the walls grout can debonded and separate the CMU courses and limiting the integrity of the wall.

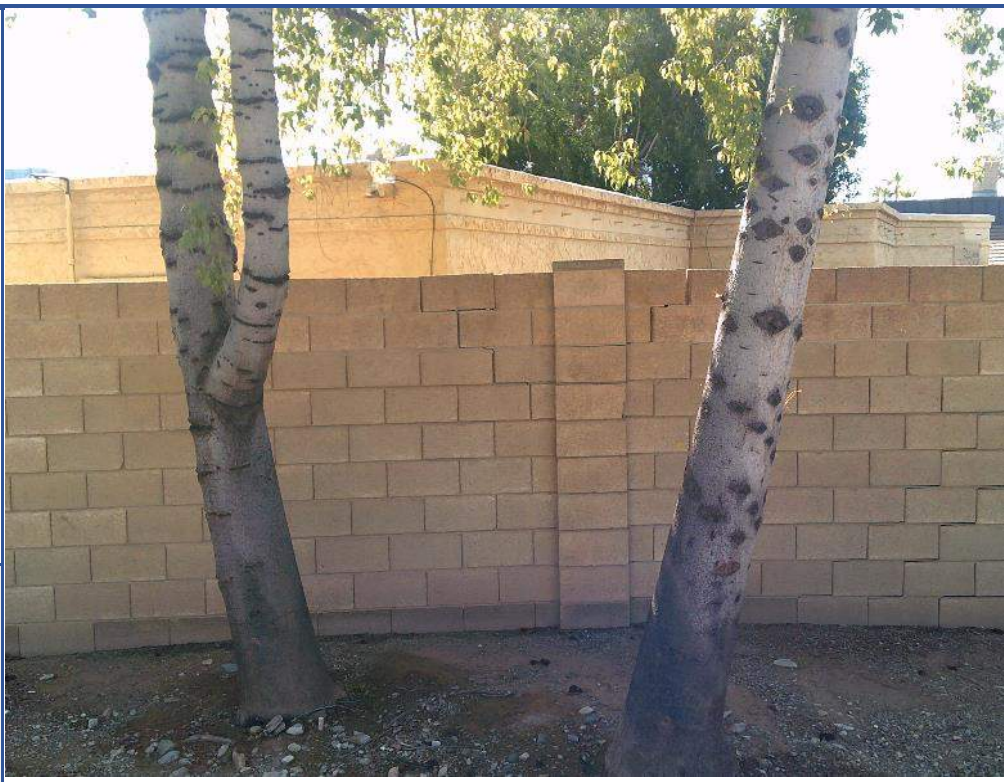
<p>Description:</p> <p>Lot 1S - Column rotation up to approximately 1/2". Multiple hairline stair case crack.</p>
<p>2</p>

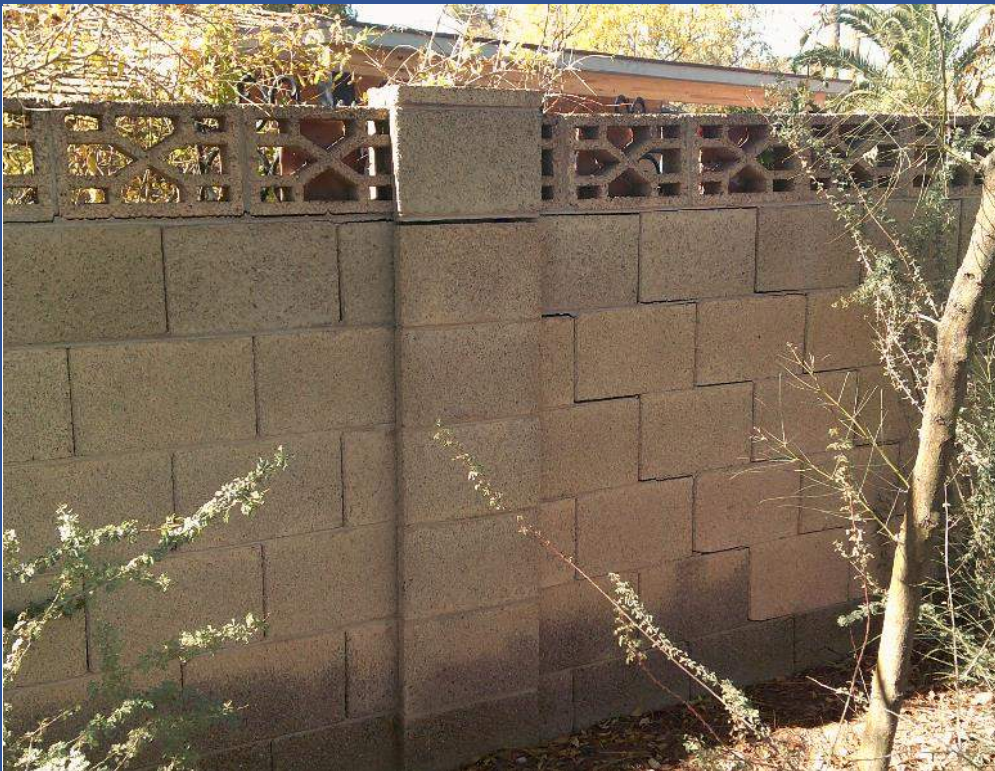
10

Lot 6 - Column separation up to approximately 1/2". Multiple hairline staircase cracks.

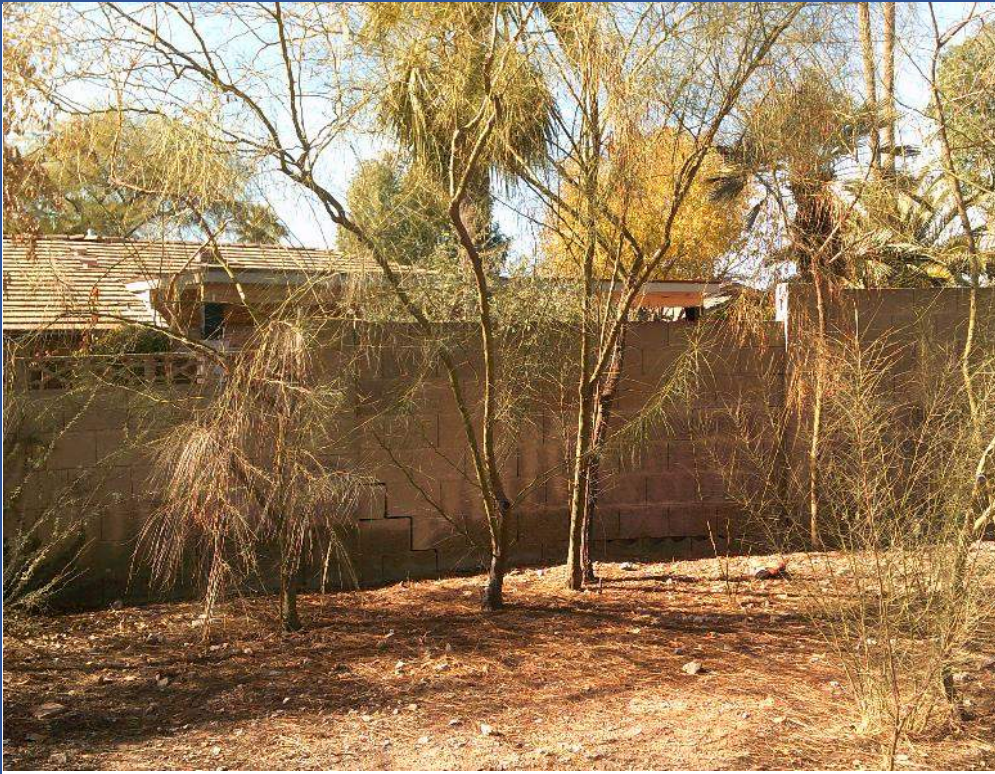
11

Lot 6 - Significant delamination. Column rotation up to approximately 1/2". Staircase crack up to approximately 3/4". Overgrowth.

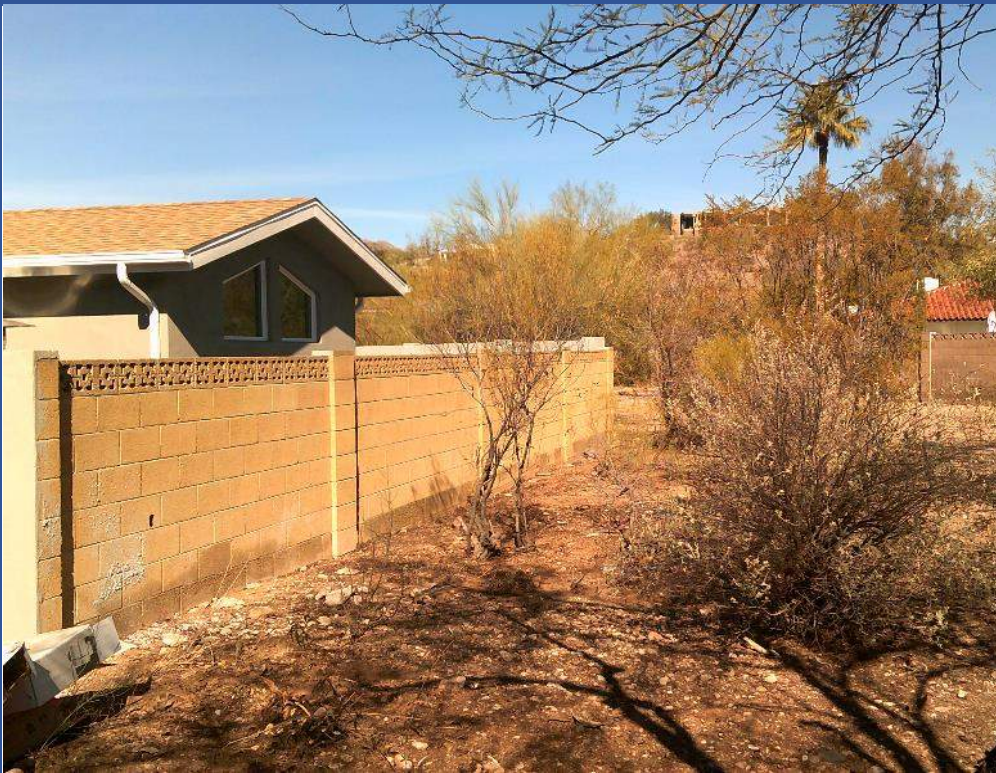
15

Lot 11S - Moderate delamination. Hairline staircase crack. Hole in course.

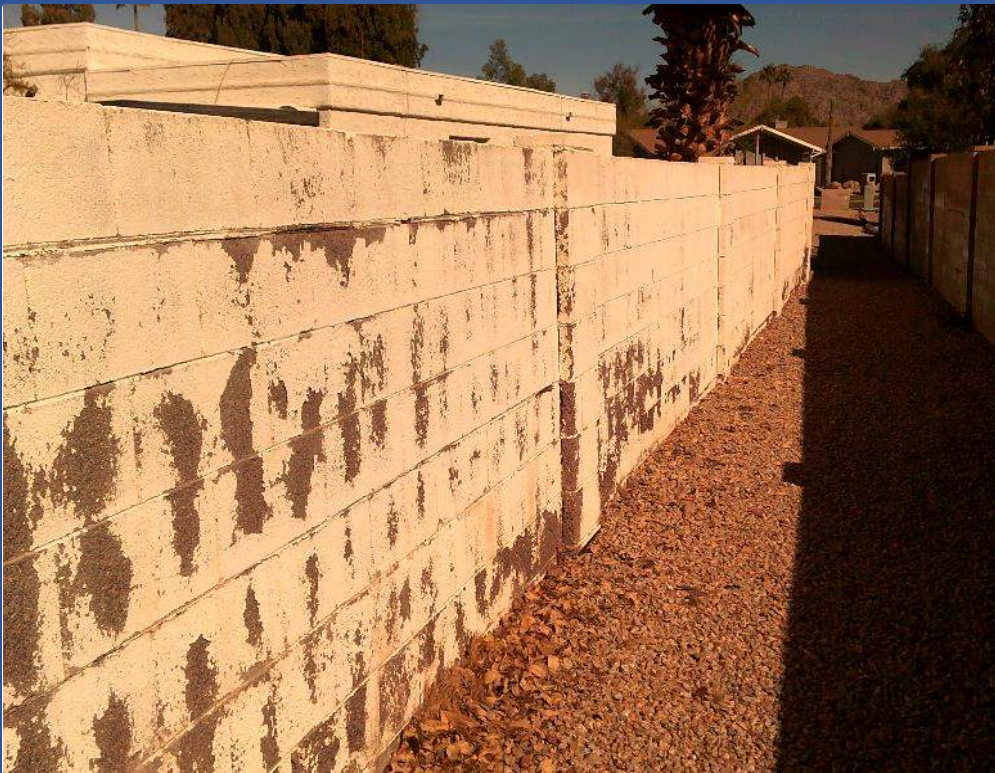
32

Lot 13S - Delamination.
Exposed and corroded
dur-o-wire.

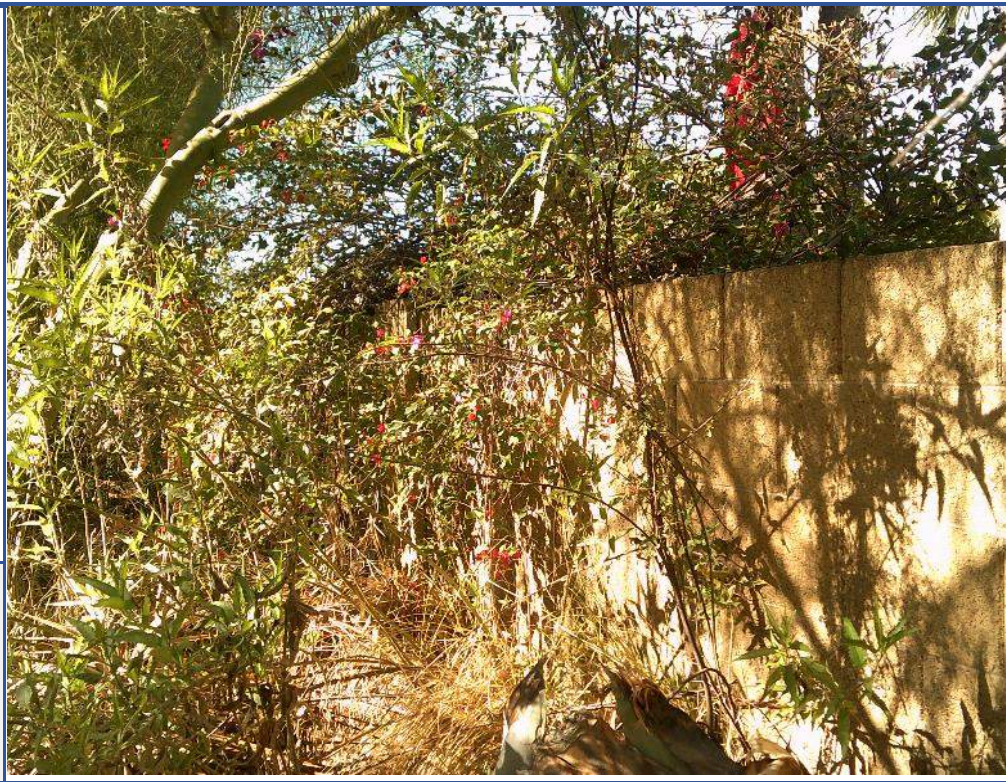
<p>Description:</p> <p>Lot 20 - Overgrowth.</p>
<p>44</p>

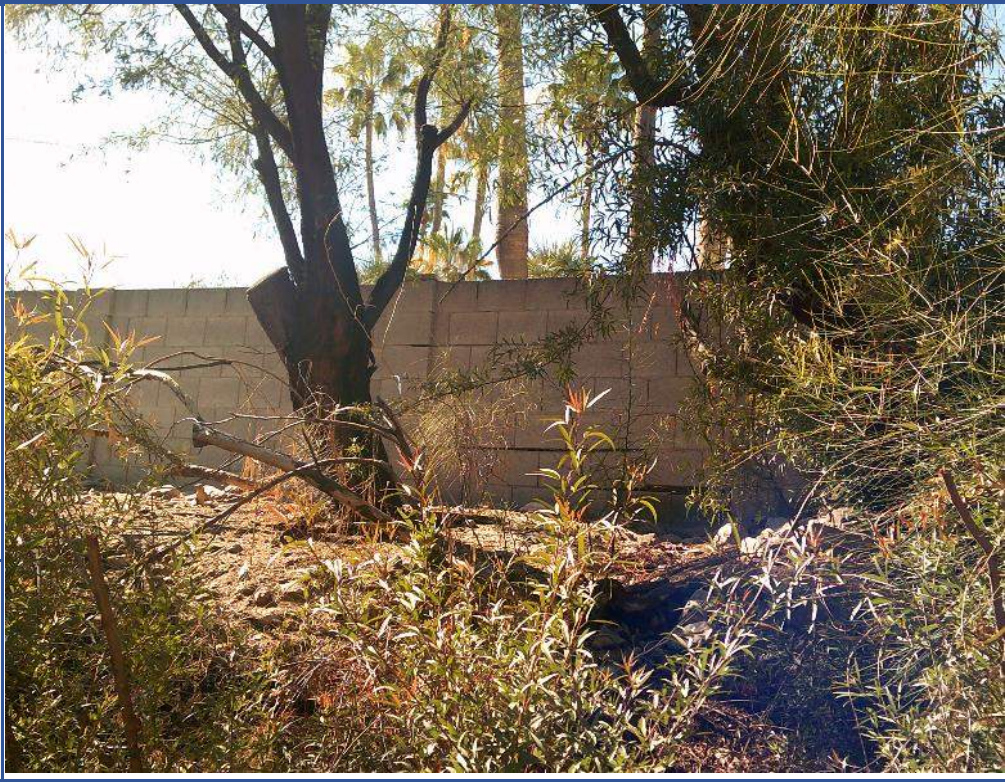
48

Lot 23 - Separation of courses with large staircase crack. Potential uplift.

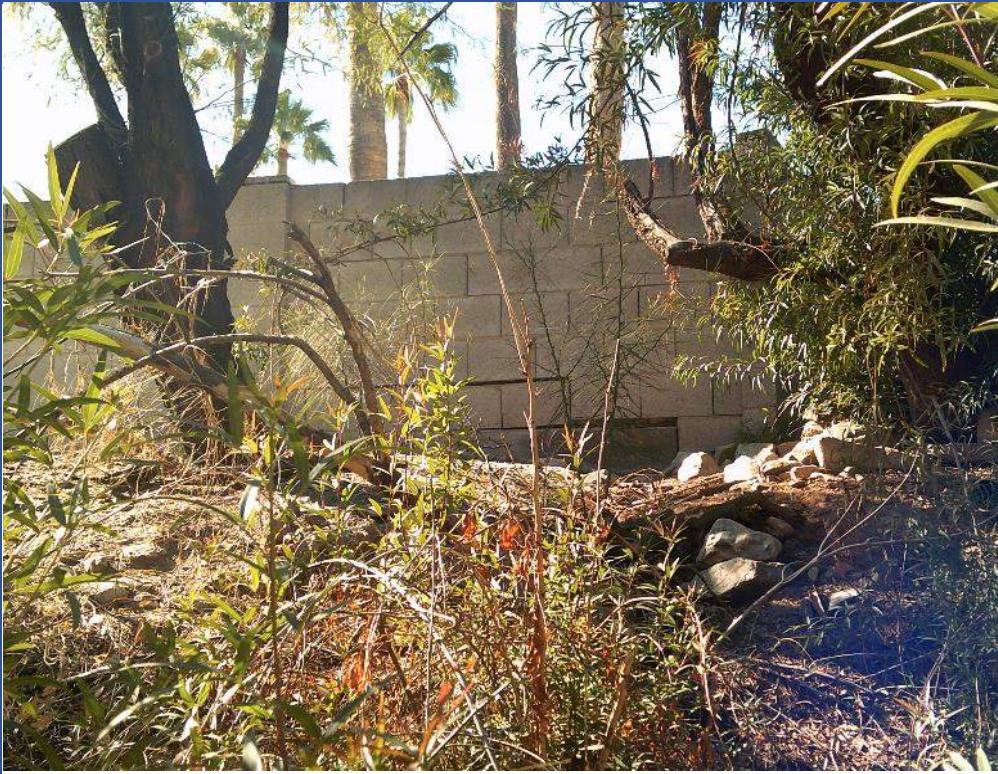
Lot 23 - Separation of courses with large staircase crack. Potential uplift.

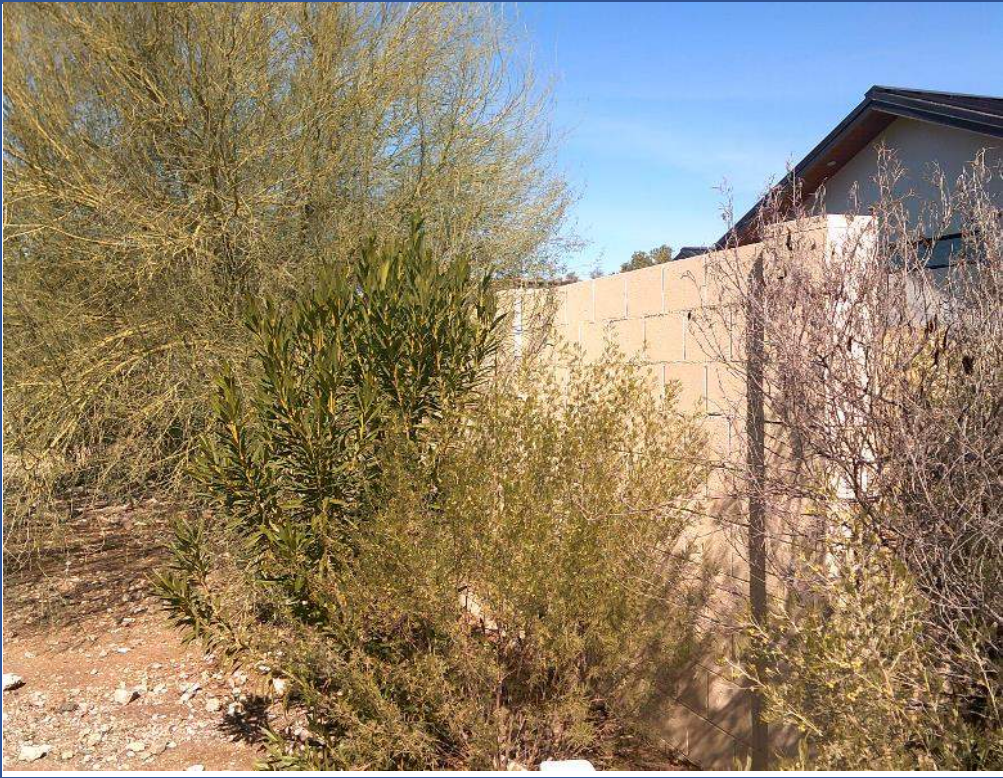
53

Lot 26 - Overgrowth.
Loose top cap.

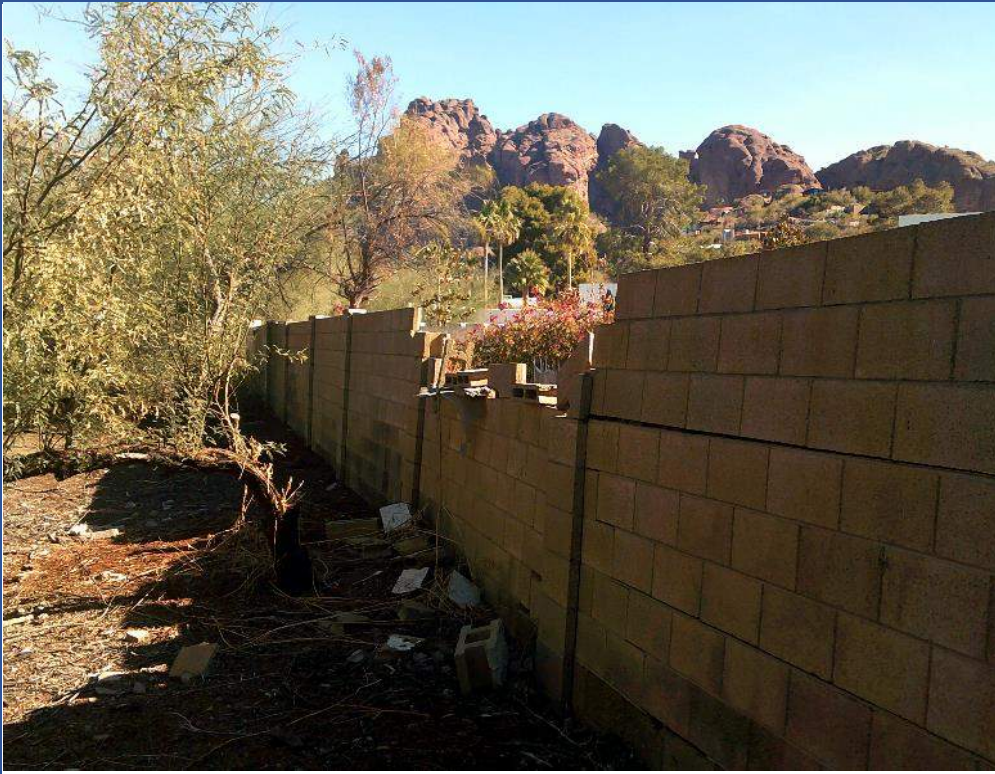
67

Lot 28 - Column rotation up to approximately 1.5" on a 6-foot wall. Potential tree falling on wall. Staircase crack up to approximately 1/2".

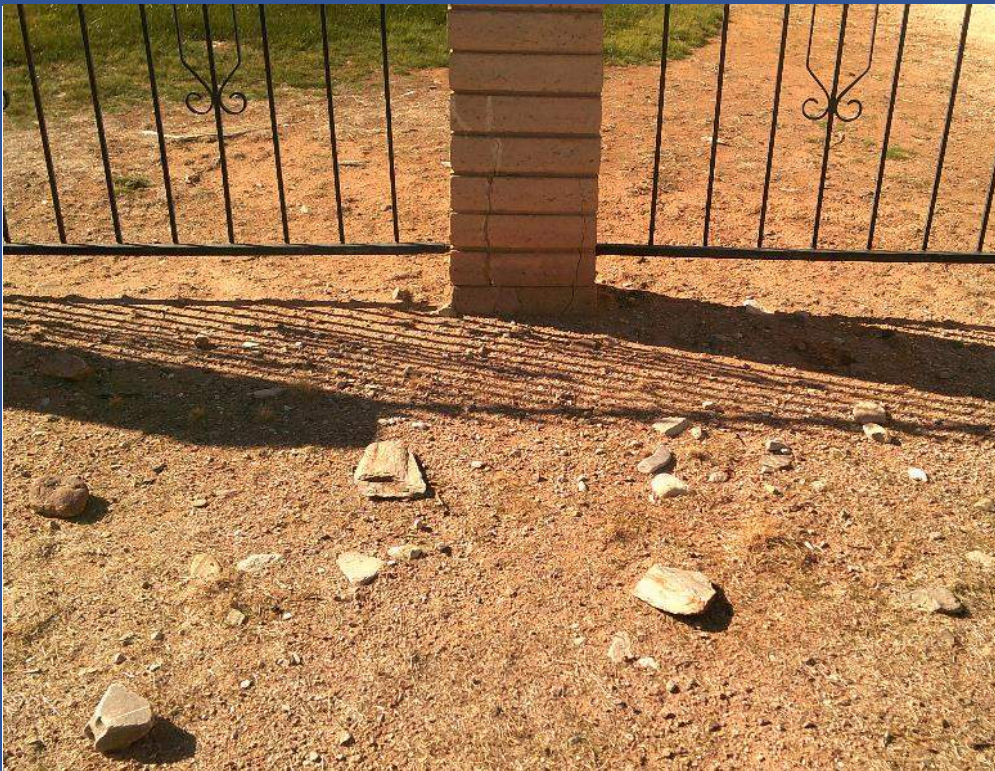
68

Lot 30 - Column rotation. Cracking on column.

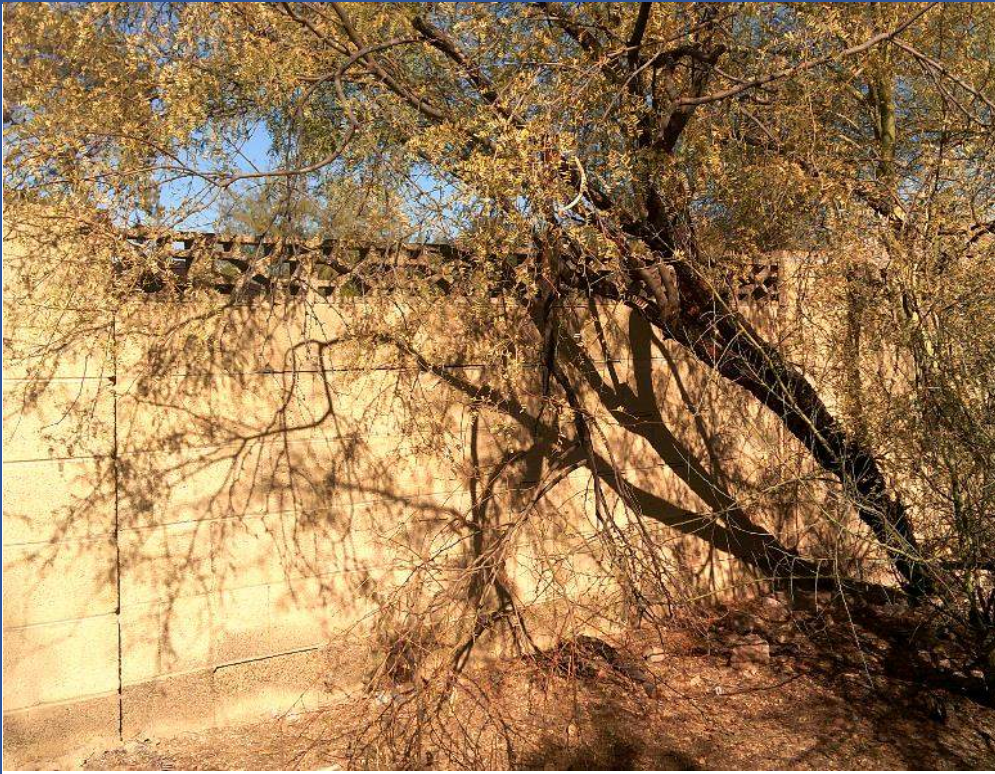
77

Lot 36 - Staircase crack up to approximately 1/4". Overgrowth.

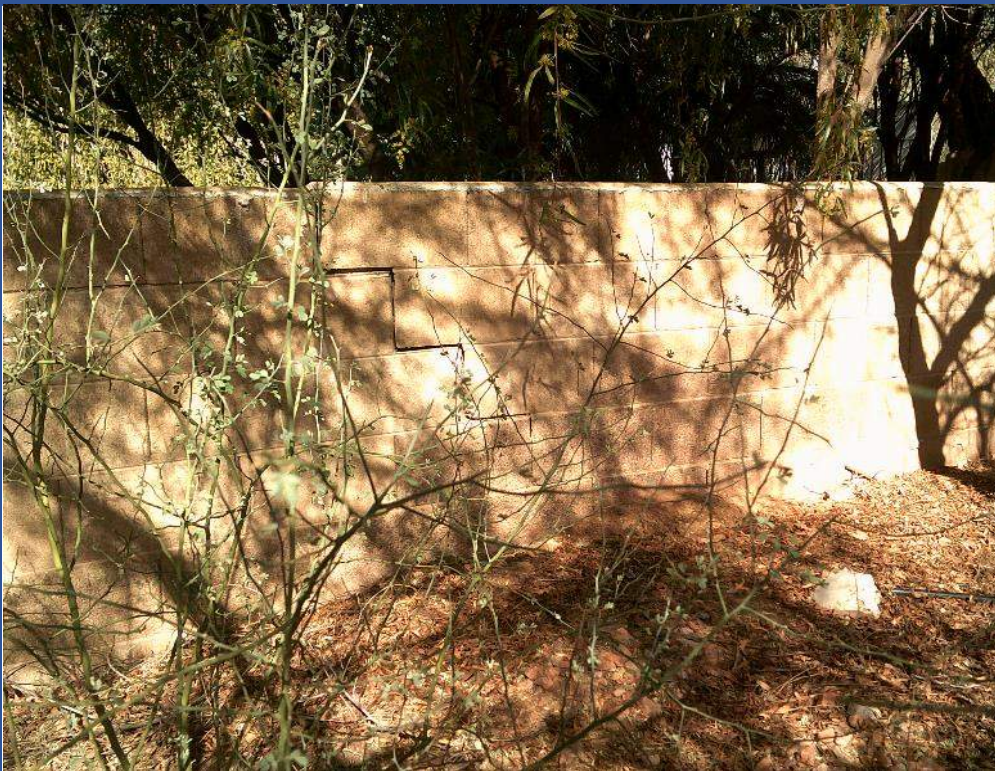
78

Lot 37 - Delamination. Staircase crack up to approximately 3/4". Overgrowth. Staircase crack on two panels is likely uplift.

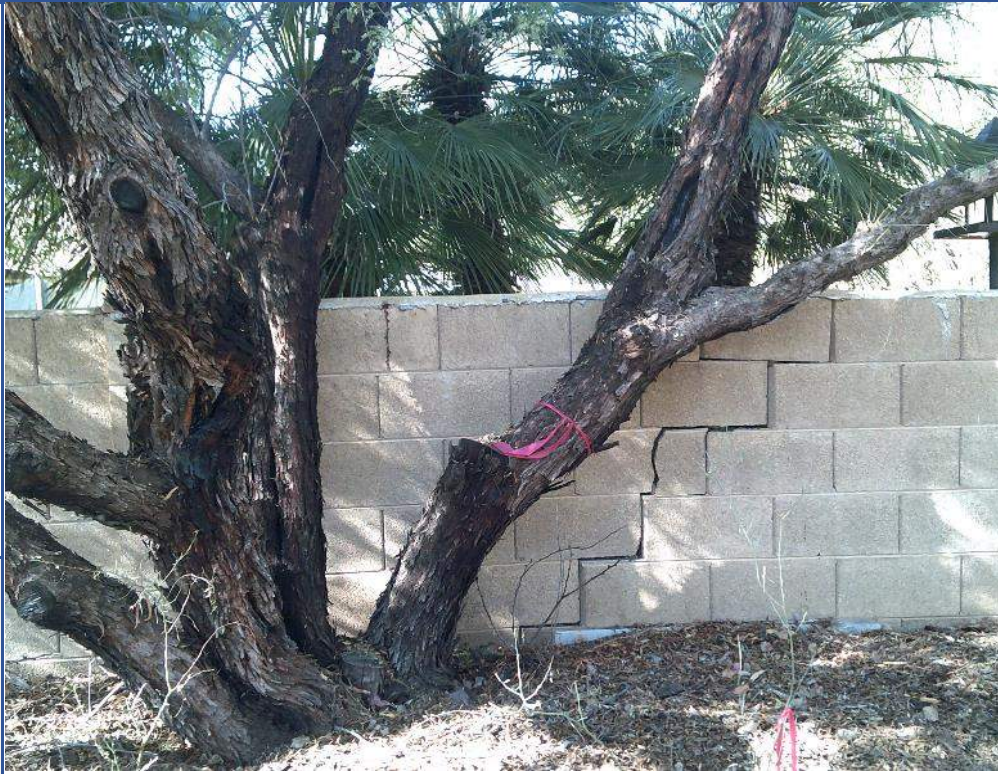
79

Lot 37 - Staircase crack up to approximately 3/4". Overgrowth. Staircase crack on two panels is likely uplift.

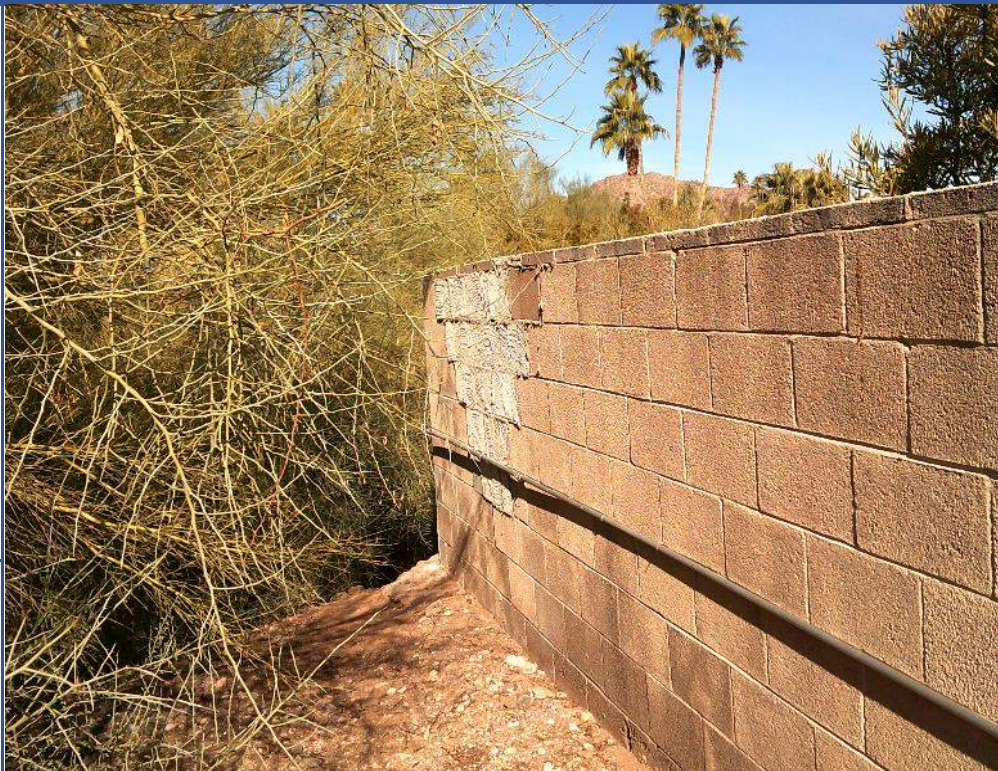
80

Lot 41S - Previous repairs.

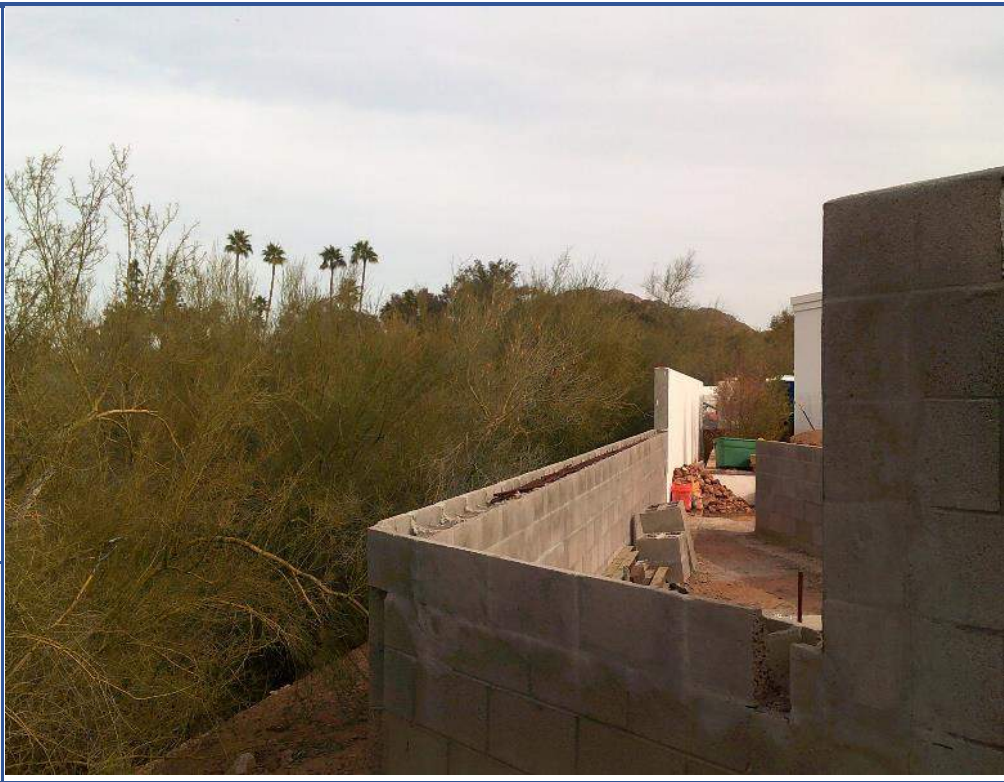
<p>Description:</p> <p>Lot 51 - On-going wall repairs.</p>
<p>94</p>

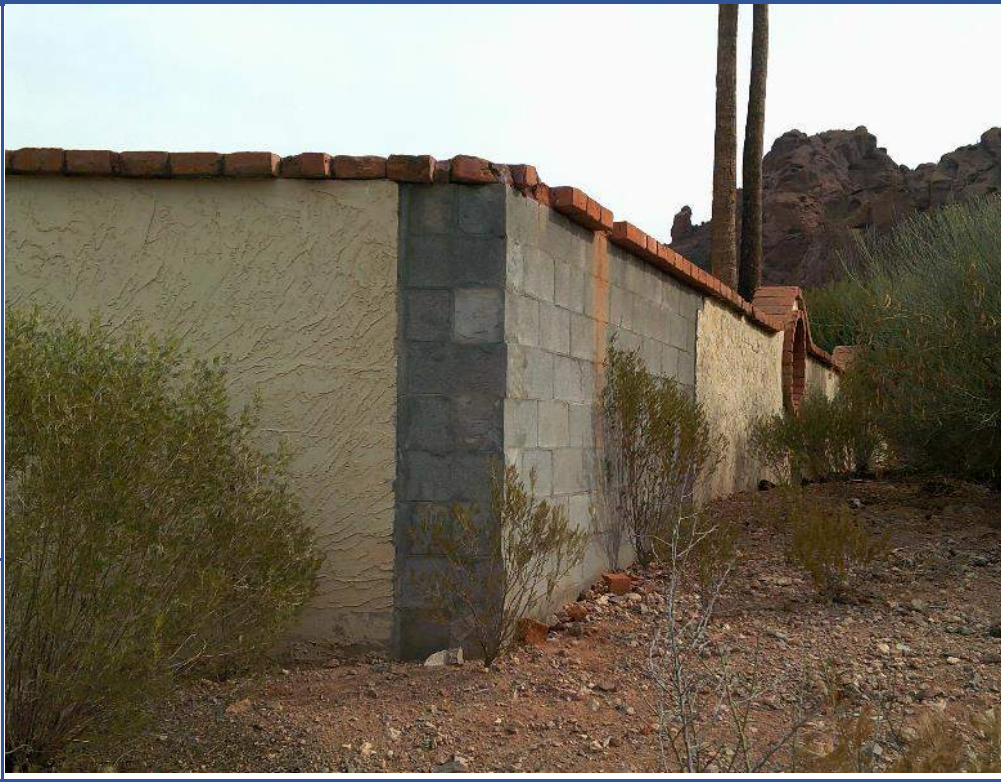
PHOTO NUMBER
105

Lot 62 - Overgrowth.
Broken top courses.

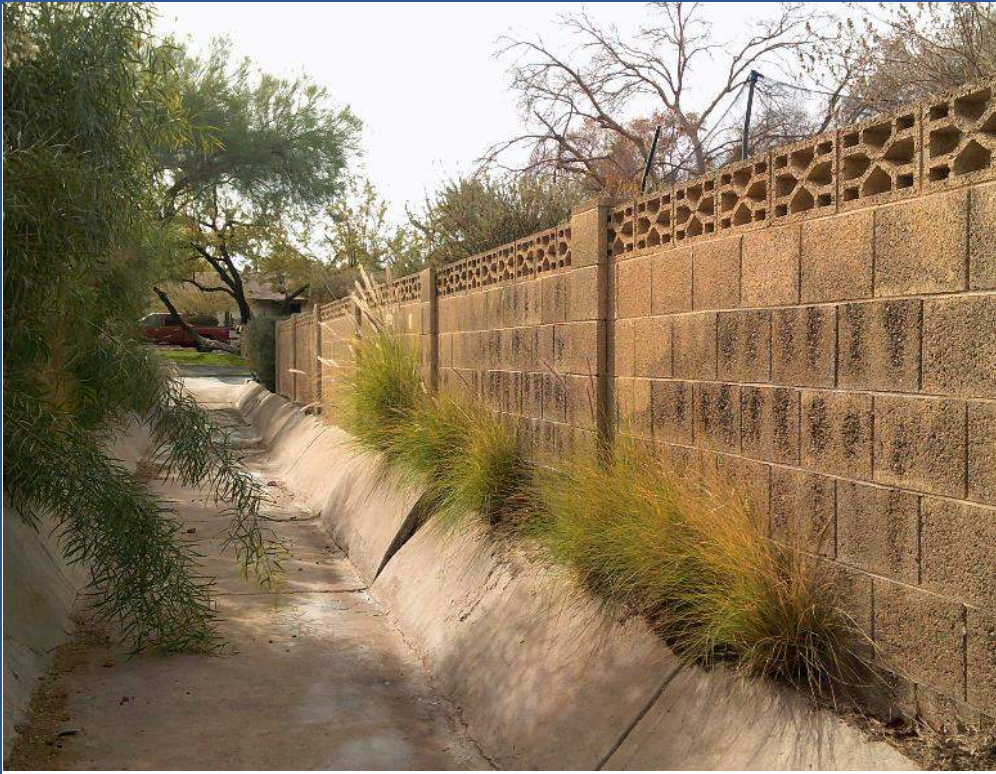
113

Lot 64S - Moderate delamination. Hairline vertical crack. Overgrowth.

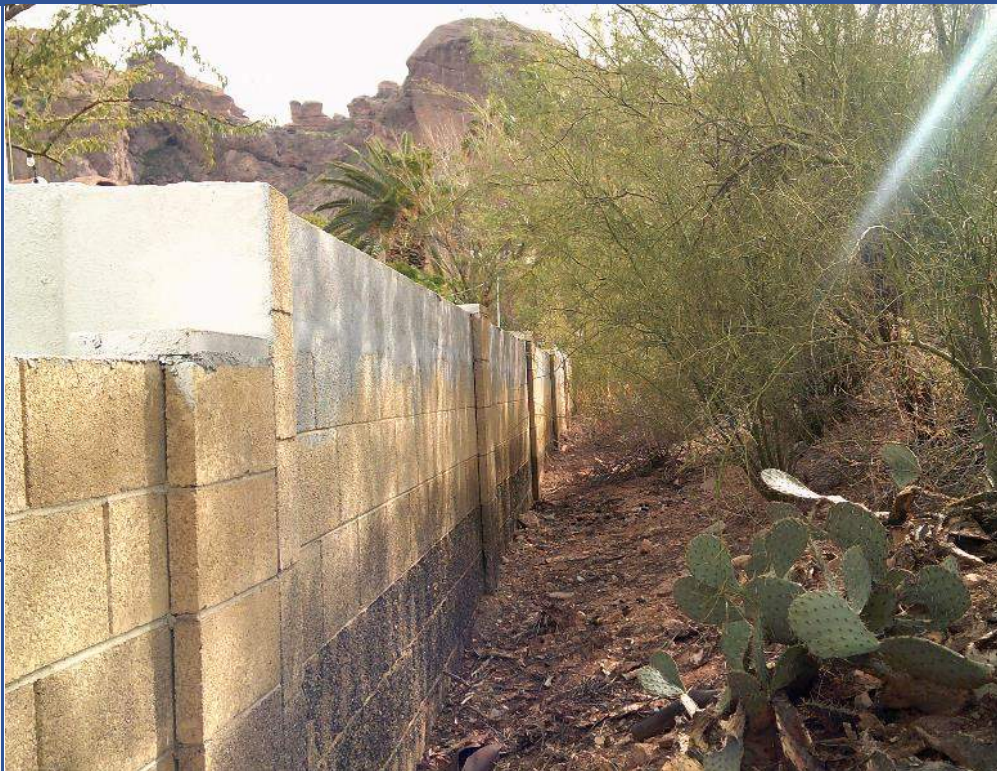
118

Lot 69 - Moderate to
significant delamination.
Overgrowth. Hole in
course. Loose top cap.
Animal feces in
immediate everywhere.

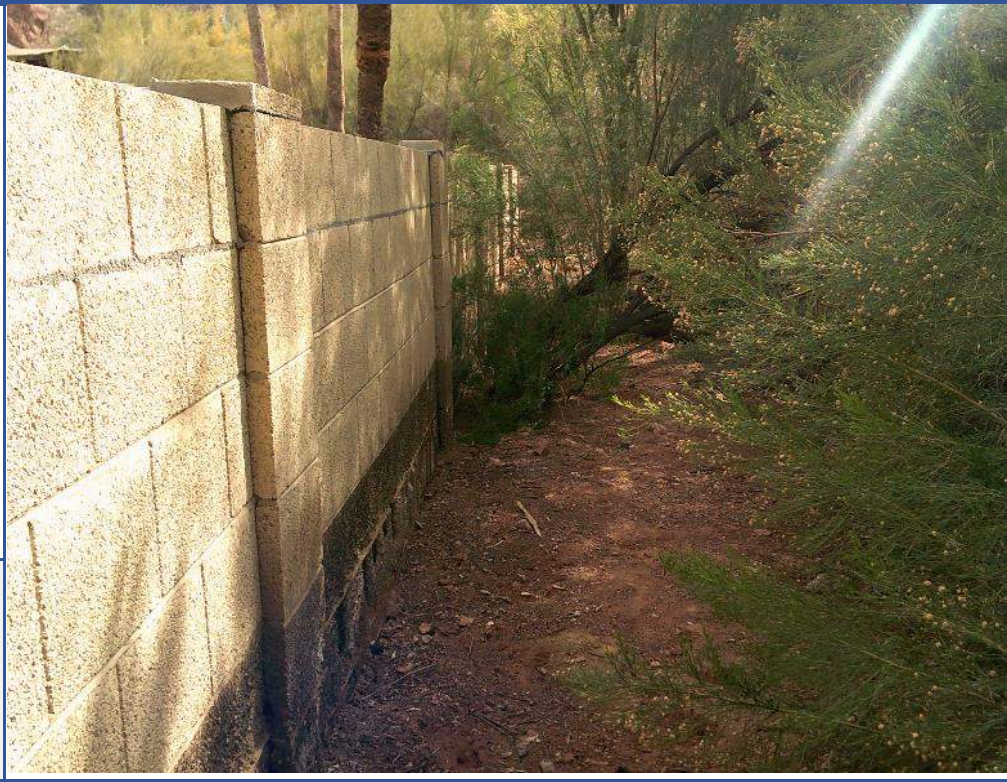
PHOTO NUMBER
119

Lot 70 - Significant delamination. Hairline vertical crack. Overgrowth. Negative slope towards wall.

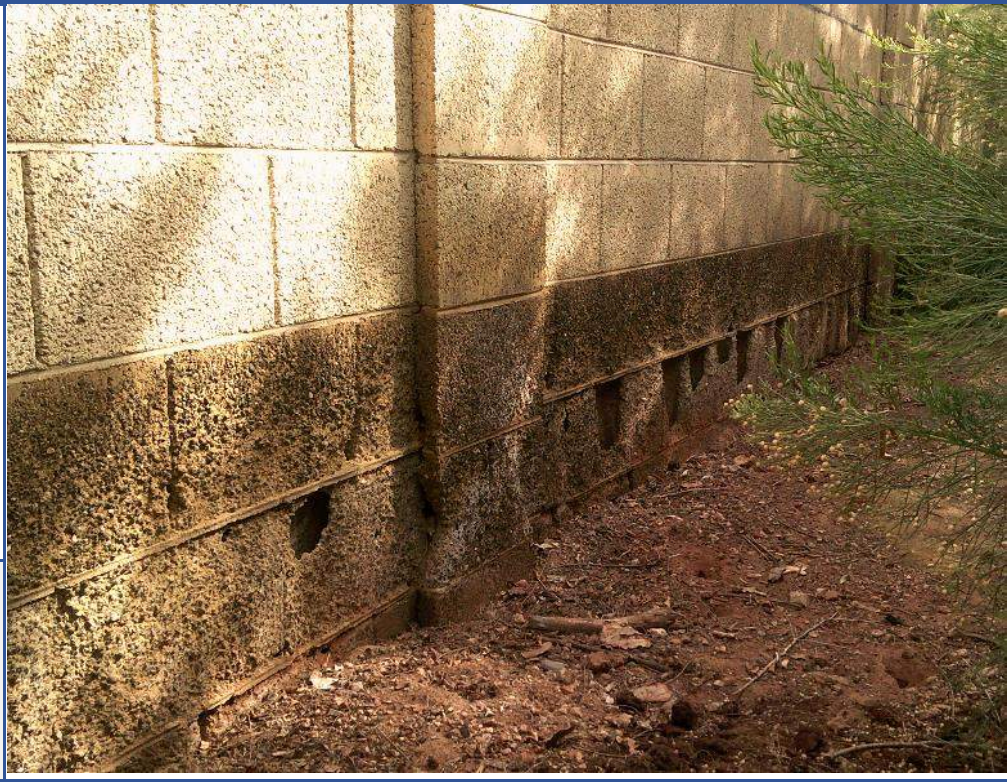
PHOTO NUMBER
120

Lot 70 - Significant delamination. Multiple holes in course.

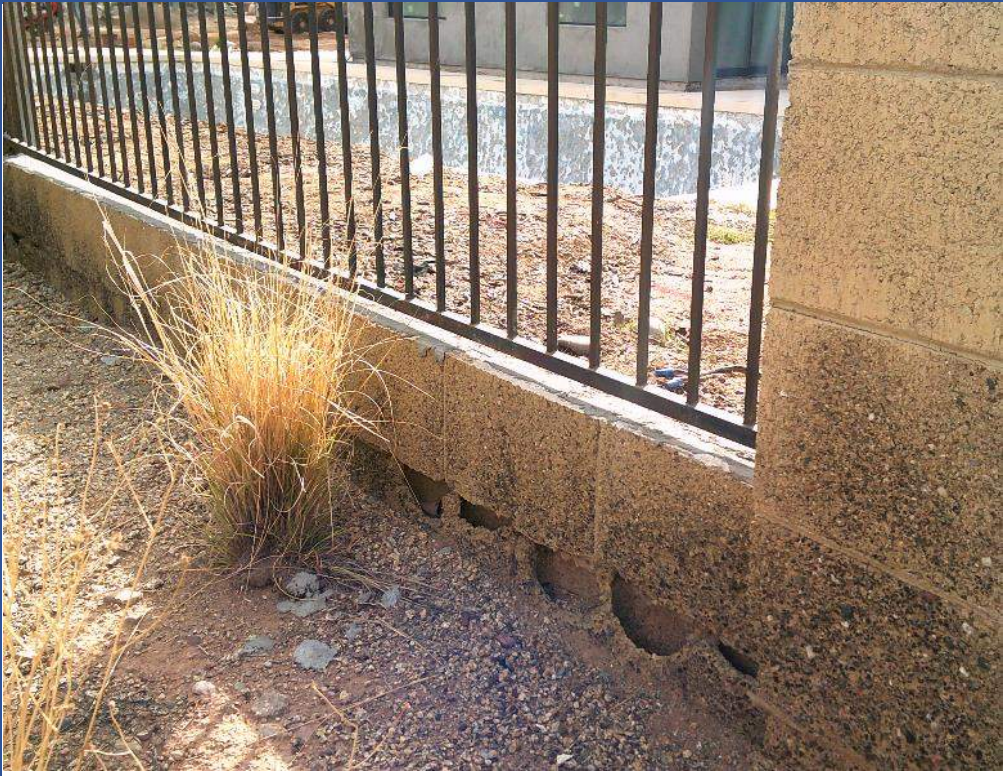
Lot 72 - Corrosion on view fence. Significant delamination.

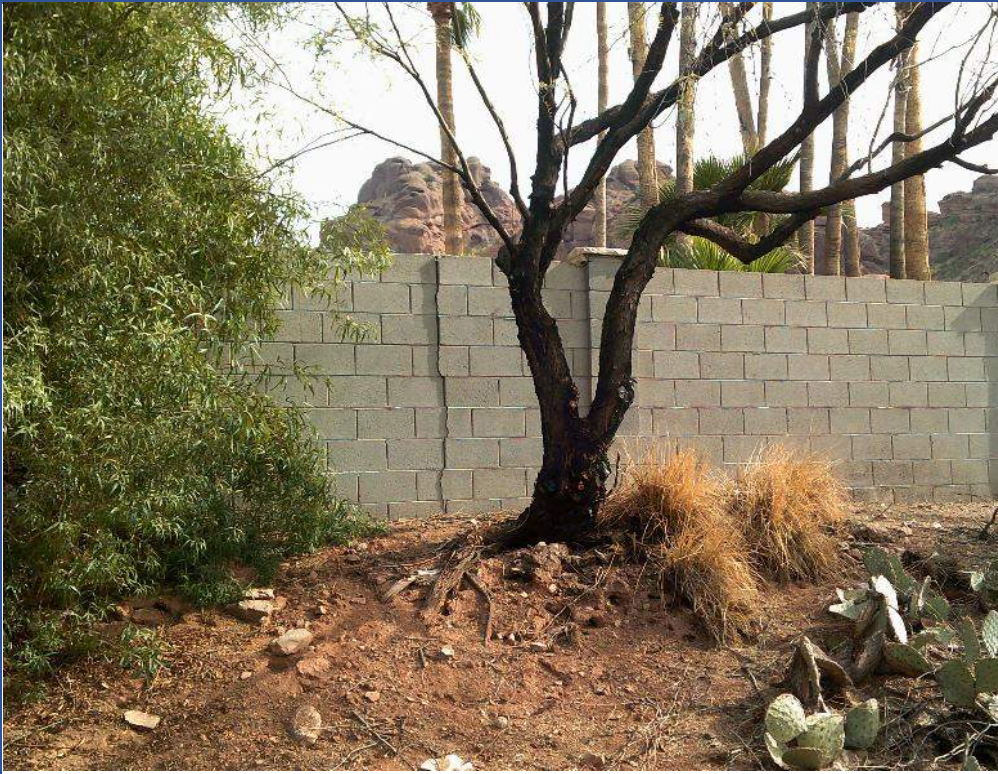
133

Lot 78 - Wall rotation up to approximately 3/4" on a 6-foot wall. Vertical crack. Overgrowth. Potential missing lateral bracing.
