CAMELBACK CANYON ESTATES BLOCK WALL EVALUATION

Number: 23-0433

Final Submittal: January 31, 2024

SERVICE: 23-0433 – BLOCK WALL STRUCTURAL EVALUATION

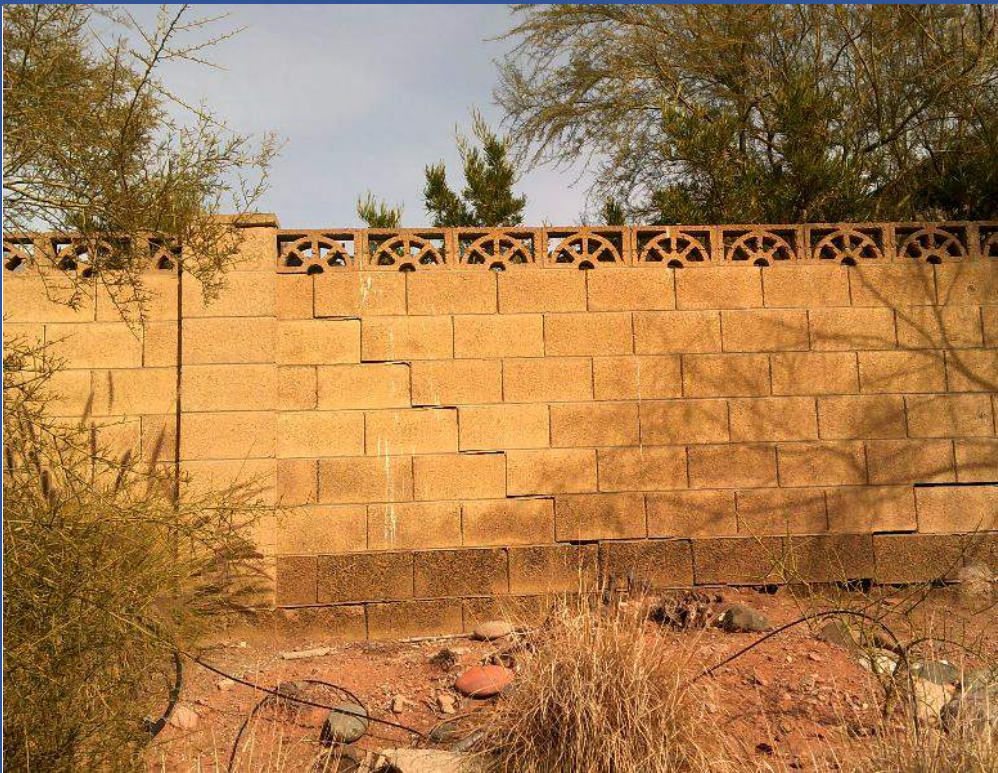
134

Lot 78 - Staircase crack. Potential missing lateral bracing.

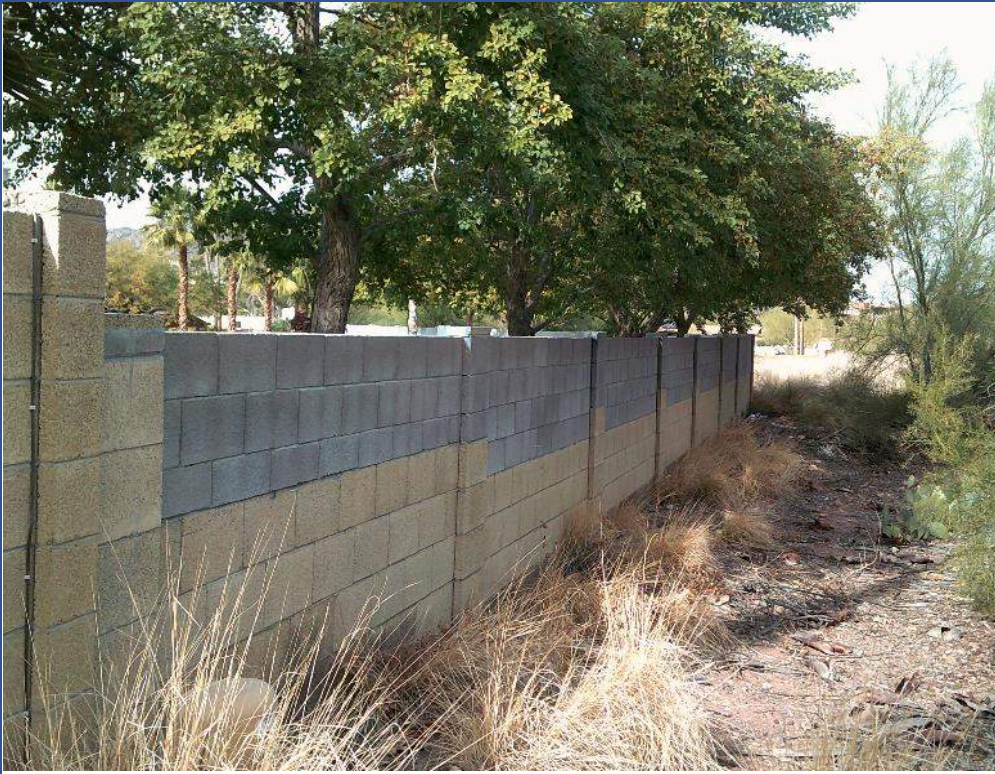
Lot 82 - Elevation. Built up wall.

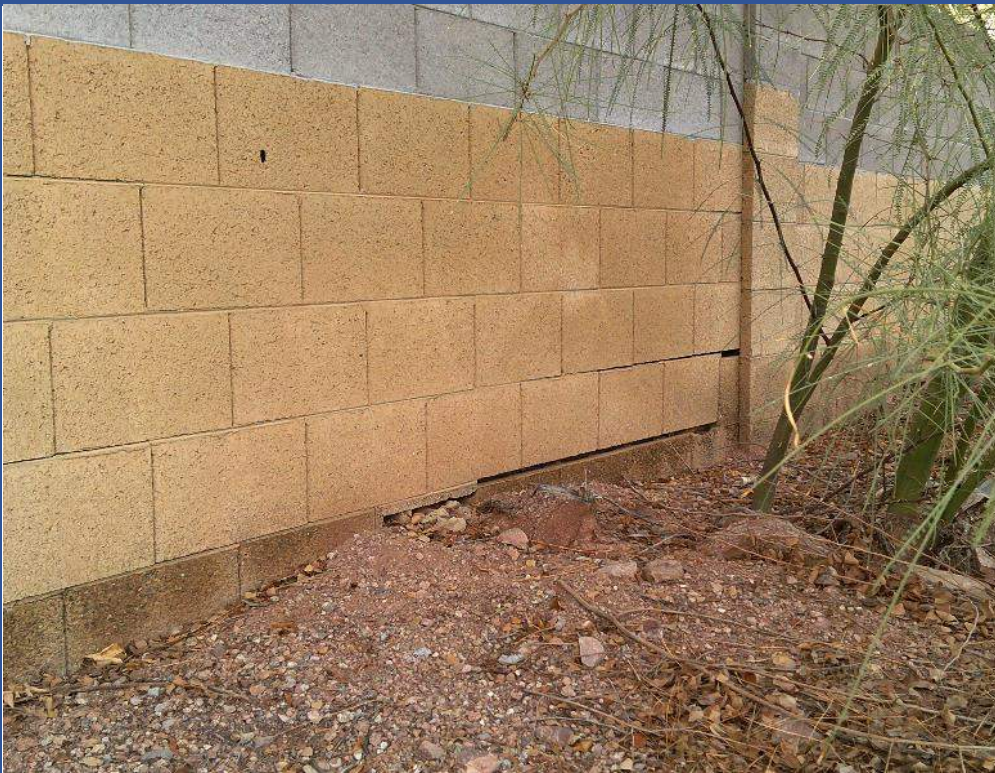
Lot 82 - Staircase crack up to approximately 1".

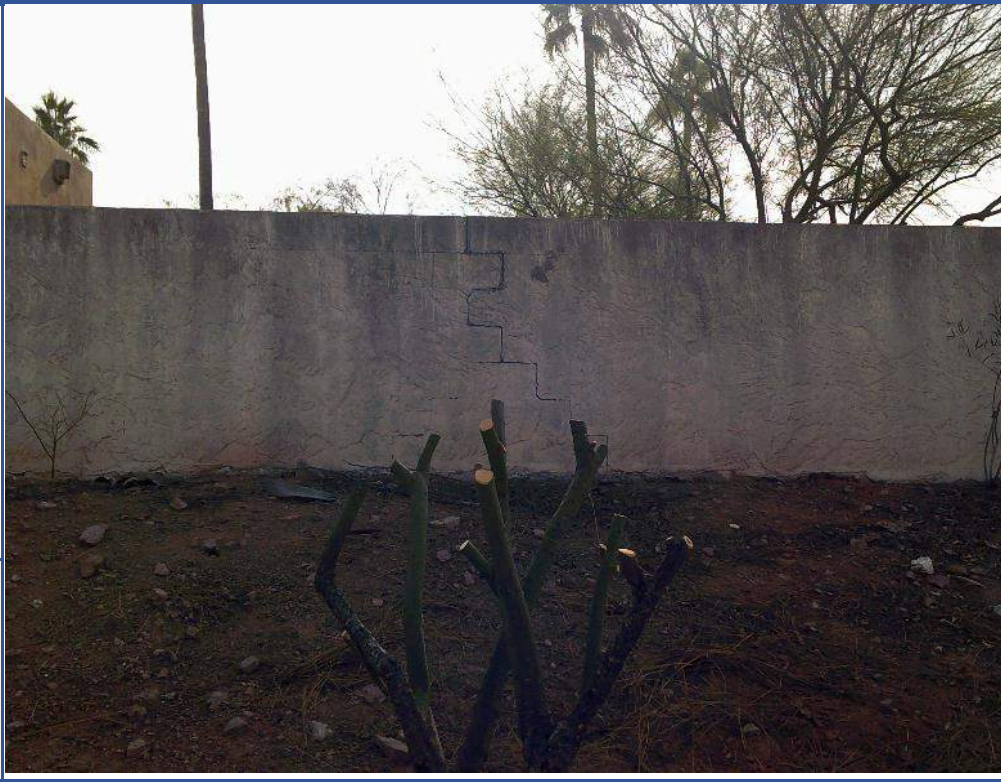
141

Lot 83 - Delamination. Staircase crack up to approximately 1/4". Hairline staircase cracks. Multiple segments with rotation up to approximately 1.25" on a 5-foot wall. Exposed footing.

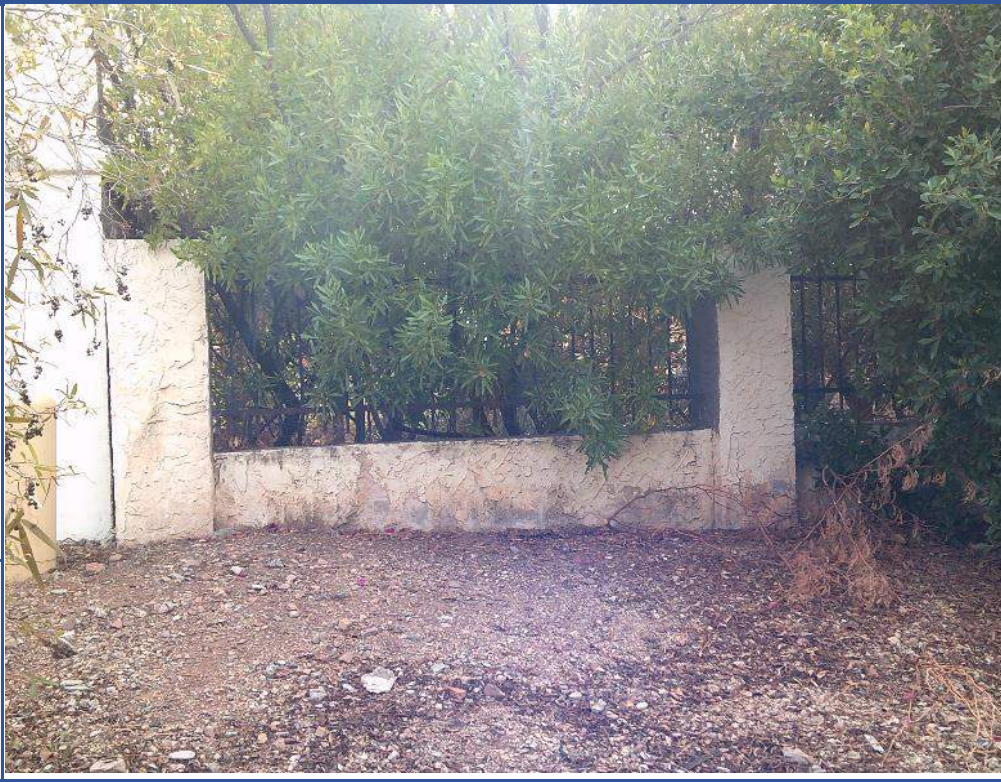
142

Lot 85 - Delamination. Column rotation up to approximately 1" on a 5.5-foot column. Overgrowth. Cracking in stucco.

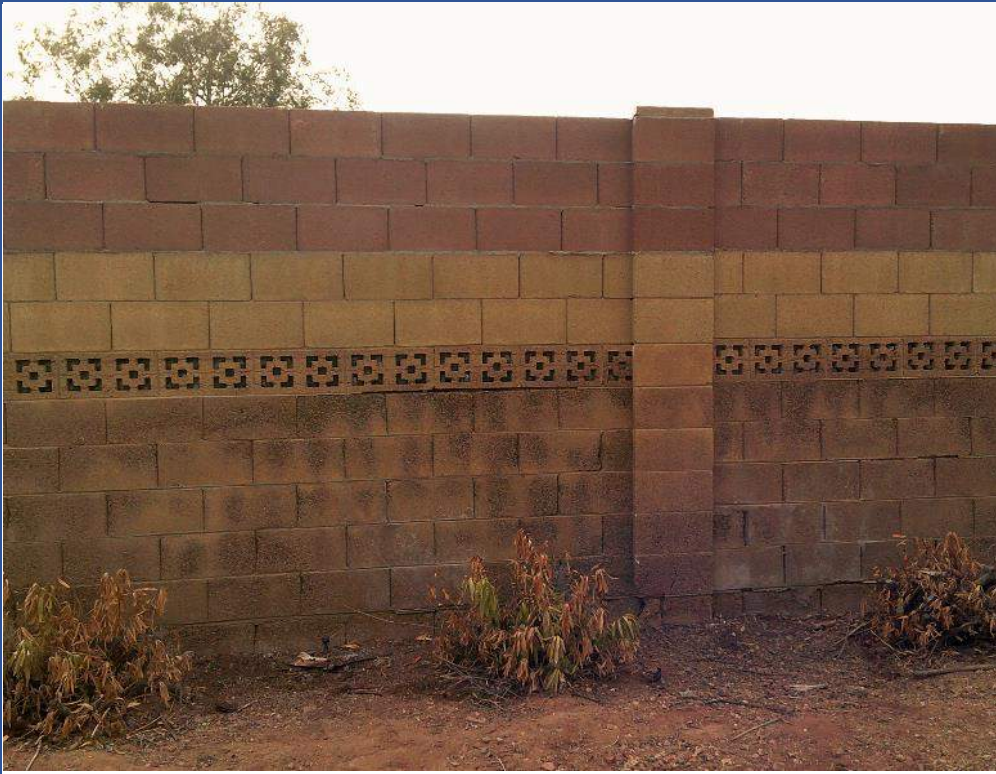
147

Lot 91 - Moderate delamination. Exposed and corroded dur-o-wire.

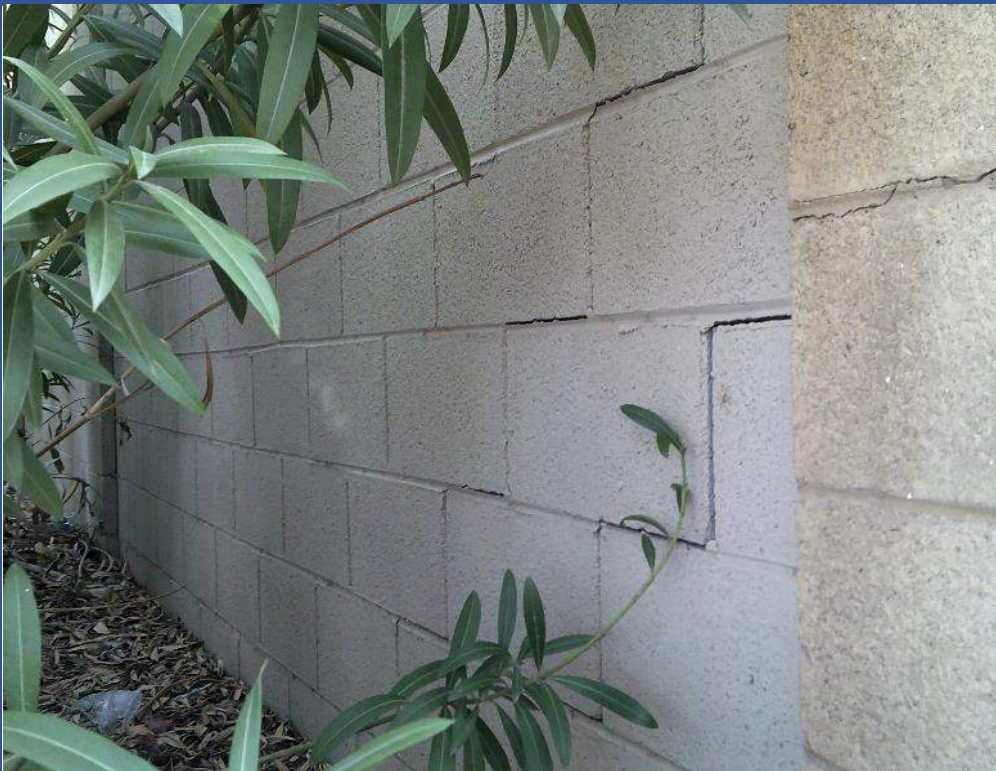
148

Lot 92 - Staircase crack. Overgrowth. Negative slope towards wall.

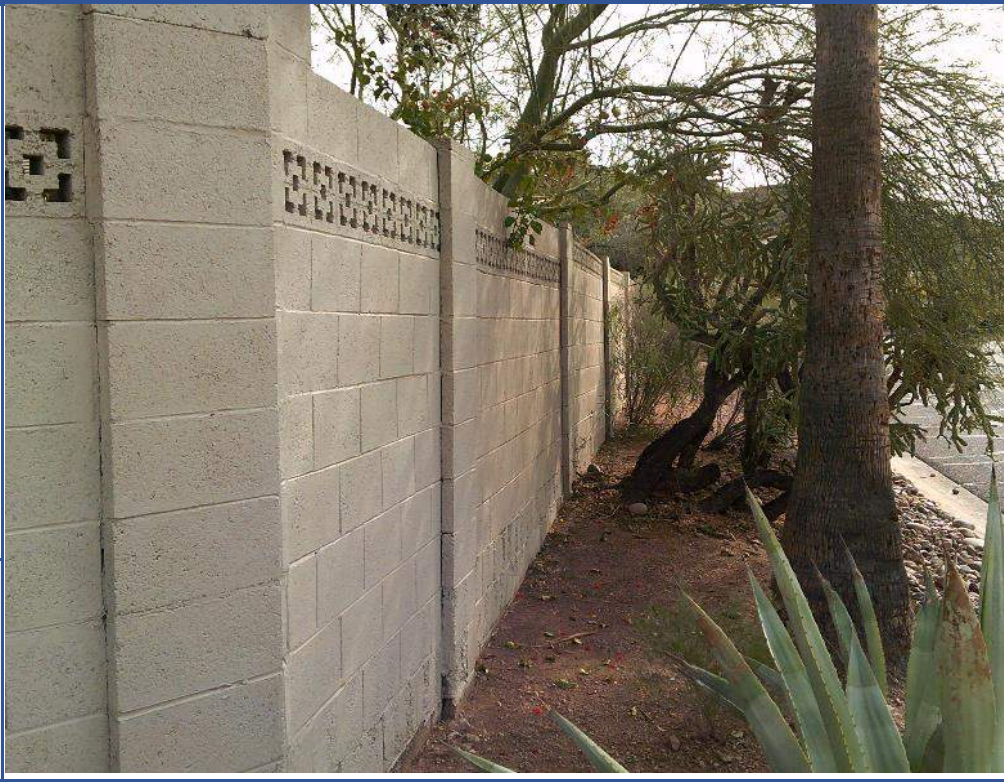
<p>Description:</p> <p>Lot 95S - Delamination. Overgrowth.</p>
<p>153</p>

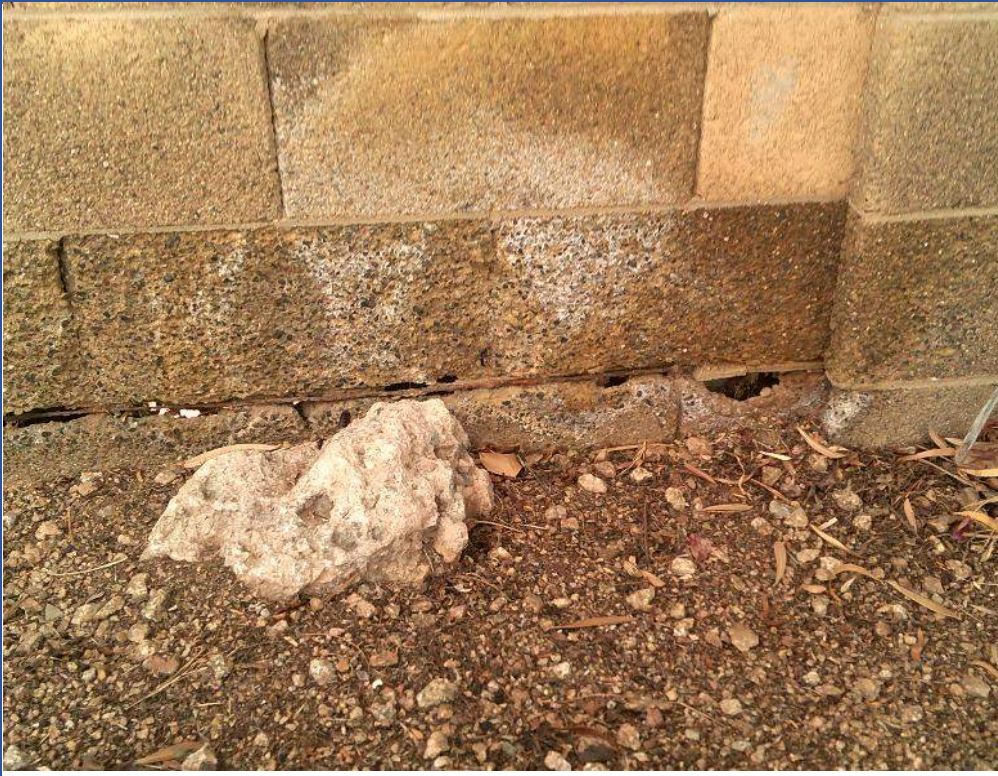
Lot 96 - Moderate delamination with delaminated grout. Exposed and corroded dur-o-wire.

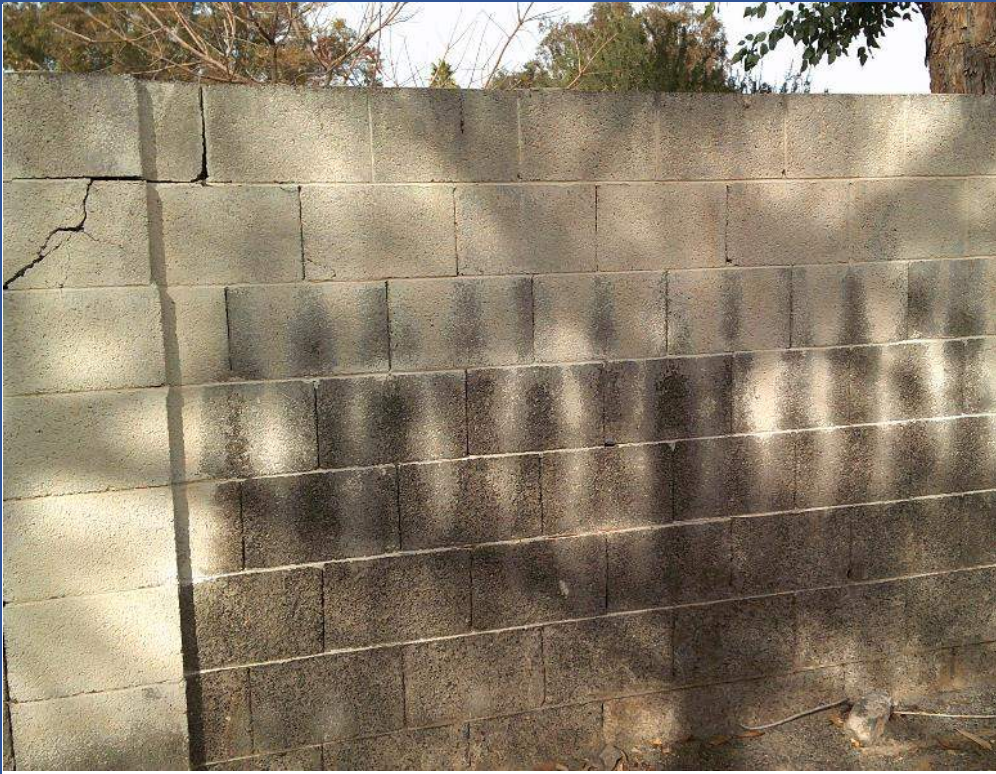
Lot 104 -
Delamination. Diagonal
crack on column.

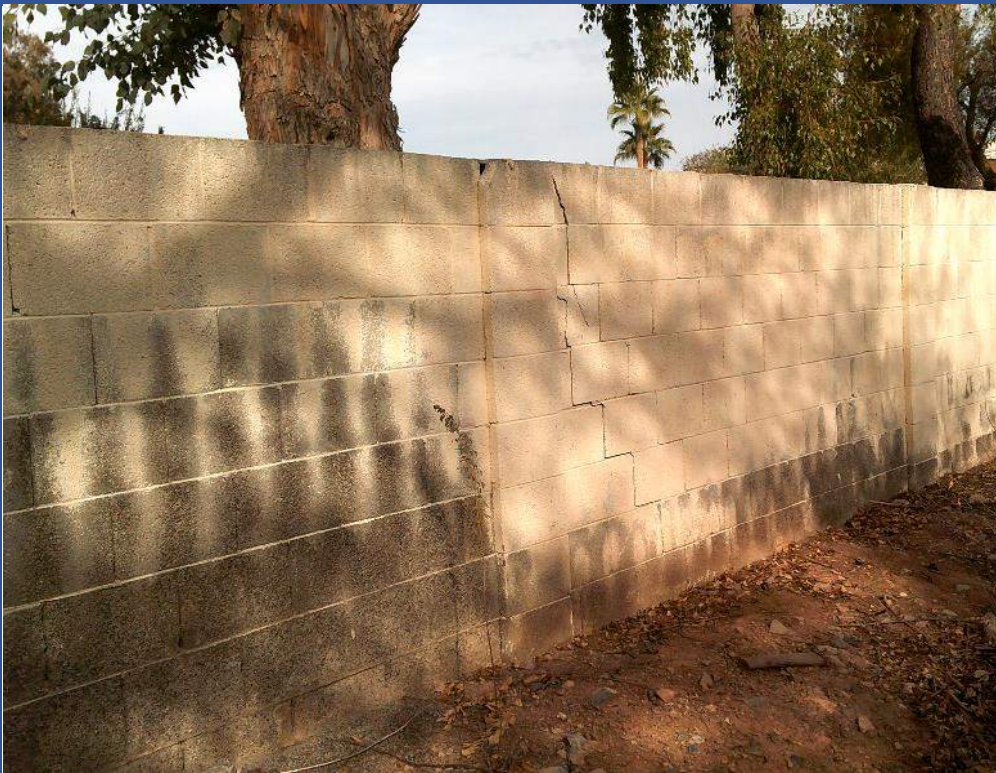
Lot 104 - Staircase
crack up to
approximately 1/4".

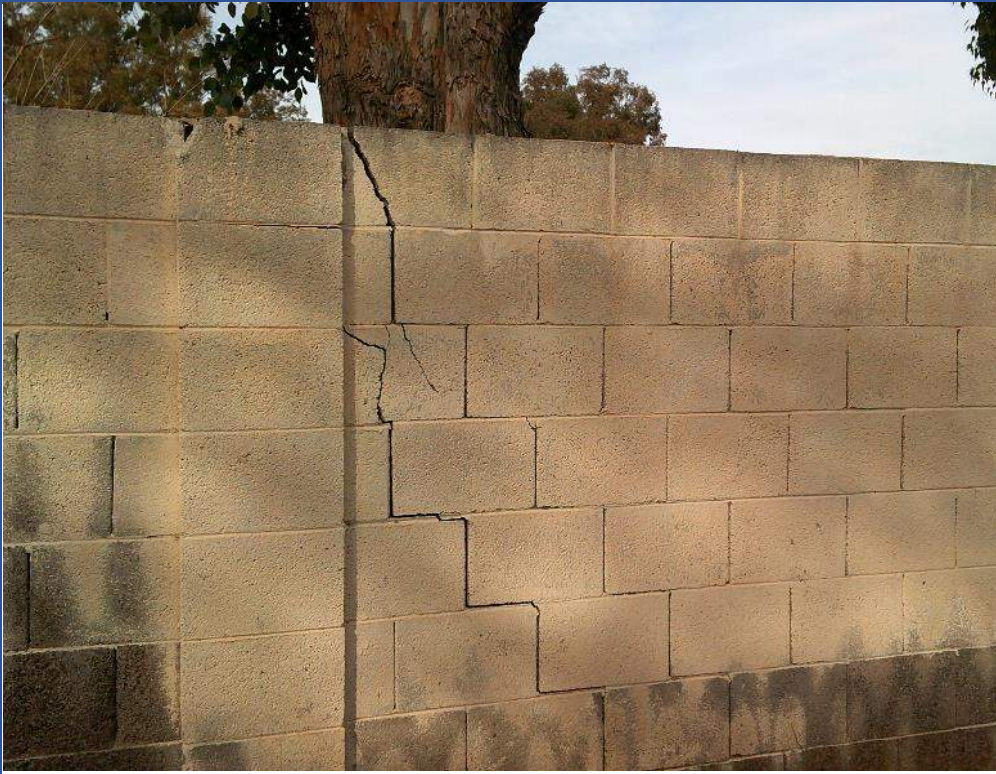
Lot 104 - Staircase
crack up to
approximately 1/4".

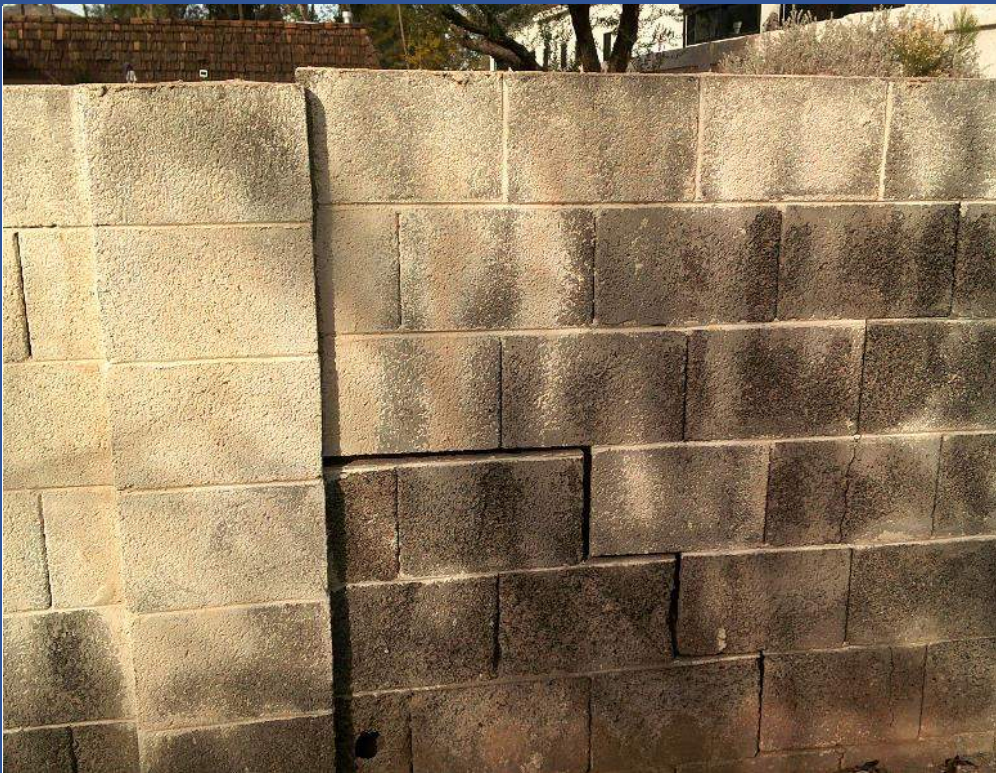
Lot 104 - Significant
delamination. Exposed
and corroded dur-o-
wire. Uplift.
