CAMELBACK CANYON ESTATES BLOCK WALL EVALUATION

Final Submittal: January 31, 2024

PROPERTY: CAMELBACK CANYON ESTATES COMMUNITY
PHOENIX, ARIZONA

SERVICE: 23-0433 – BLOCK WALL STRUCTURAL EVALUATION

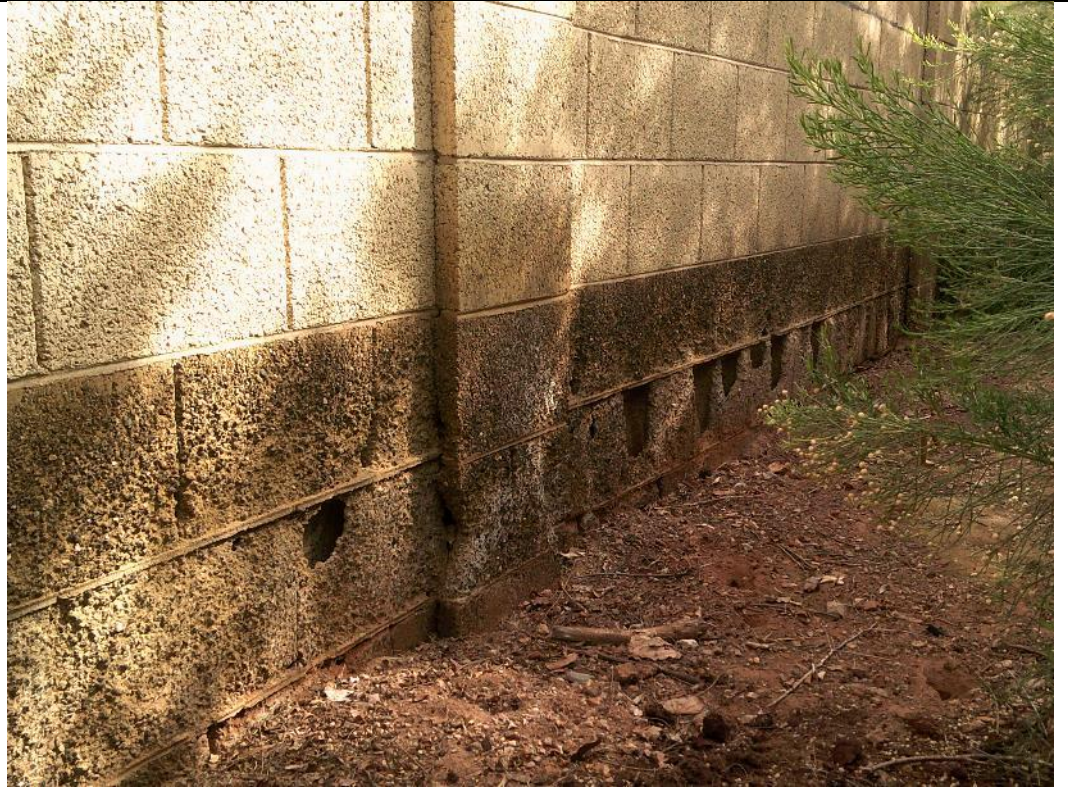
- ✓ Water intrusion leading to block delamination

Water intrusion is sometimes visibly observed by the presence of efflorescence and may result in the delamination and block degradation, eventually leading to structural failure.

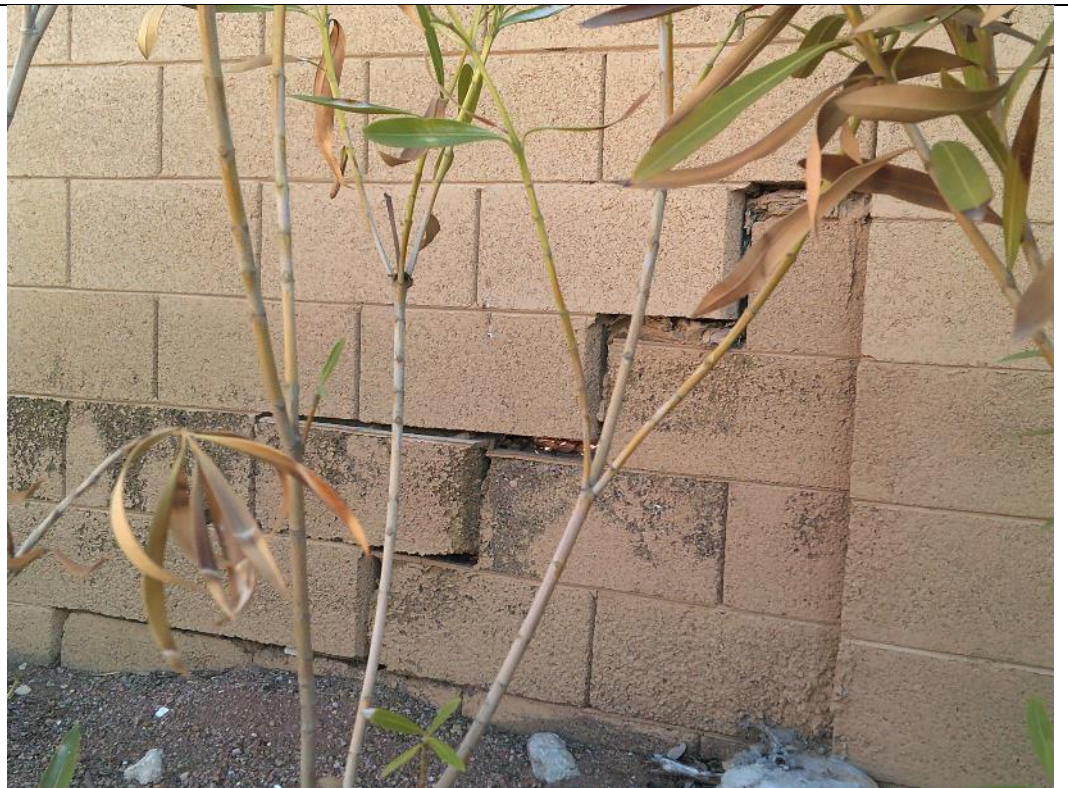
- ✓ Stair step cracking

Stair step cracking is typically a result of movement in the block wall foundation, tree roots, and/or the wall experiencing a permanent lean or "tilting". The condition becomes exacerbated when moisture intrusion exists in addition to the movements described above.

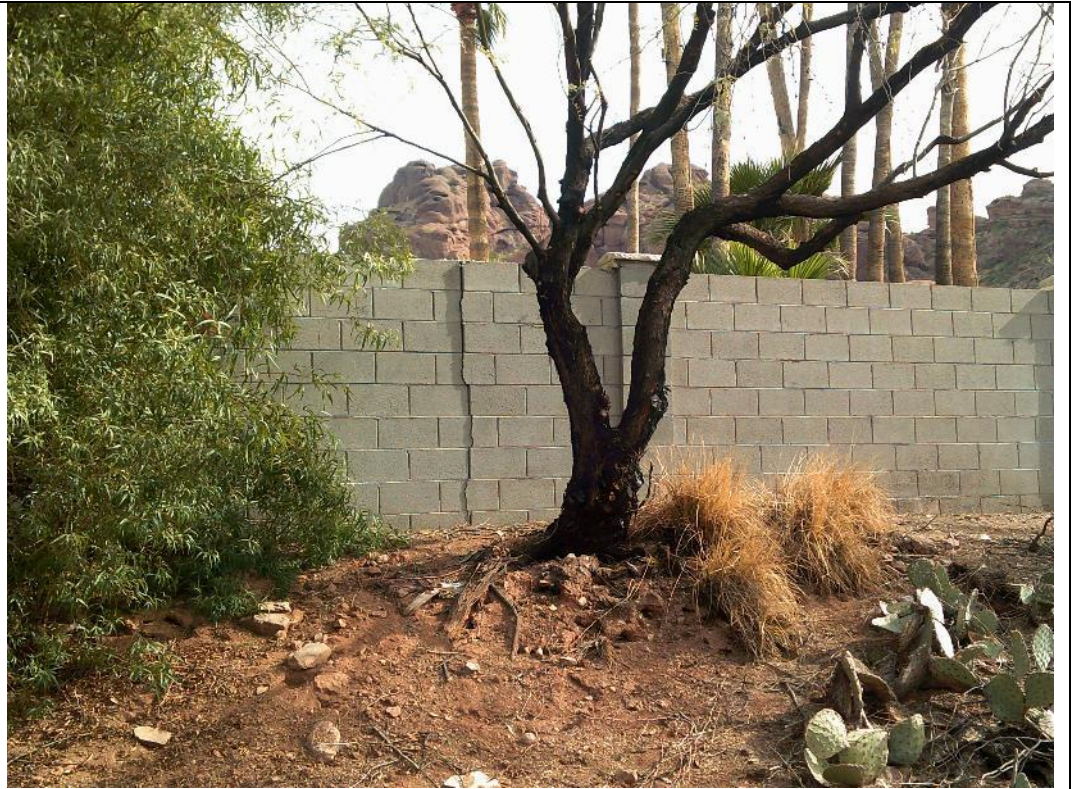
✓ Vertical Cracking

Vertical cracking is typically a result of either control joints that are too far apart, wall rotation / leaning, or some type of external element such as tree roots or tree branches. Water intrusion into the wall can exacerbate the condition.

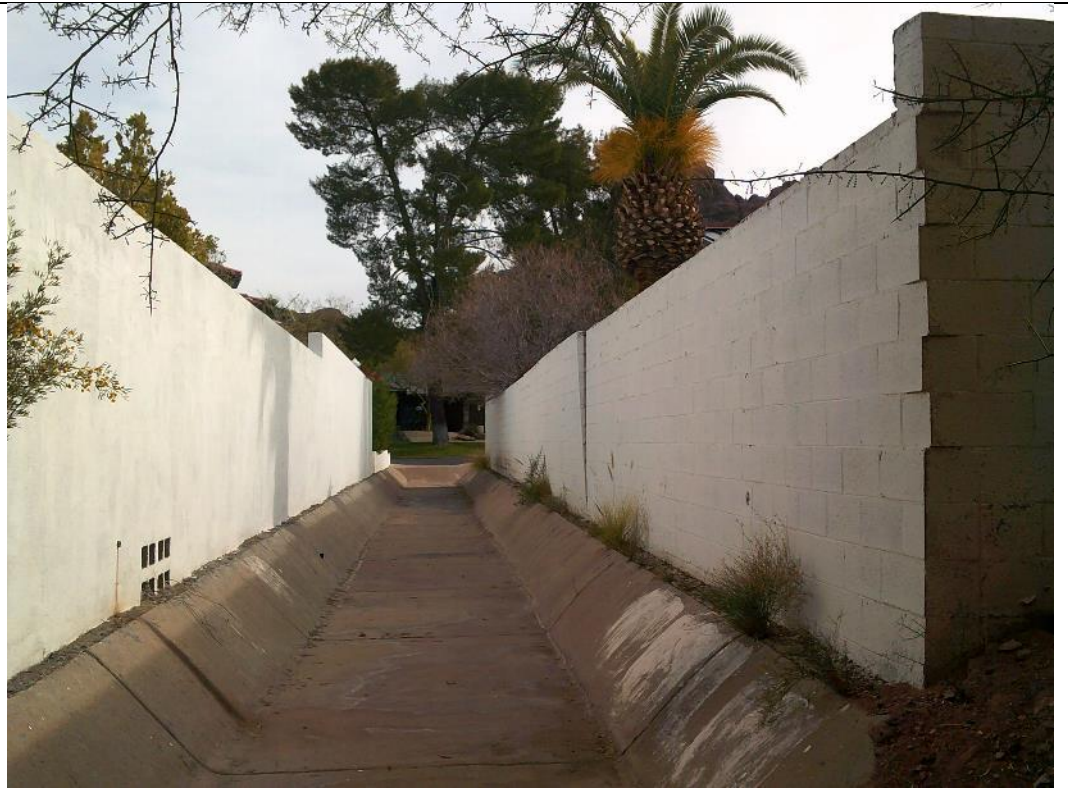
✓ Leaning or "tilting" wall segments and view fence

Leaning or "tilting" wall segments typically occur due to missing vertical reinforcement, insufficient footings, or structural failure of the internal wall elements (such as at the bond beam).

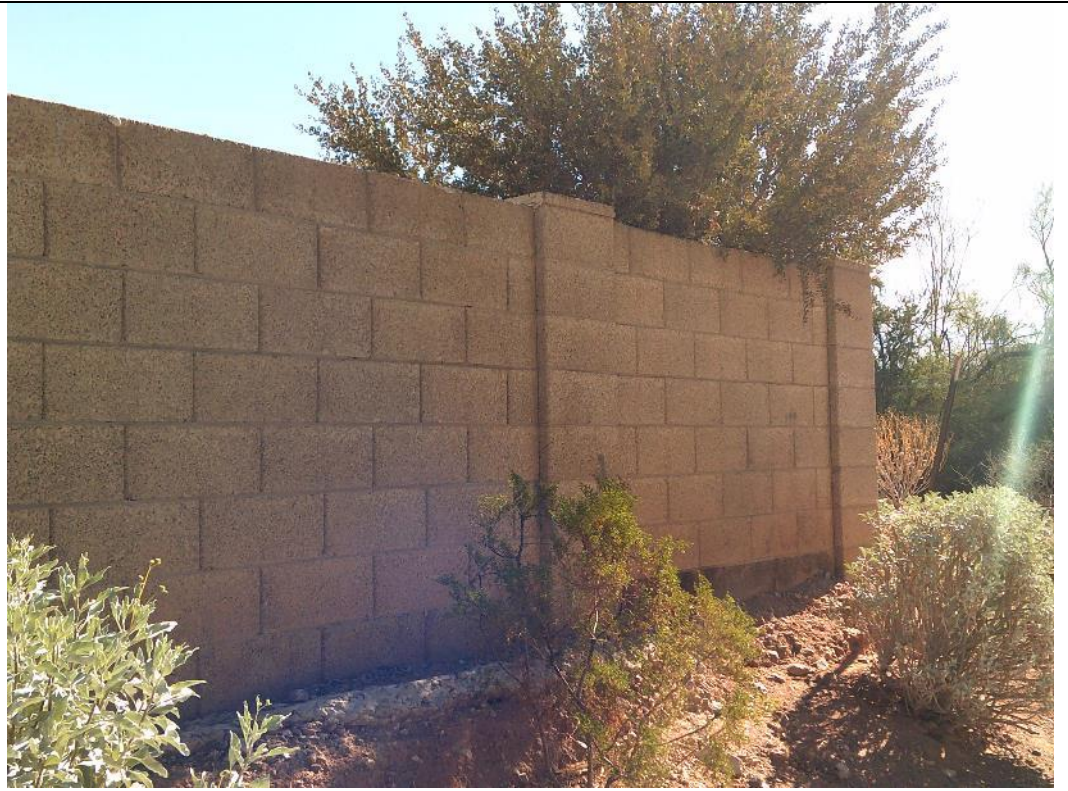
✓ Exposed Footings
Through Erosion or
Construction

Exposed footings are typically of two types – either because they were constructed in a way that they were never fully covered (which is not usually a problem for the walls), or footings that are exposed due to erosion. If the footings are exposed from erosion, this may result in significant structural deficiencies or wall failure.

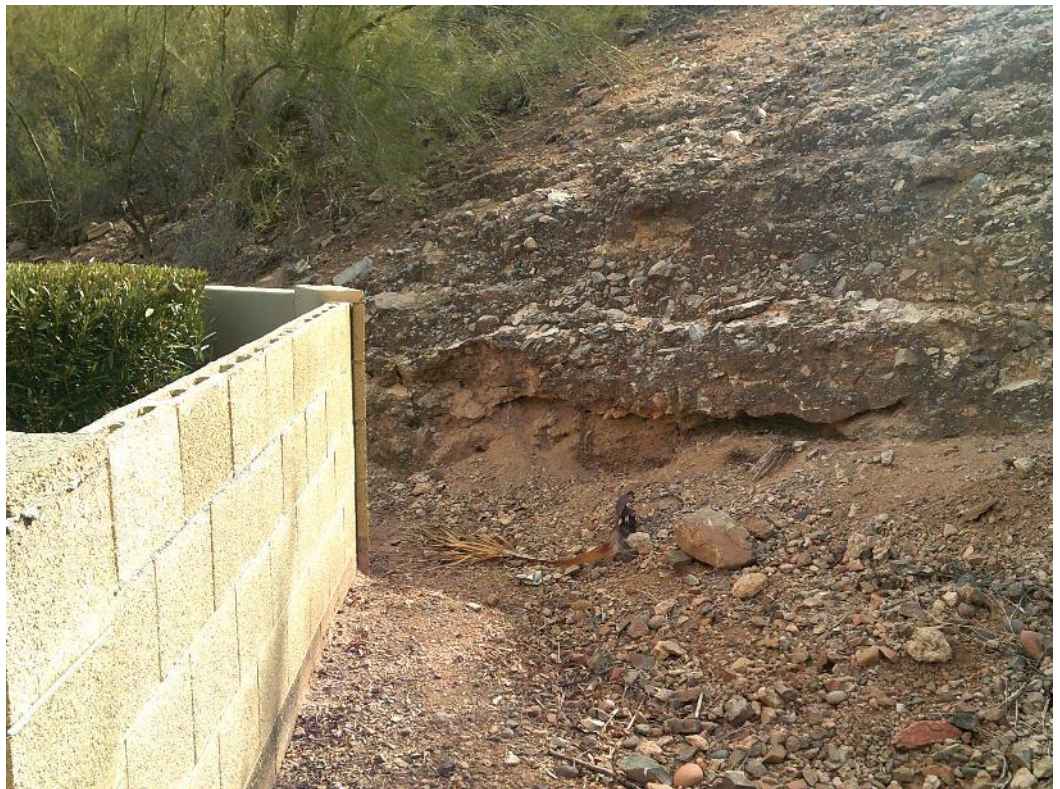
✓ General Wall
Repairs

General wall repairs include corroded wrought iron, broken blocks, missing/broken top caps, holes in the walls, broken CMU blocks, missing bolts on wrought iron fencing, missing column top caps, missing trim on columns, and other similar repair issues.

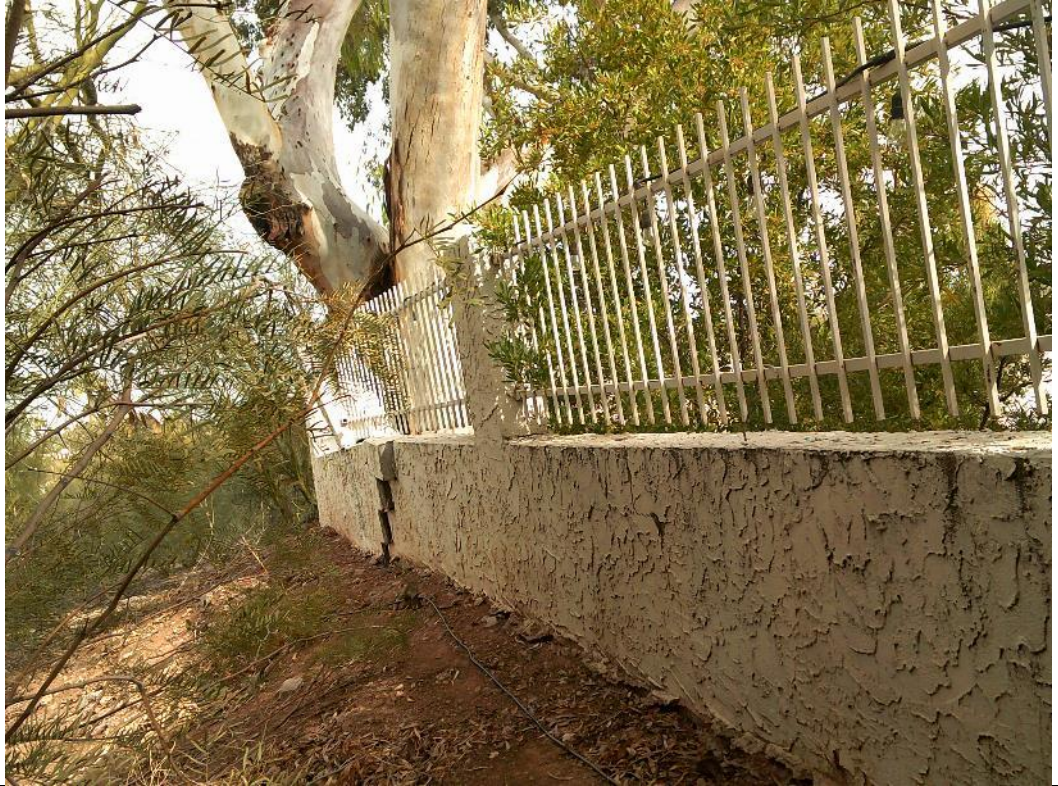
✓ Landscape
Overgrowth and
Irrigation
Systems

Landscape planters, shrubs, and tree overgrowth can allow moisture penetration into the wall and in the case of trees, the roots can undermine the footing system causing failure. In addition, many times irrigation systems will be a source for masonry walls to be constantly soaked leading to delamination and ultimate failure.

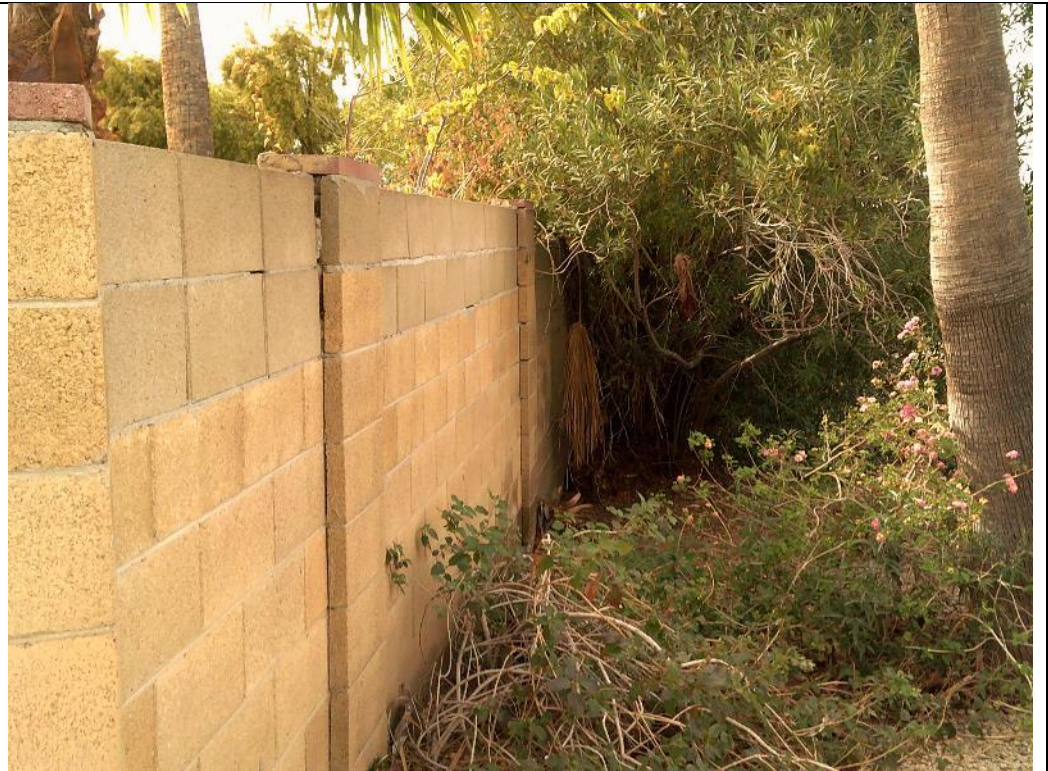
✓ Landscape
Overgrowth and
Irrigation
Systems

Landscape planters, shrubs, and tree overgrowth can allow moisture penetration into the wall and in the case of trees, the roots can undermine the footing system causing failure. In addition, many times irrigation systems will be a source for masonry walls to be constantly soaked leading to delamination and ultimate failure.

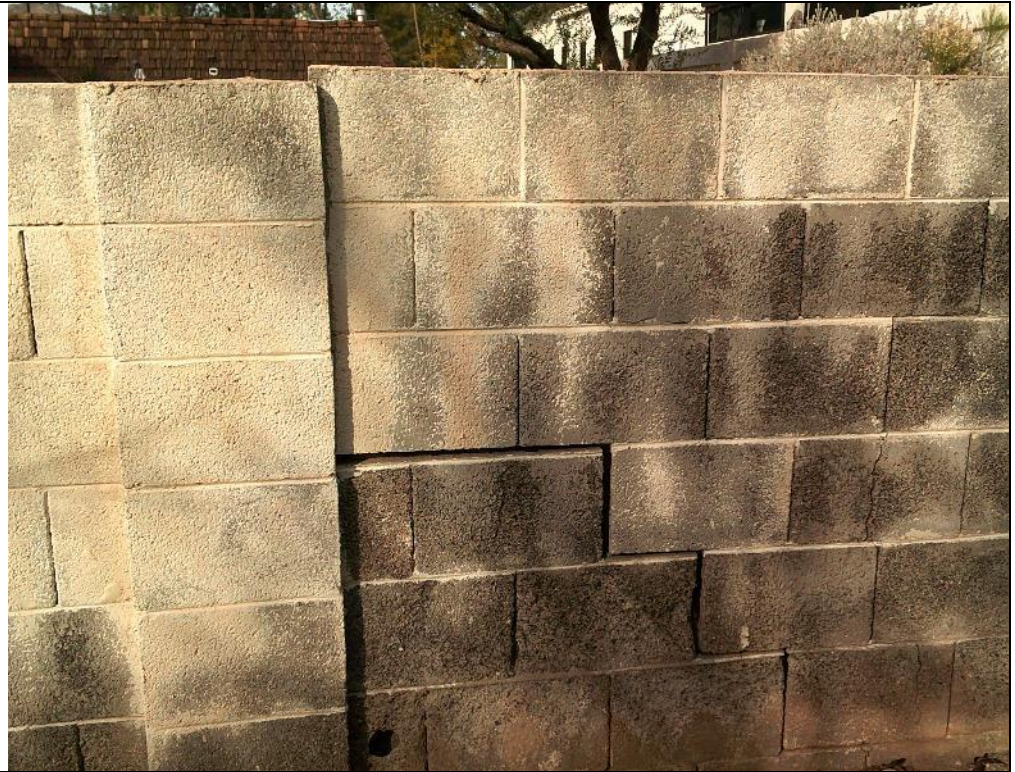
✓ Uplift

Roots from vegetation and settlement of the wall can cause uplifting conditions for a portion or all of the wall. Portions of the walls grout can debonded and separate the CMU courses and limiting the integrity of the wall.

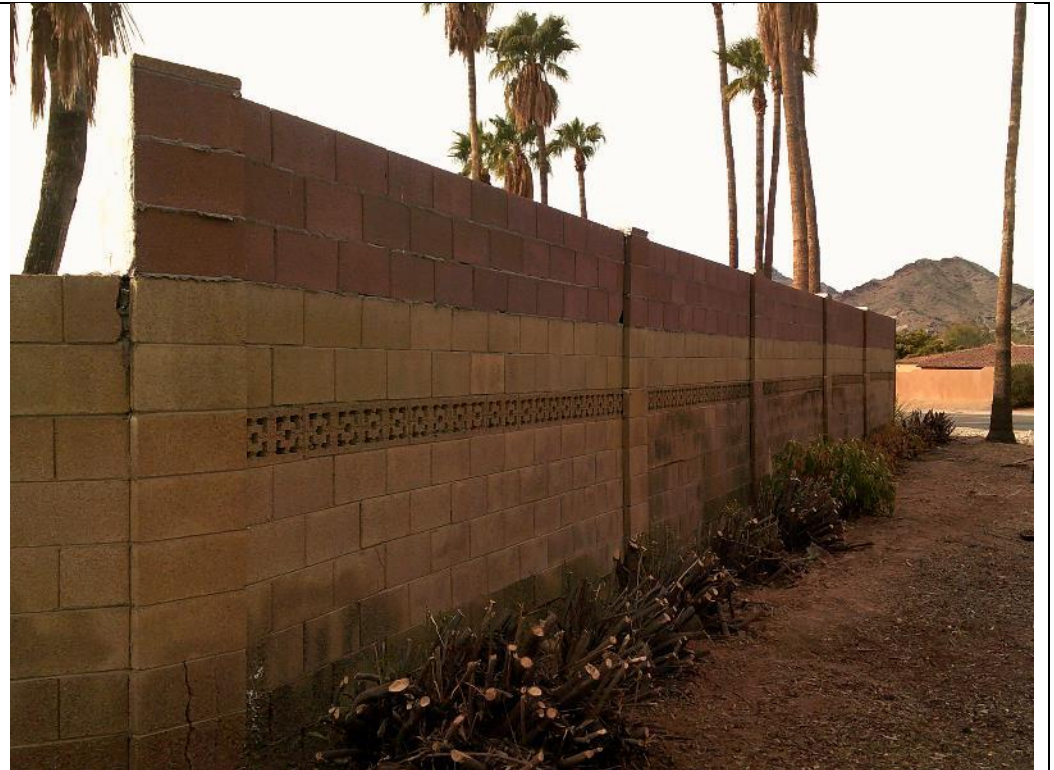
✓ Built-Up Wall

Landscape When the wall is increased in height, the wall is built up. A built-up wall may be overloading the wall below from the vertical reinforcing and the footing size may be improperly sized with respect to the wall height. Wall rotation and partial collapse has potential to occur.

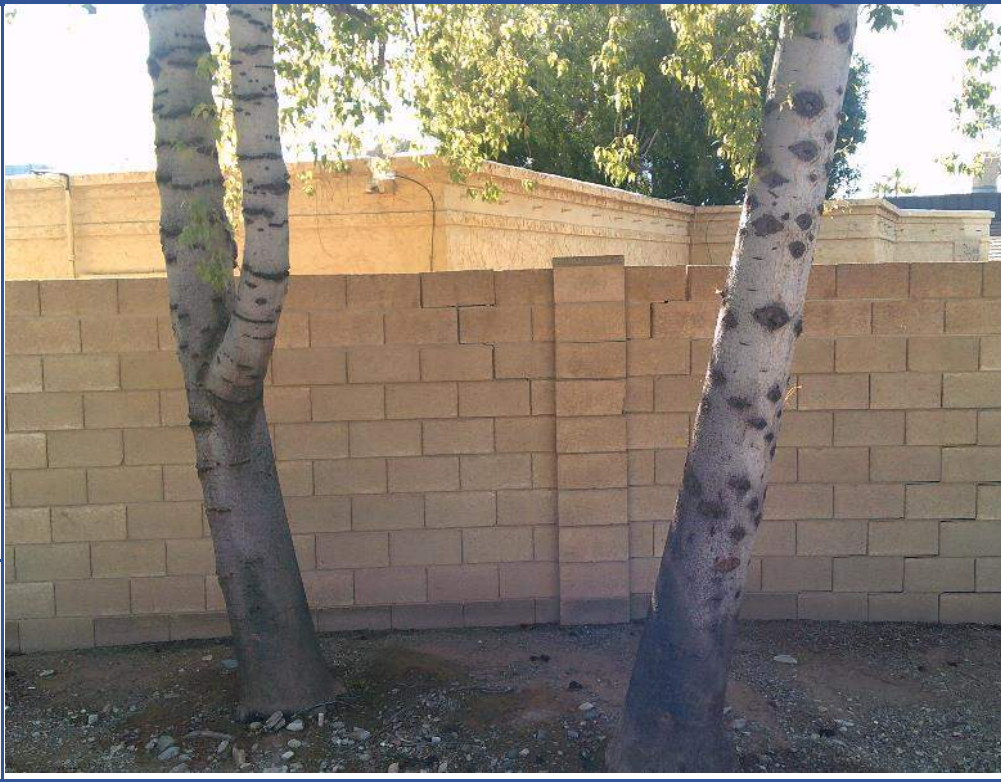
PHOTO NUMBER
2

Lot 1S - Column rotation up to approximately 1/2". Multiple hairline stair case crack.

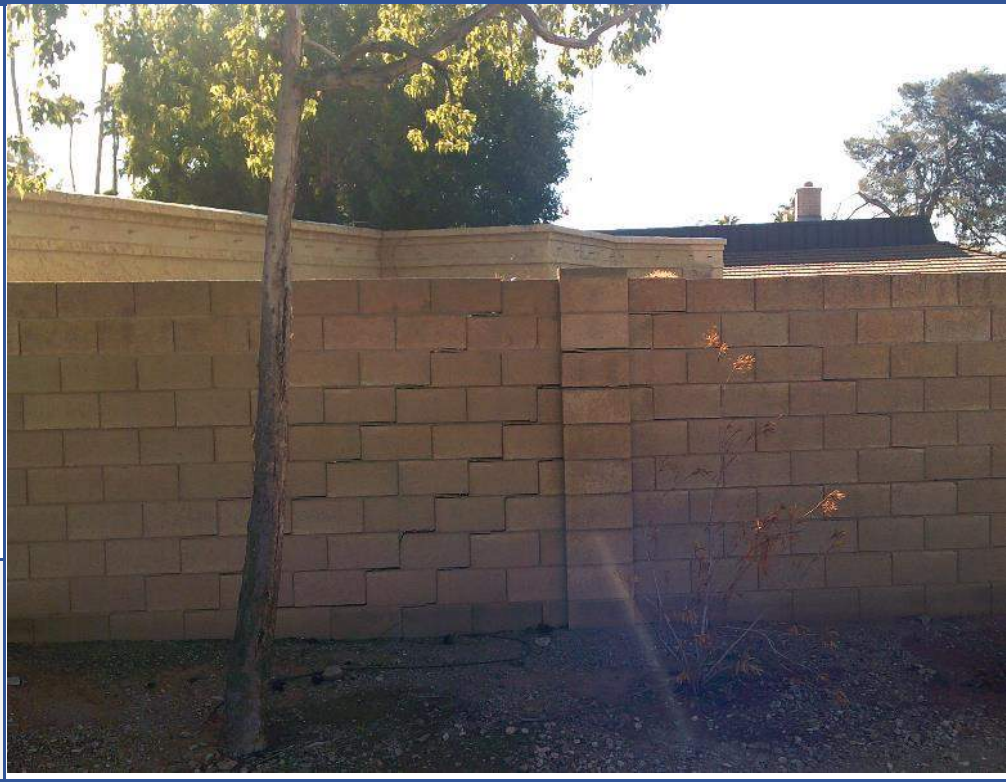
<p>Description:</p> <p>Lot 1S - Multiple hairline stair case crack. Potential uplift.</p>
<p>3</p>

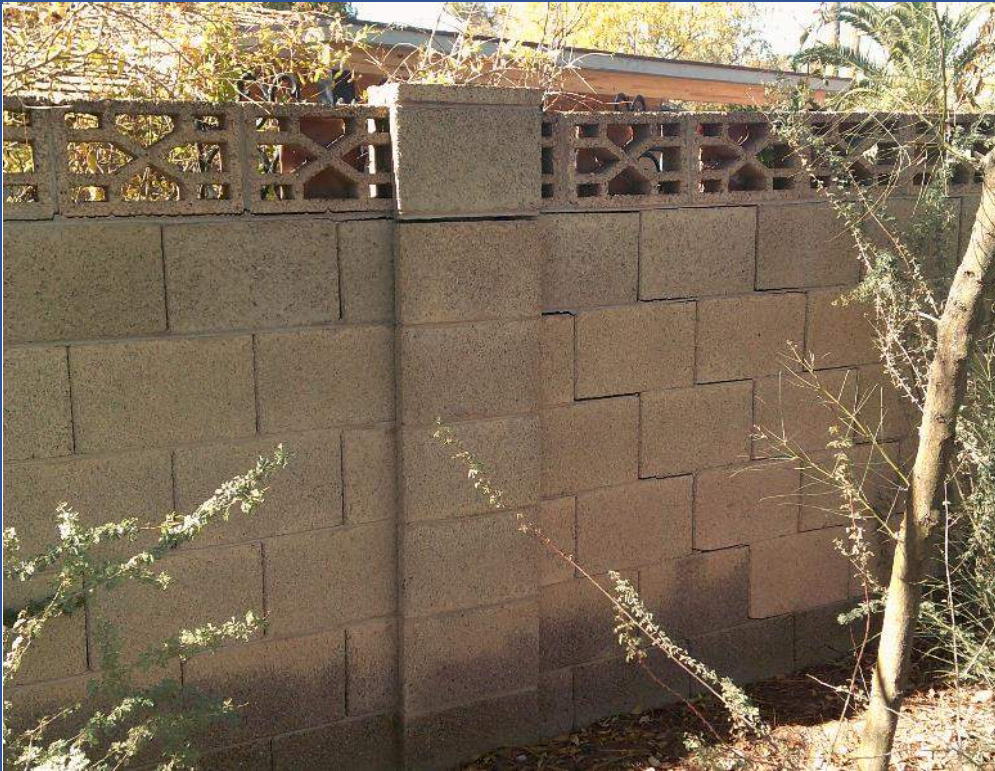
10

Lot 6 - Column separation up to approximately 1/2". Multiple hairline staircase cracks.

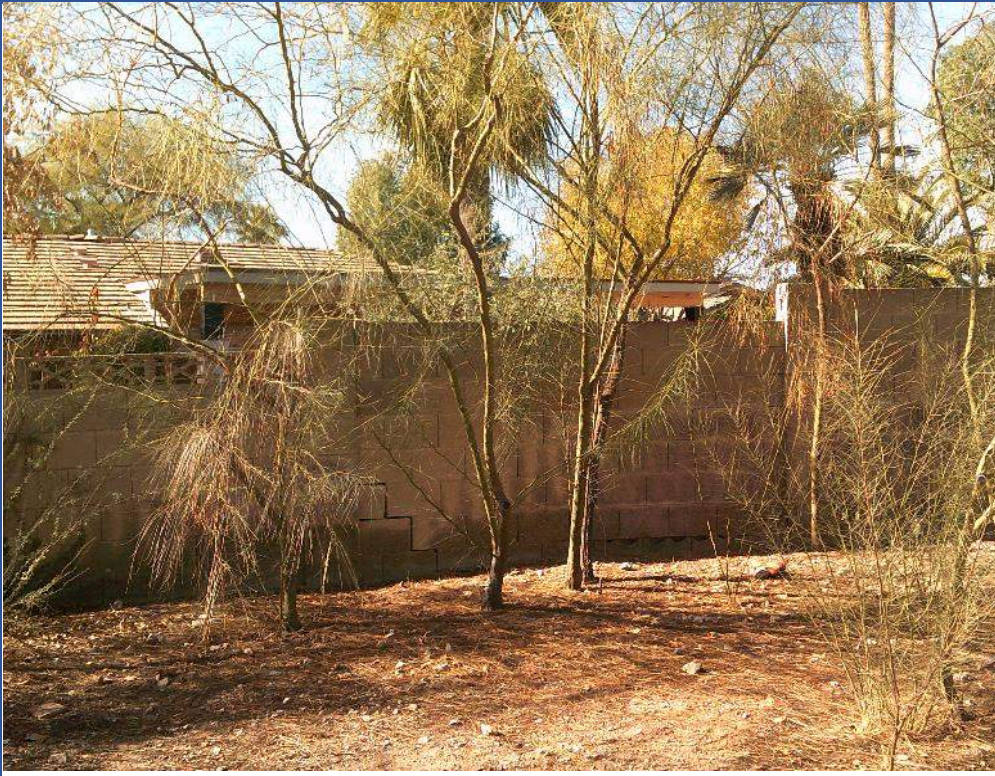
11

Lot 6 - Significant delamination. Column rotation up to approximately 1/2". Staircase crack up to approximately 3/4". Overgrowth.

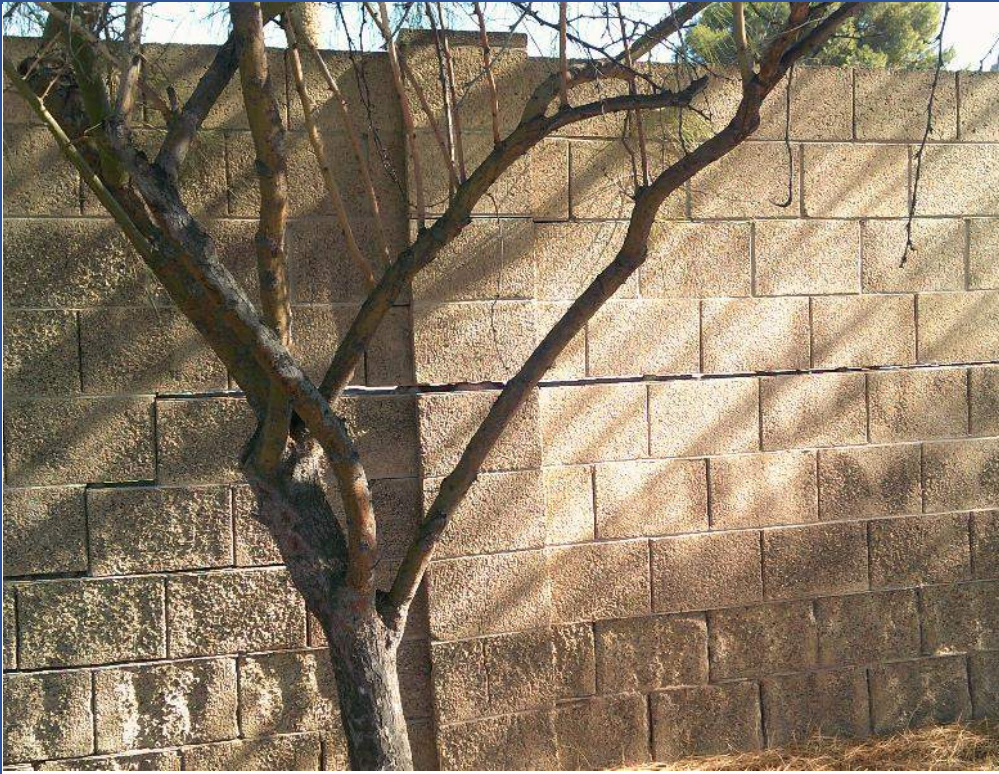
14

Lot 8S - Staircase crack and column separation.

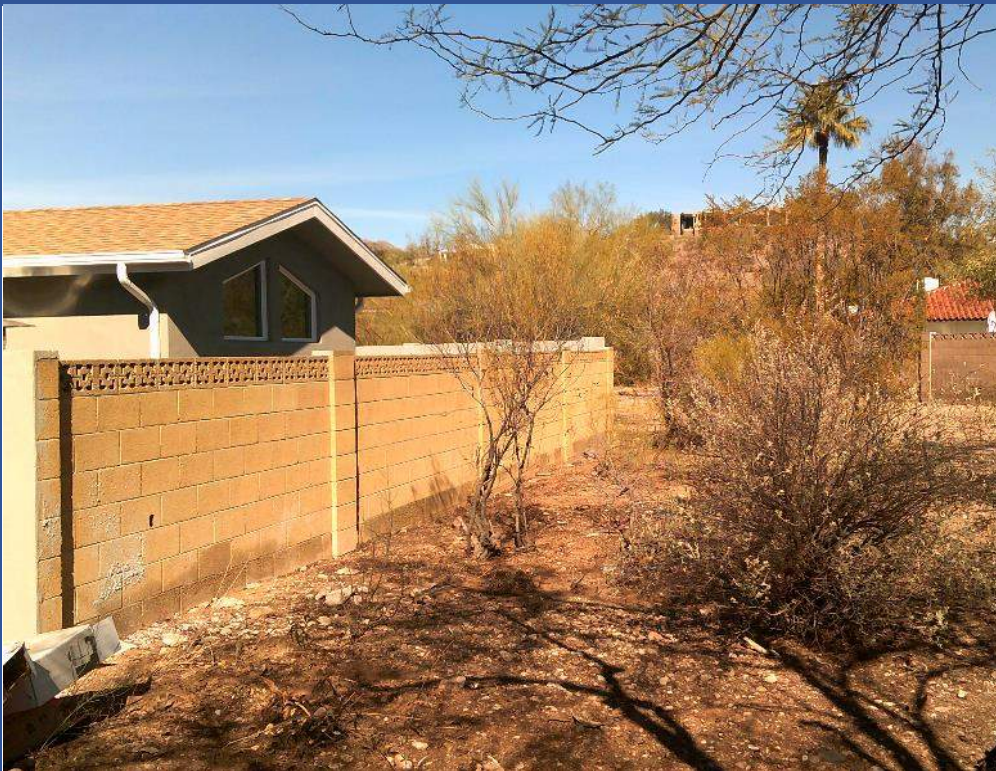
16

Lot 11S - Moderate delamination. Hairline staircase crack. Hole in course.

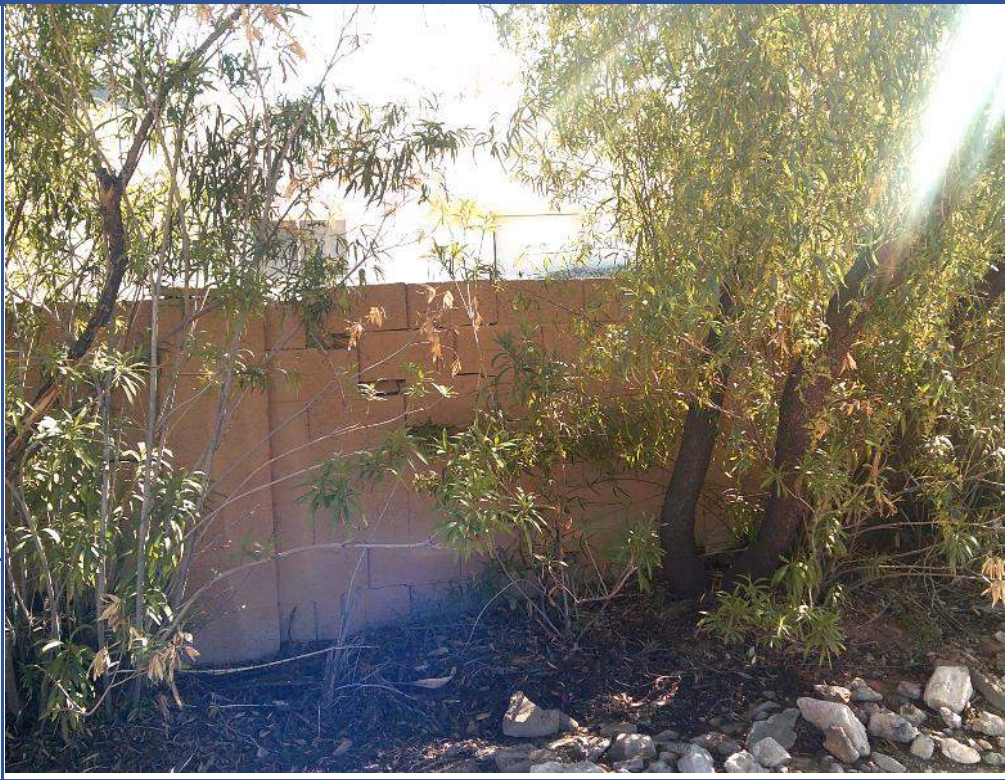
Lot 13 - Overgrowth.
Loose top cap. Uplift at
2-1/2".

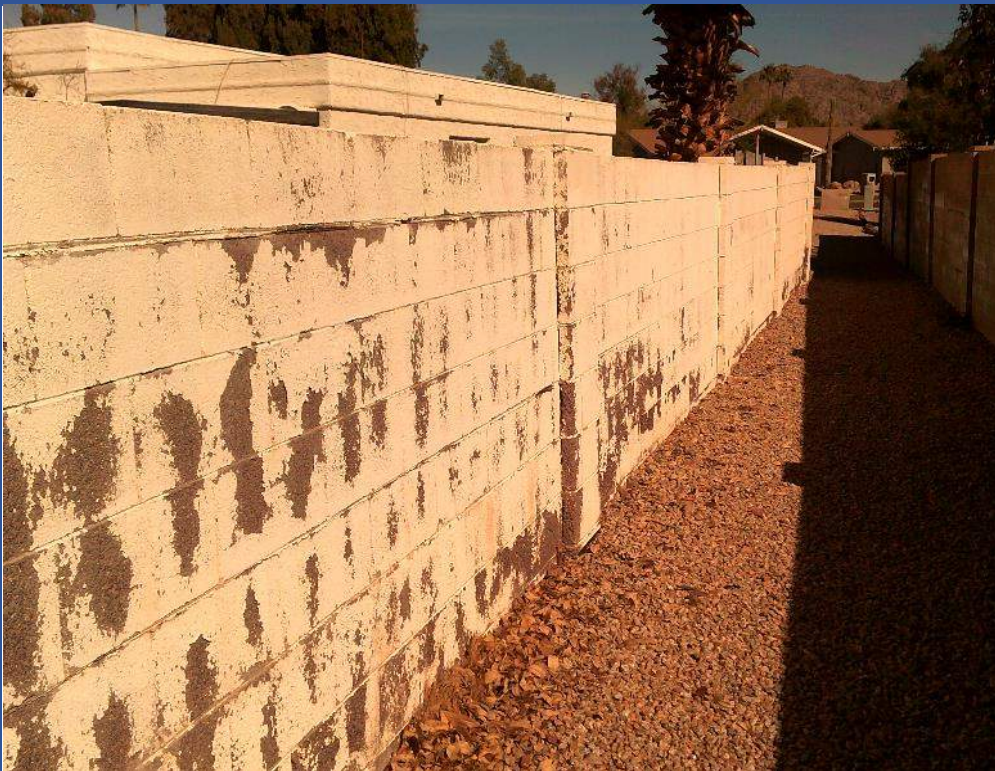
31

Lot 13S - Delamination.
Exposed and corroded
dur-o-wire.

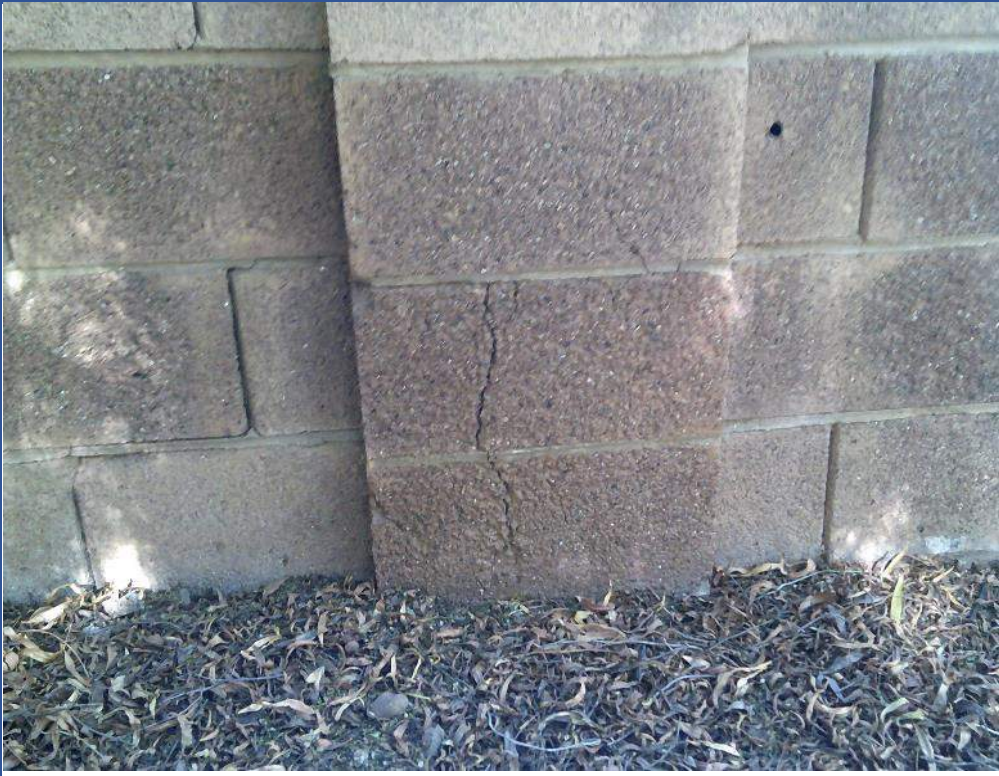
43

Lot 19 - Delamination.
Hairline staircase crack.
Hairline vertical crack.

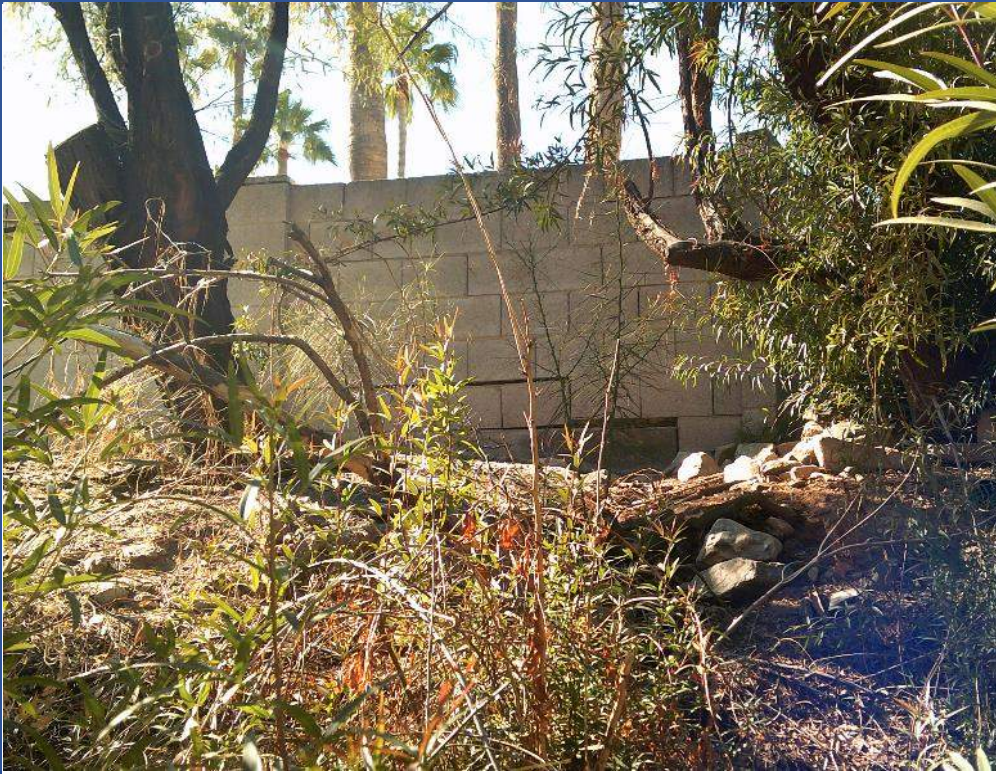
Lot 23 - Separation of courses with large staircase crack. Potential uplift.

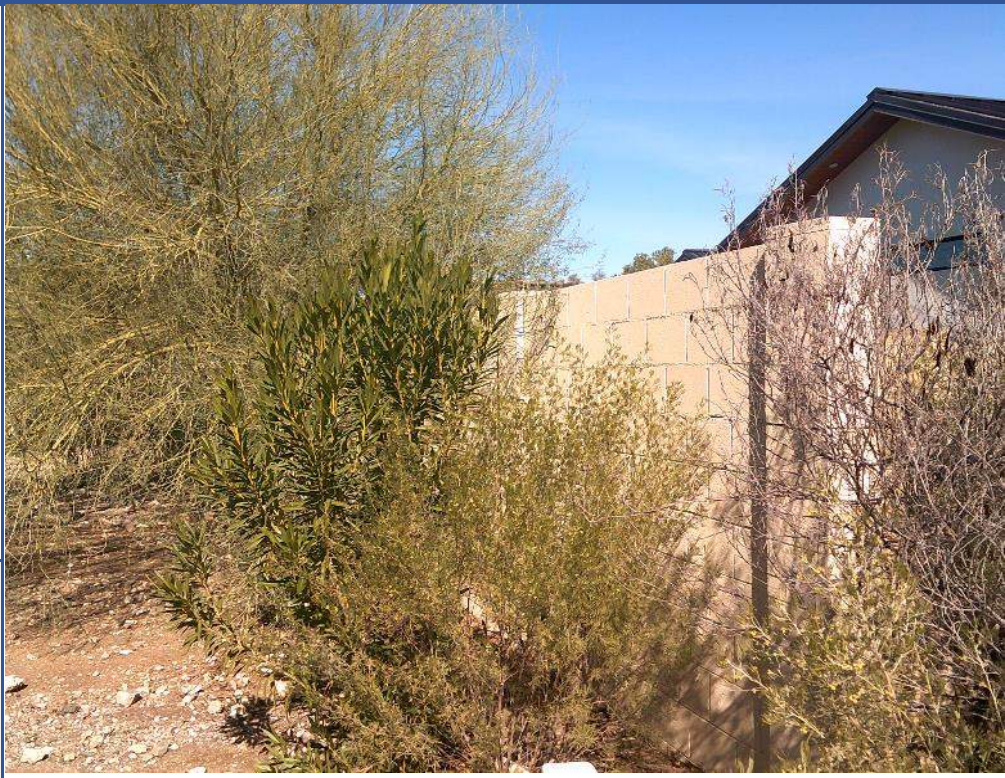
53

Lot 26 - Overgrowth.
Loose top cap.

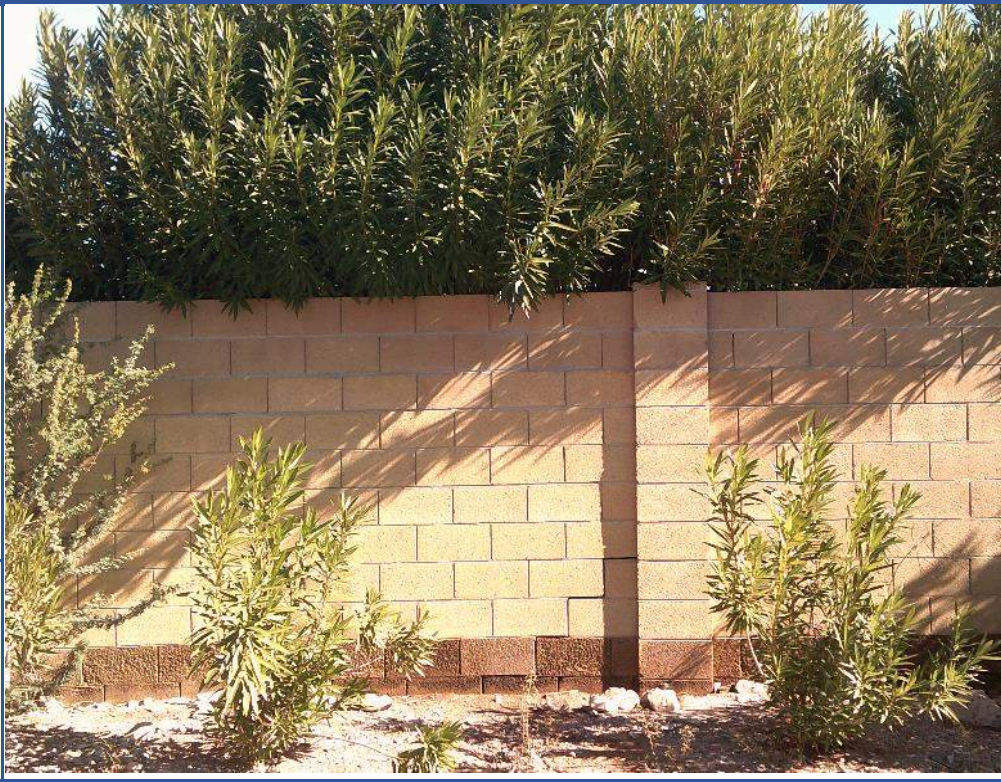
56

Lot 27 - Delamination. Overgrowth. Staircase crack.

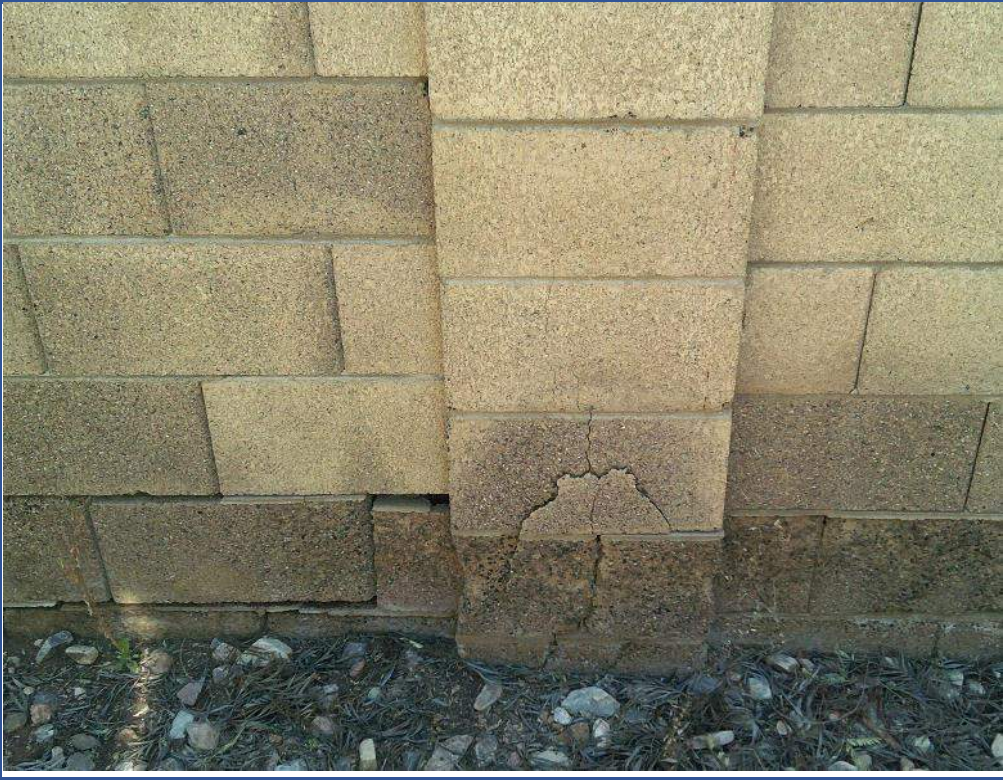
59

Lot 27 - Staircase
crack. Delamination.

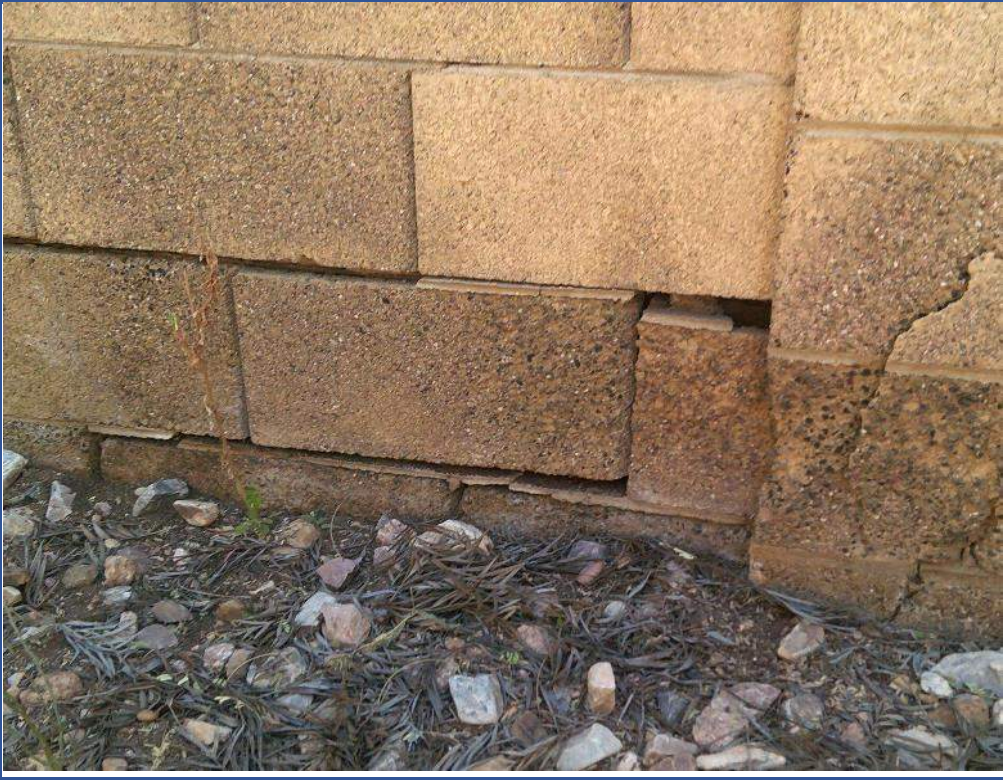
60

Lot 27 - Staircase
crack. Delamination.

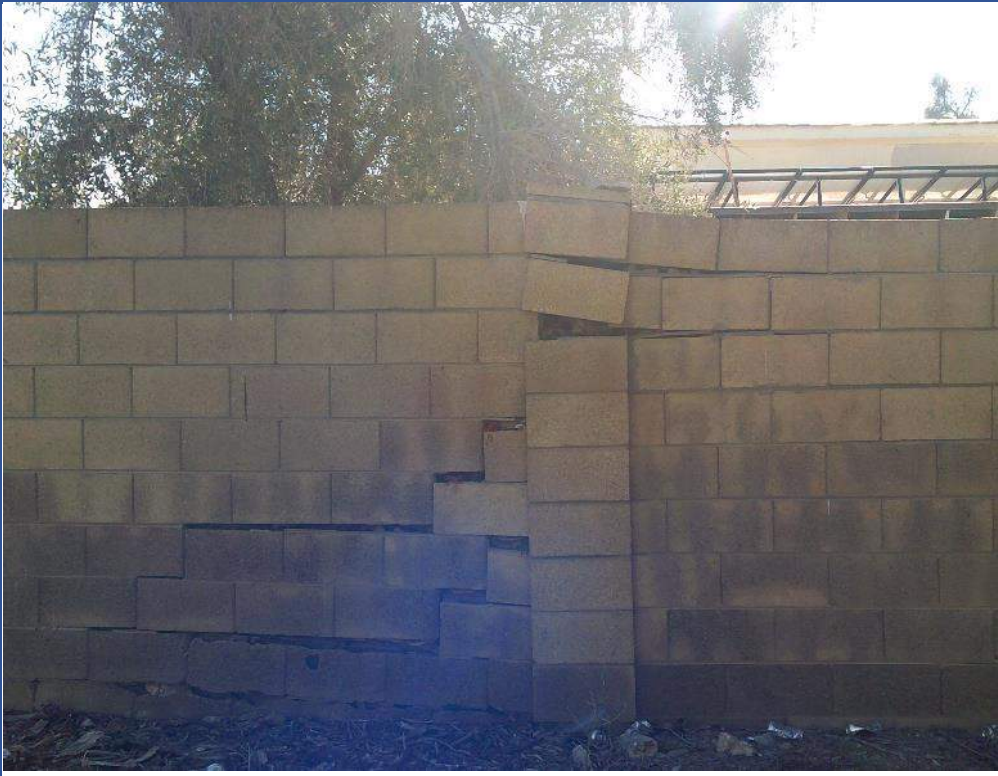
63

Lot 28 - Uplift up to approximately 2".
Column rotation up to approximately 1.5" on a 6-foot wall. Potential tree falling on wall.
Staircase crack up to approximately 2".

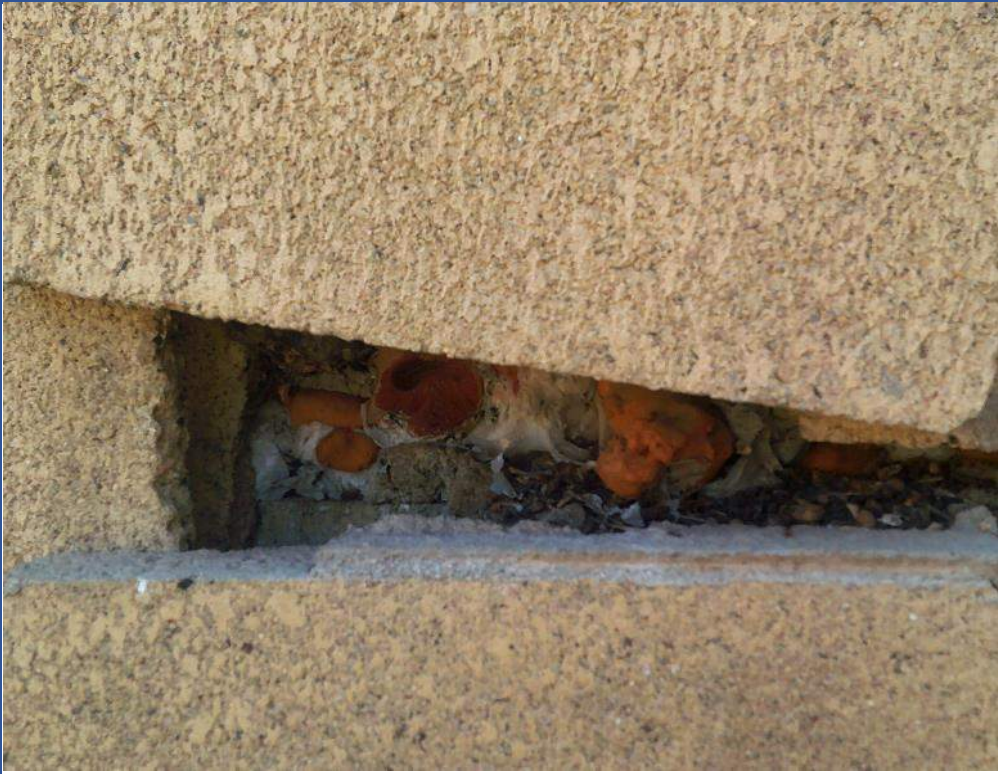
64

Lot 28 - Previous repairs.

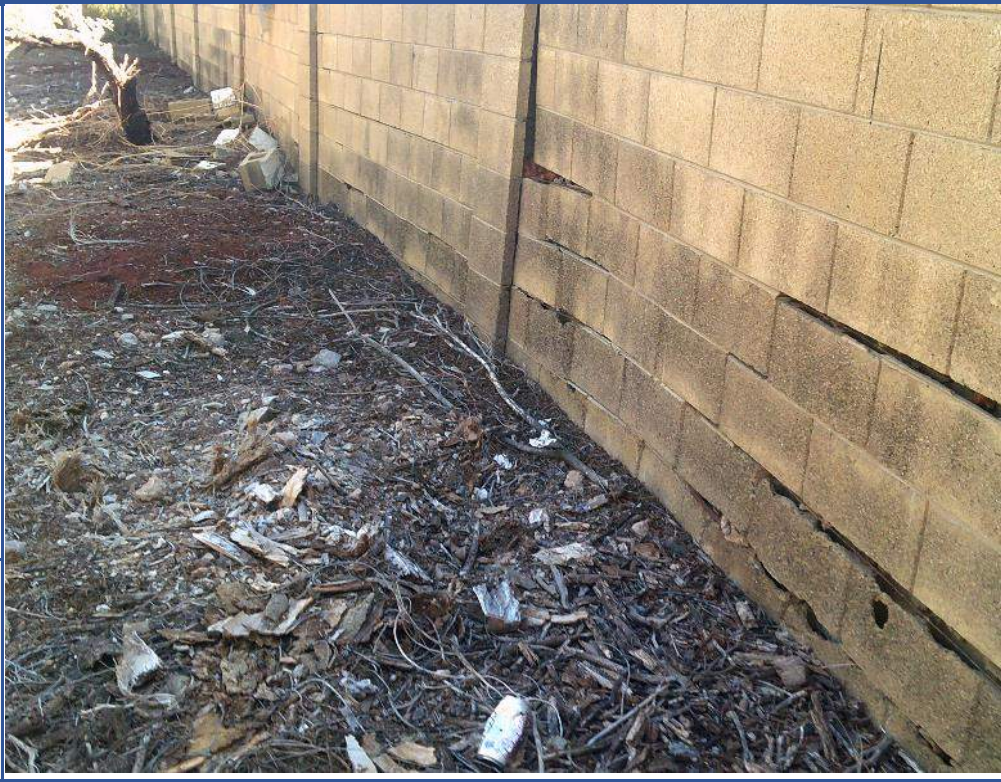
65

Lot 28 - Uplift and staircase crack.
