CAMELBACK CANYON ESTATES BLOCK WALL EVALUATION

Final Submittal: January 31, 2024

PROPERTY: CAMELBACK CANYON ESTATES COMMUNITY
PHOENIX, ARIZONA

SERVICE: 23-0433 – BLOCK WALL STRUCTURAL EVALUATION

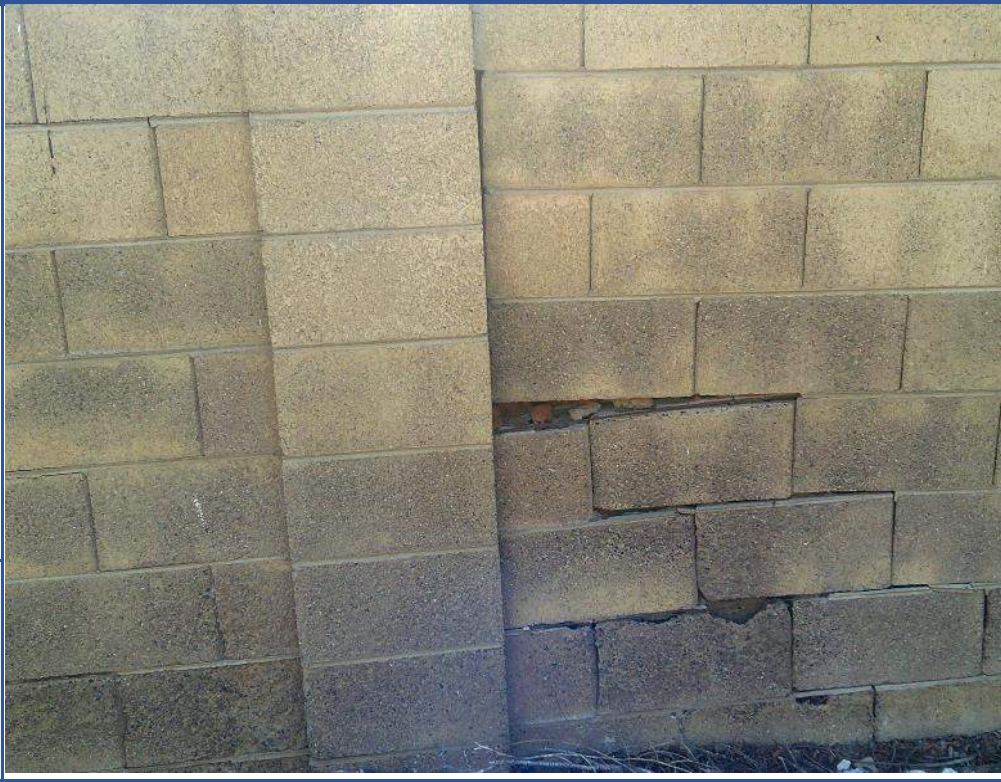
66

Lot 28 - Delamination staircase crack with previous repairs.

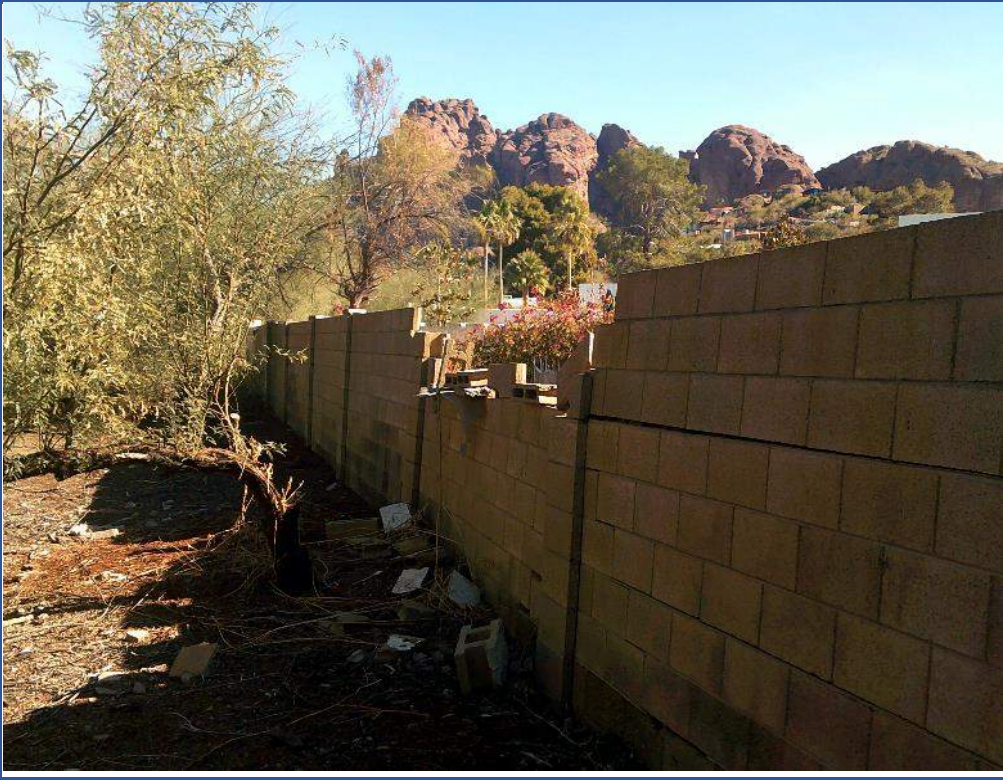
67

Lot 28 - Column rotation up to approximately 1.5" on a 6-foot wall. Potential tree falling on wall. Staircase crack up to approximately 1/2".

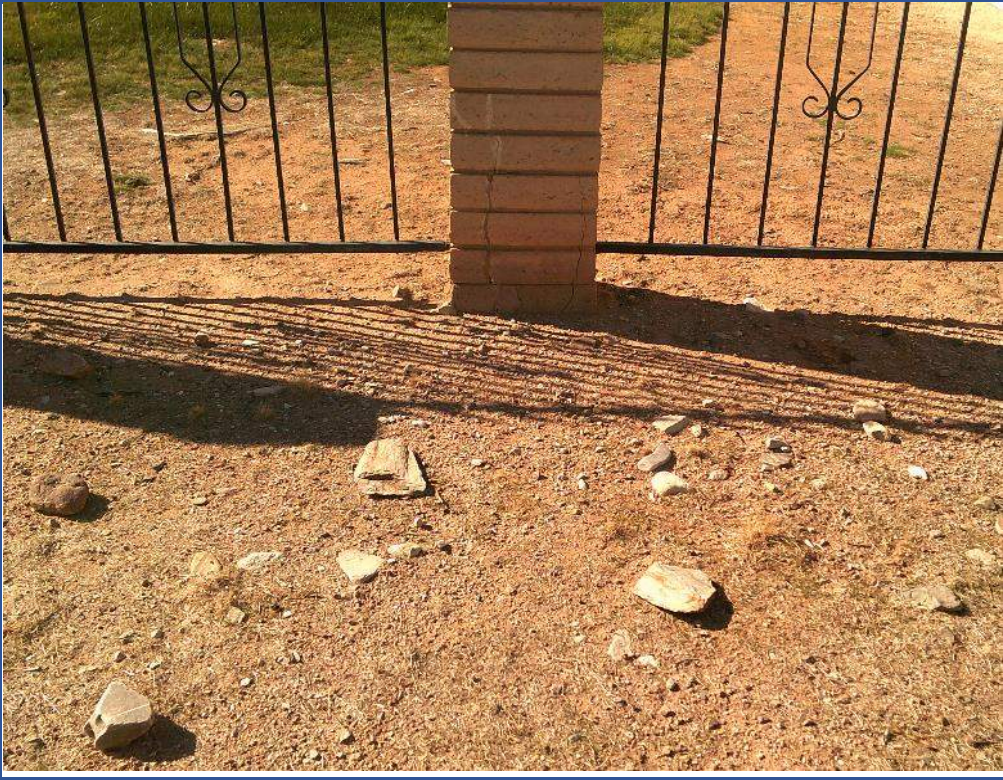
68

Lot 30 - Column rotation. Cracking on column.

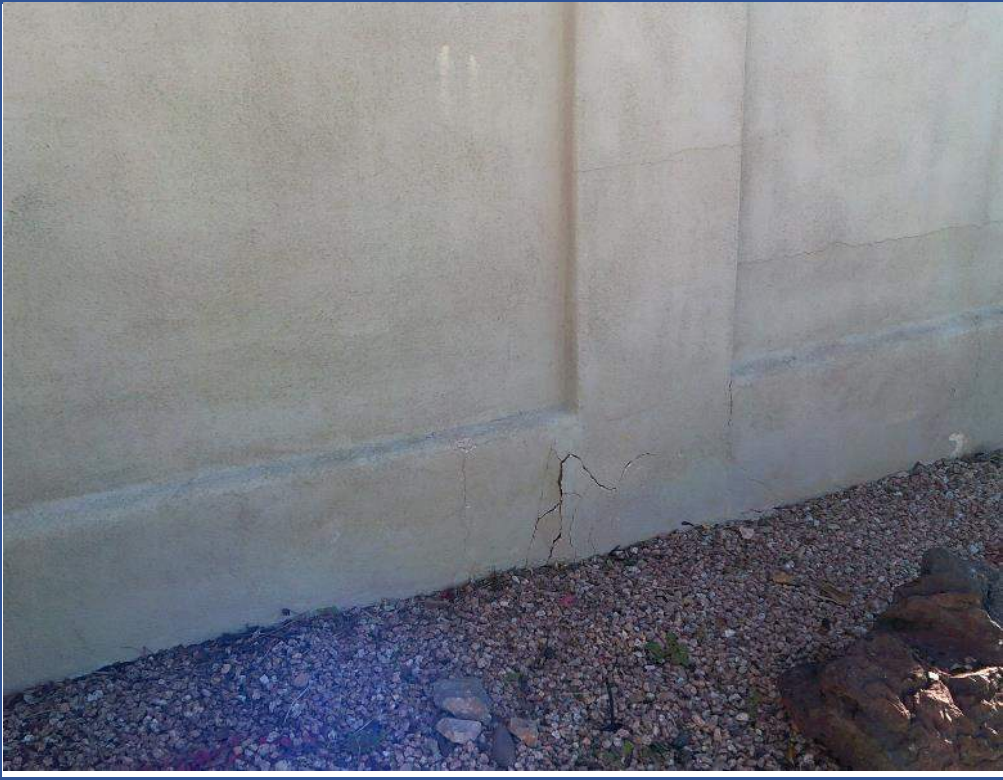
74

Lot 35S - Hairline staircase crack.

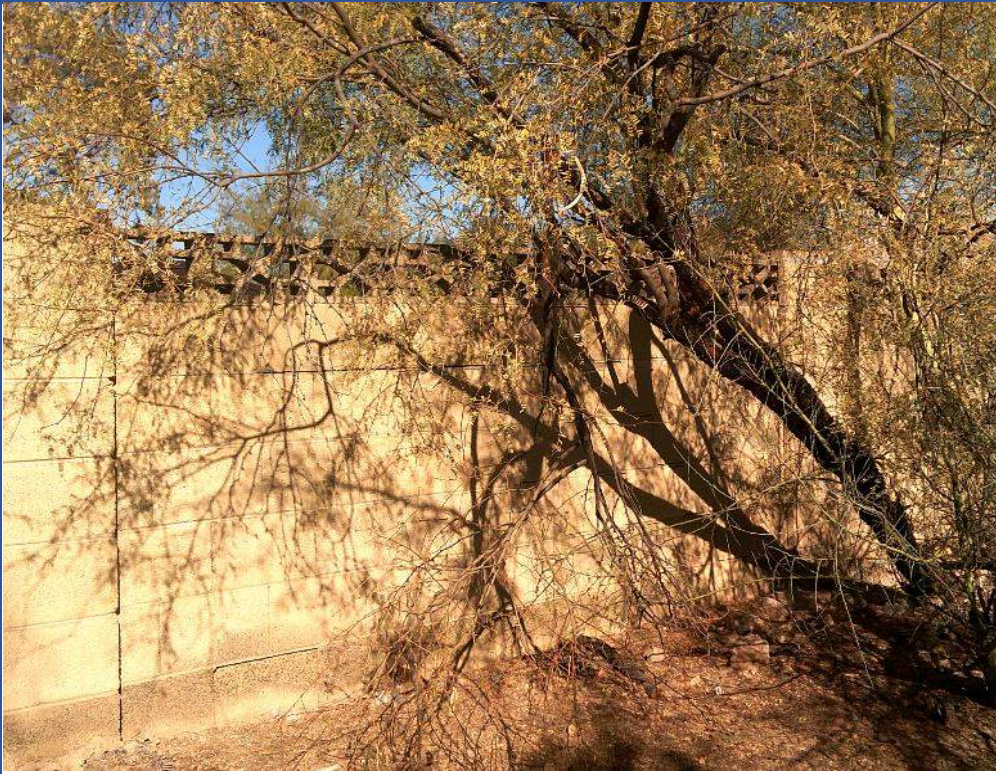
77

Lot 36 - Staircase crack up to approximately 1/4". Overgrowth.

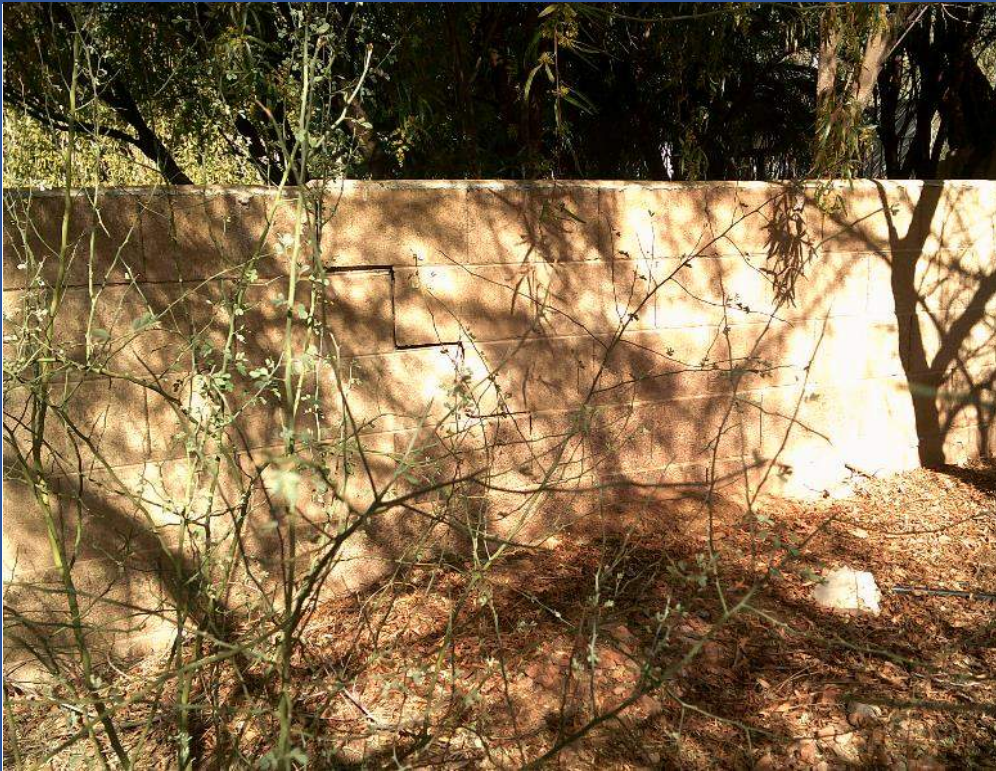
78

Lot 37 - Delamination. Staircase crack up to approximately 3/4". Overgrowth. Staircase crack on two panels is likely uplift.

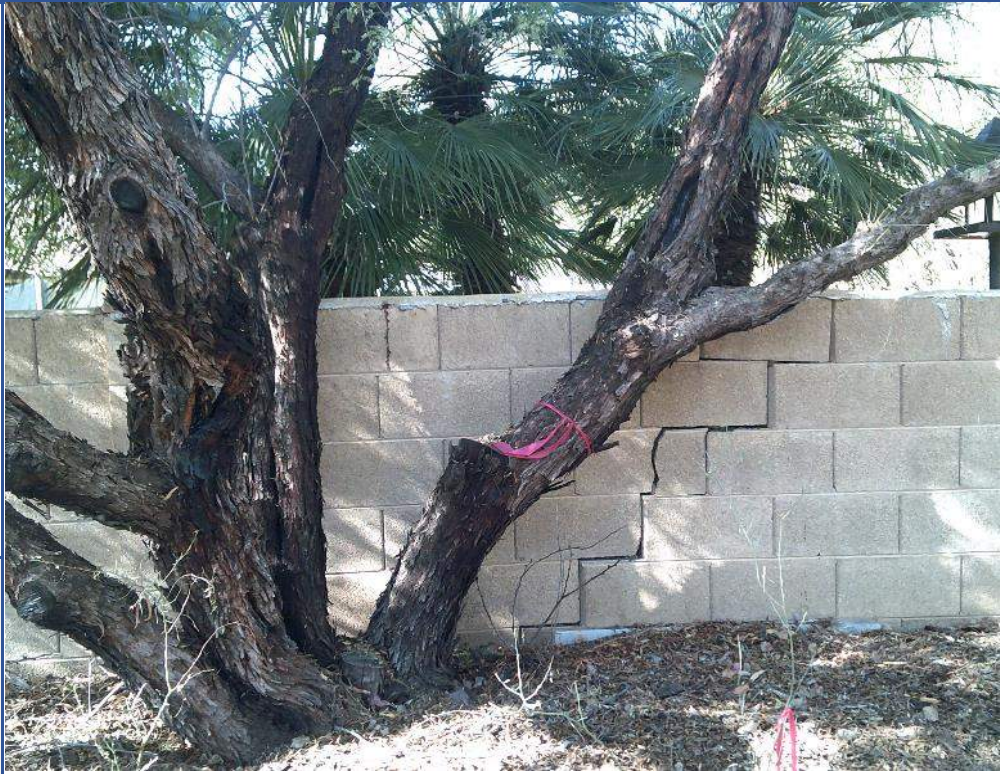
79

Lot 37 - Staircase crack up to approximately 3/4". Overgrowth. Staircase crack on two panels is likely uplift.

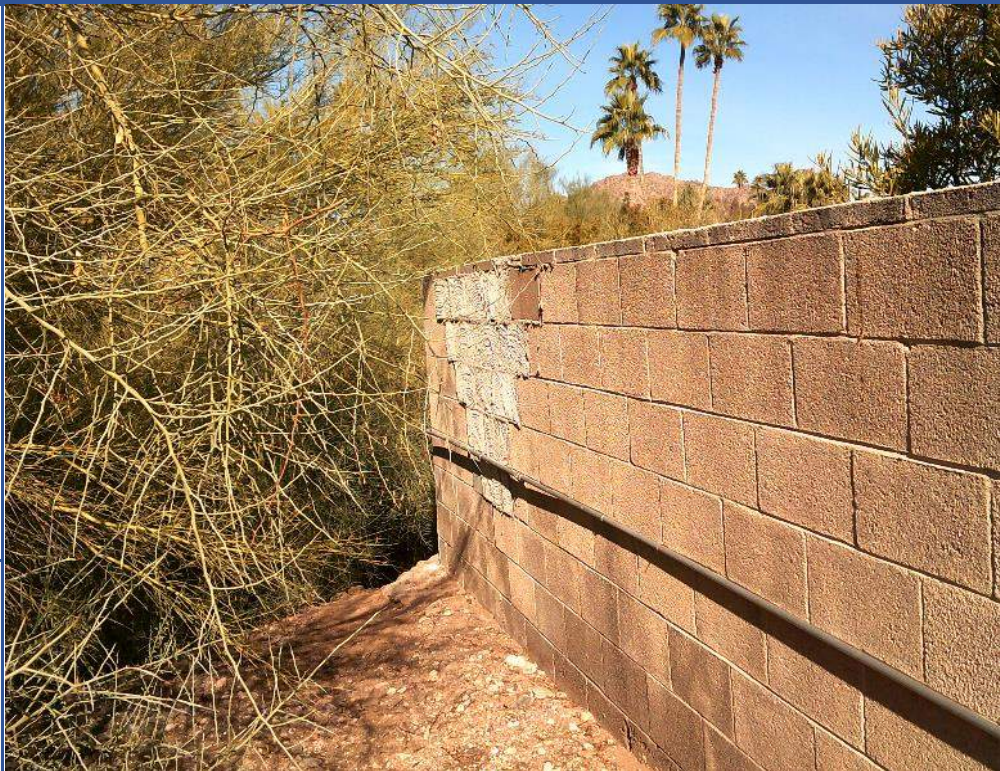
80

Lot 41S - Previous repairs.

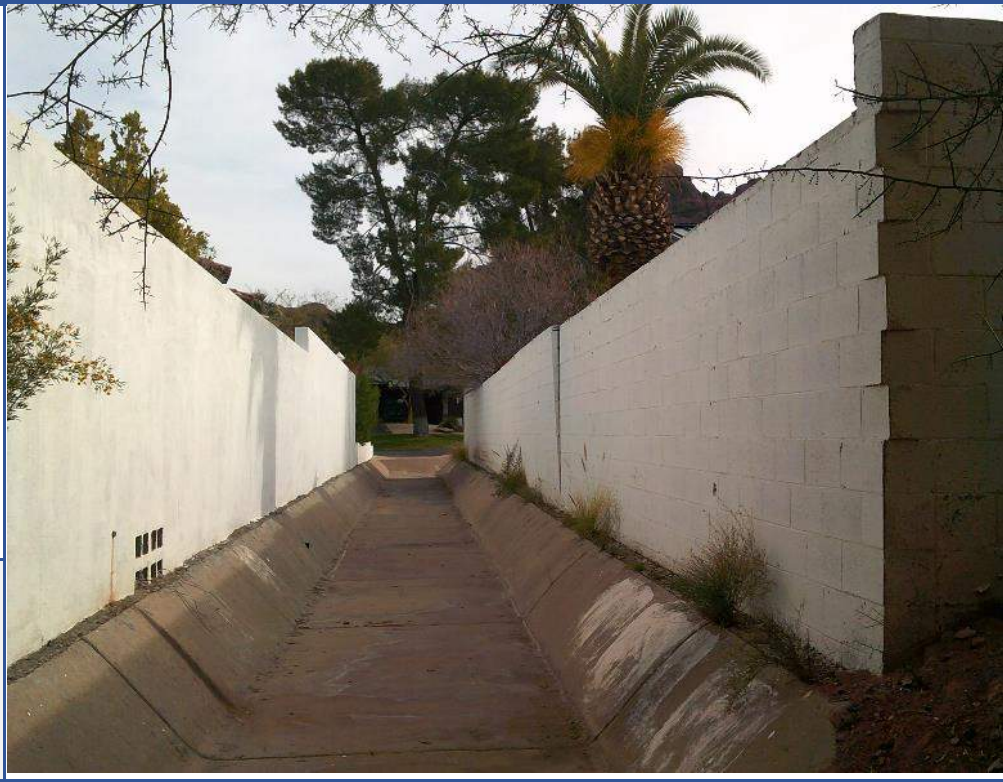
89

Lot 50S - Wall rotation up to approximately 2" over 4-feet on 7-foot wall. Overgrowth. Multiple hairline staircase cracks.

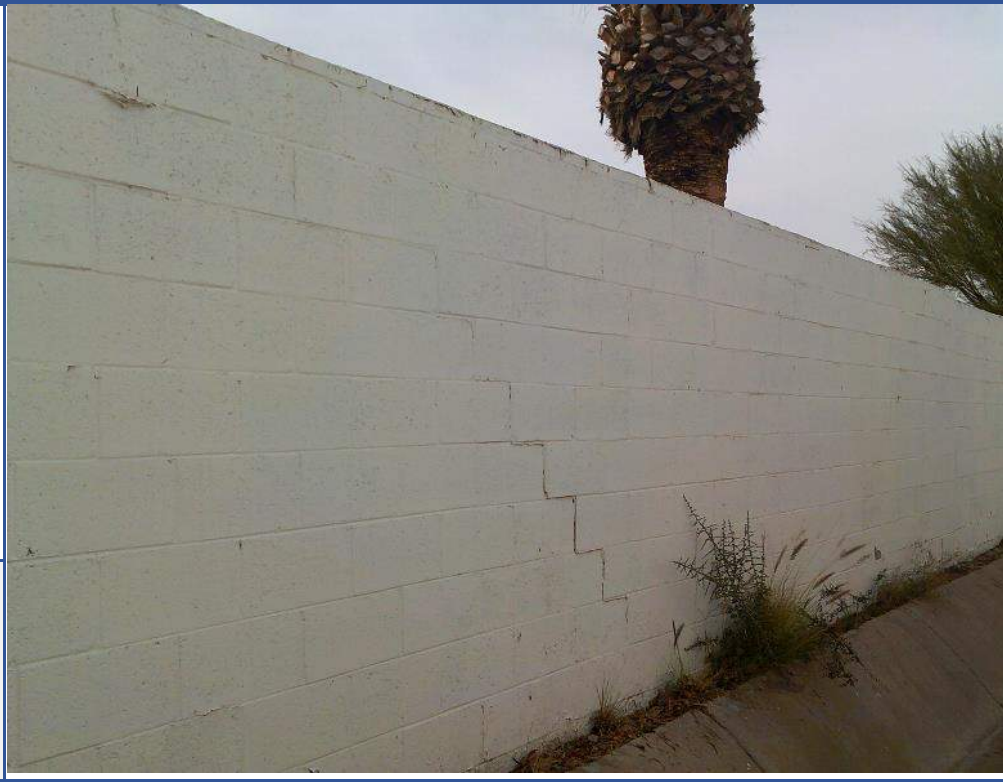
90

Lot 50S - Multiple hairline staircase cracks.

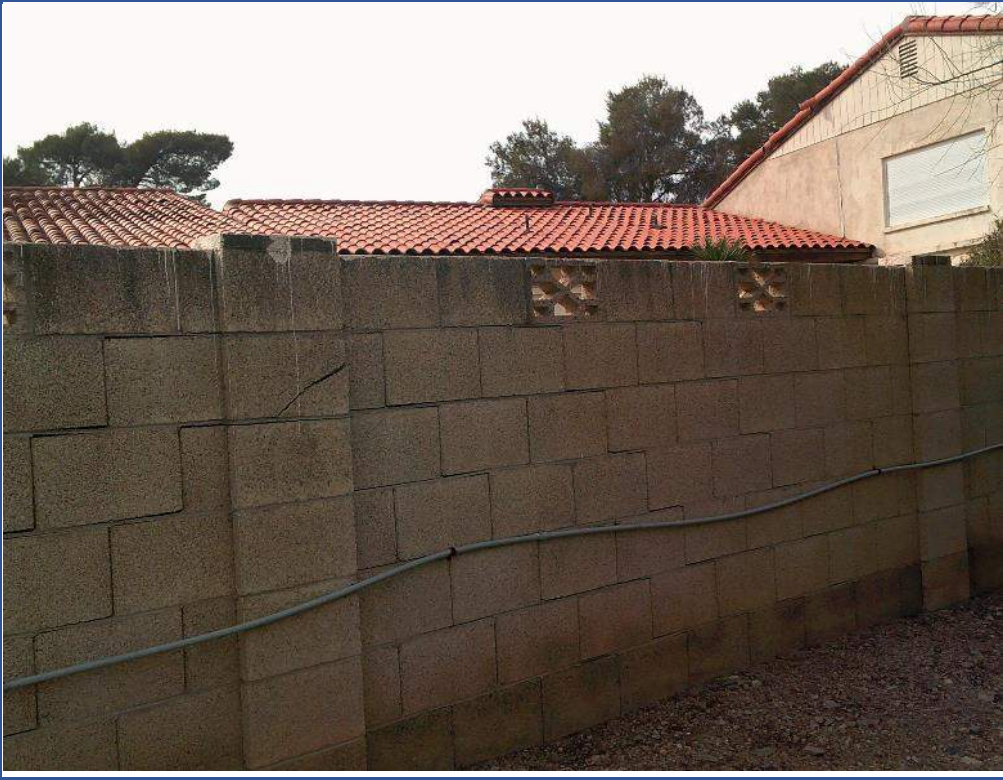
96

Lot 51 - Multiple staircase cracks up to approx 1/4".

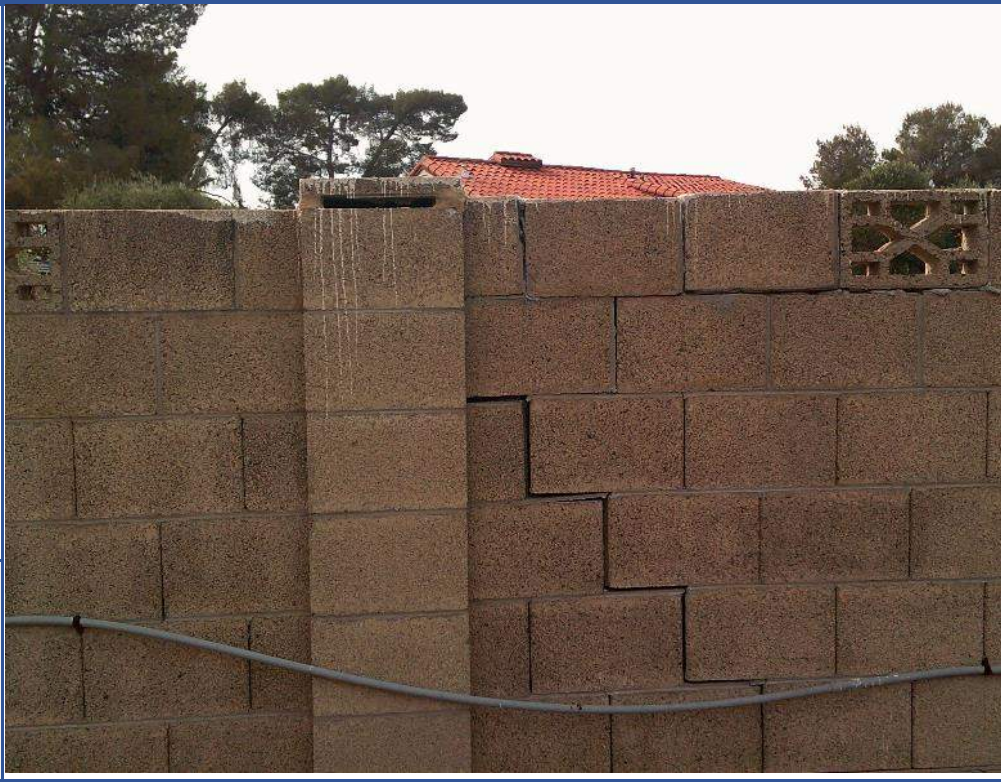
98

Lot 51 - Multiple staircase cracks up to approximately 1/4". Multiple loose top caps.

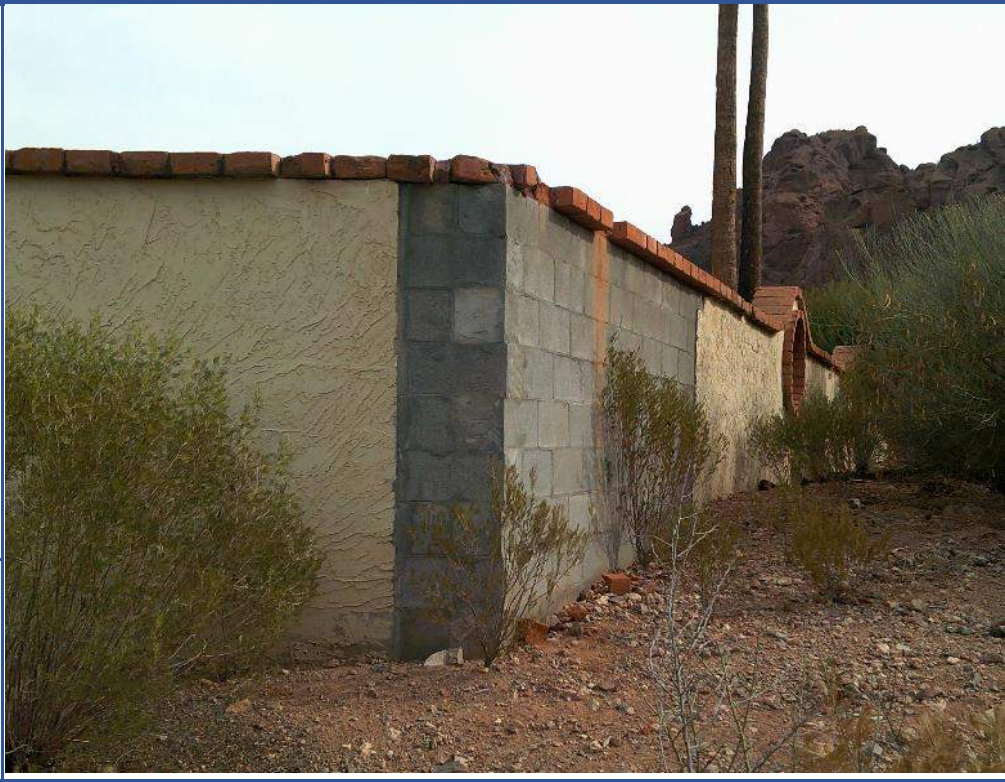
PHOTO NUMBER
105

Lot 62 - Overgrowth.
Broken top courses.

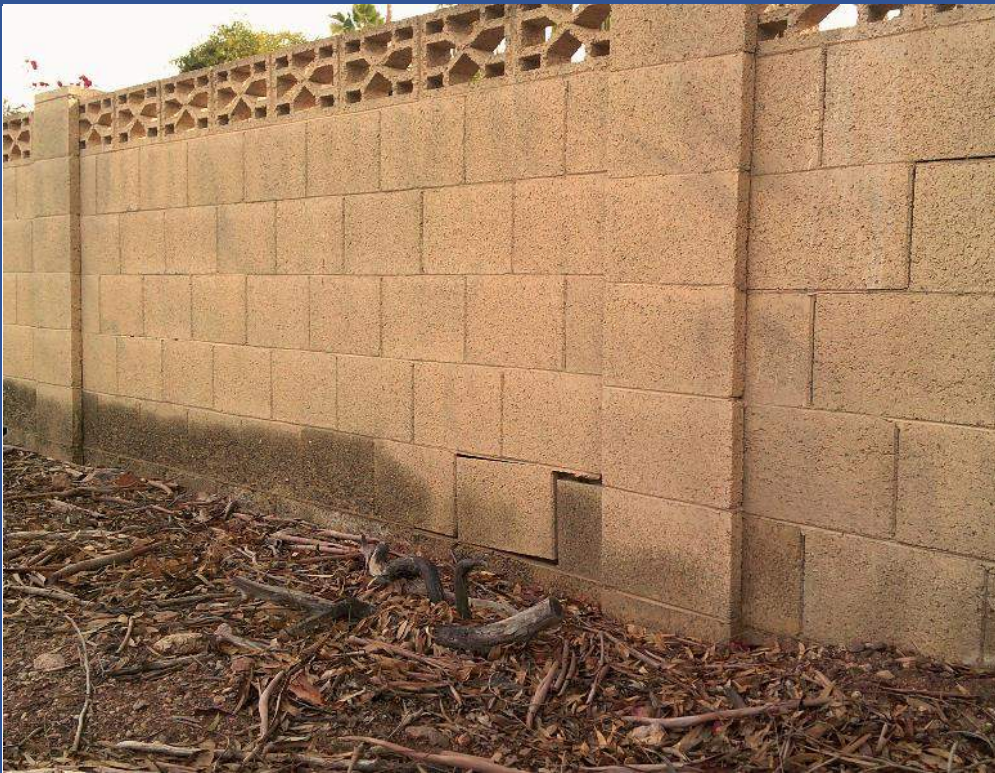
112

Lot 64 - Staircase crack
up to approximately
3/4". Uplift up to
approximately 1".

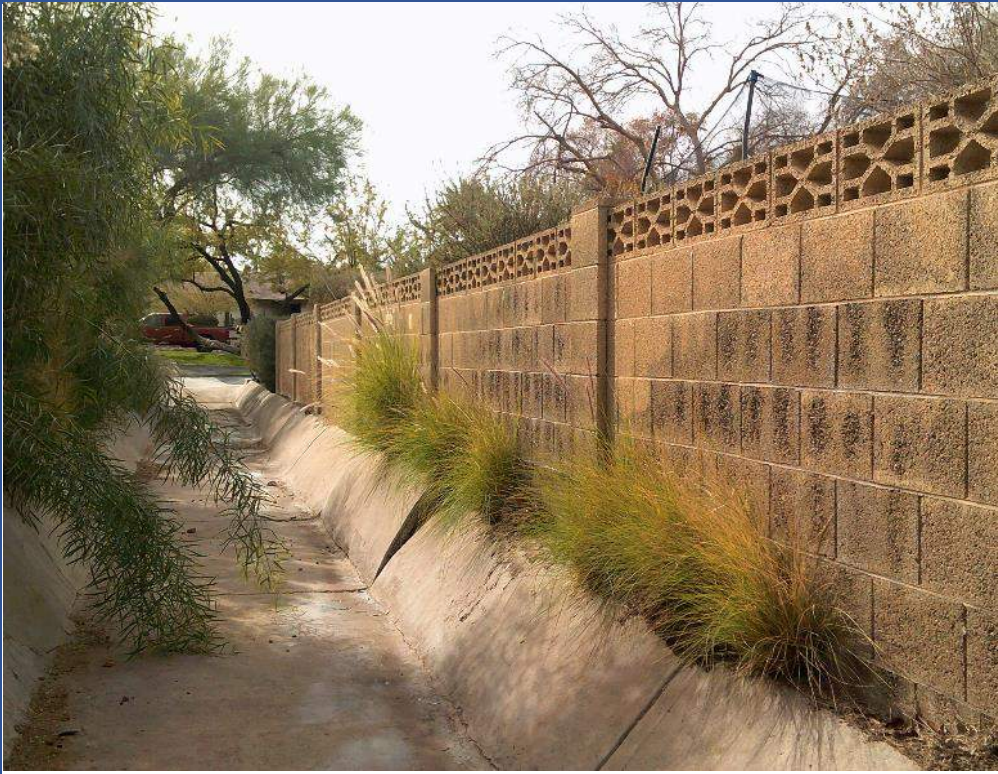
113

Lot 64S - Moderate delamination. Hairline vertical crack. Overgrowth.

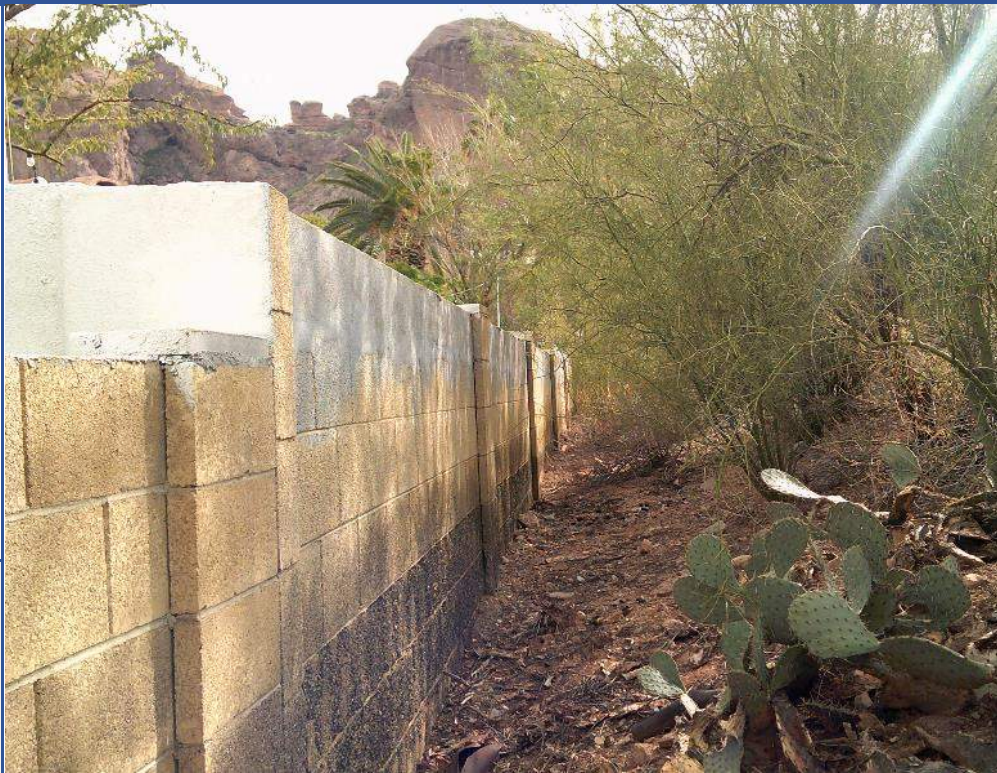
118

Lot 69 - Moderate to significant delamination. Overgrowth. Hole in course. Loose top cap. Animal feces in immediate everywhere.

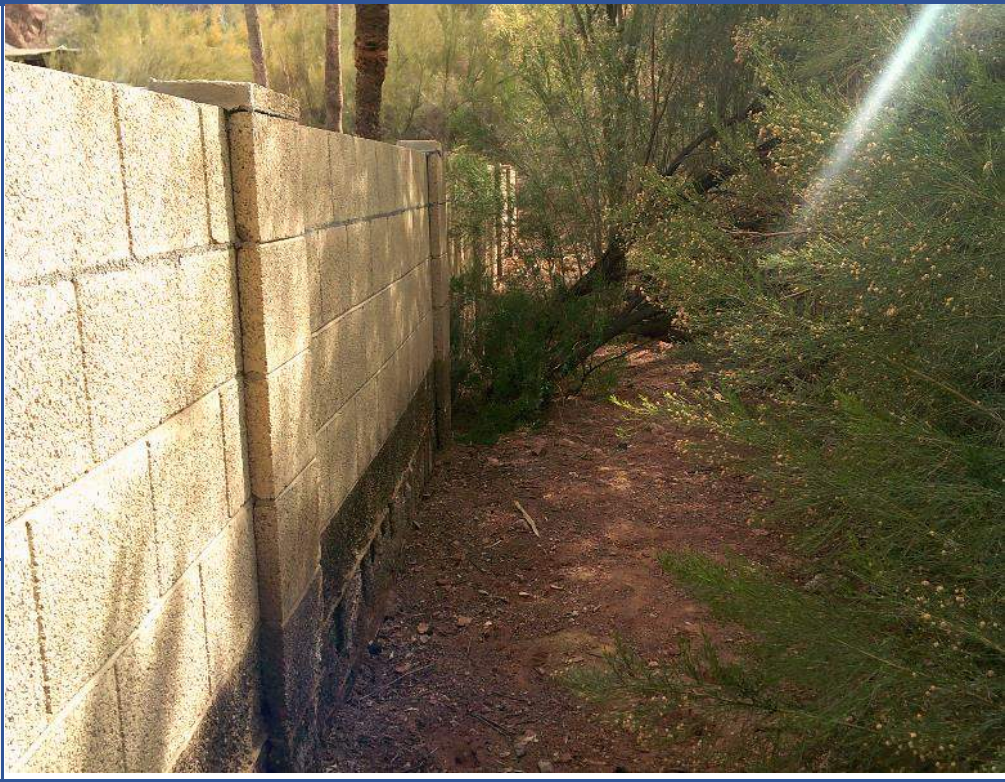
119

Lot 70 - Significant delamination. Hairline vertical crack. Overgrowth. Negative slope towards wall.

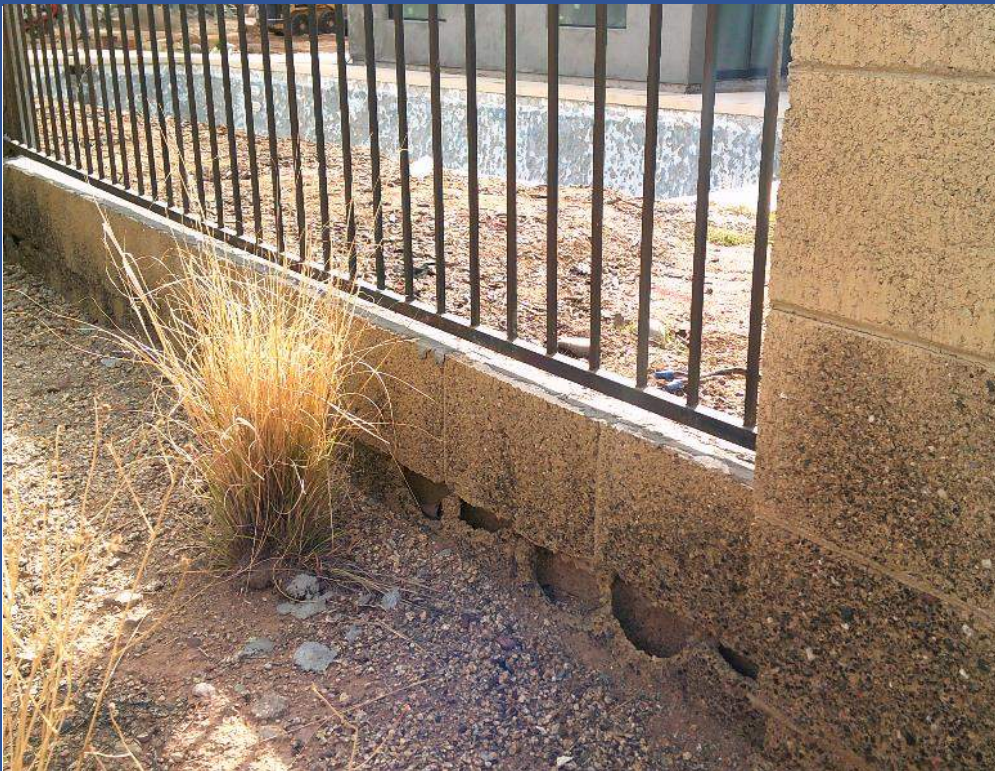
126

Lot 72 - Corrosion on view fence. Significant delamination.

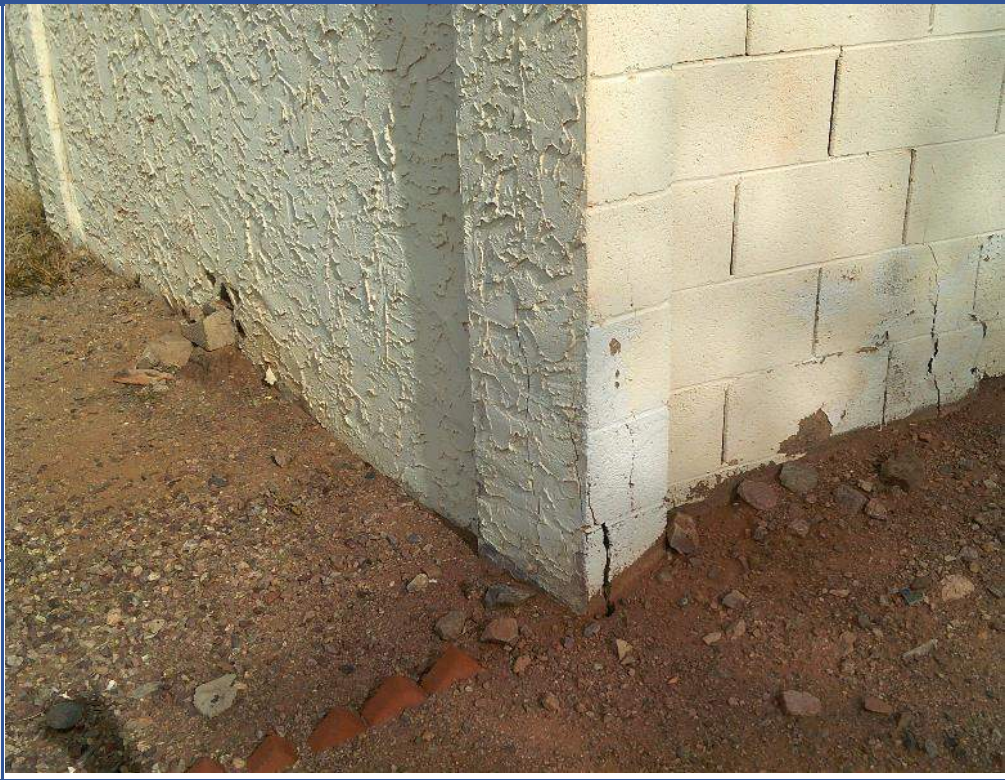
Lot 76 - Vertical crack
at column.

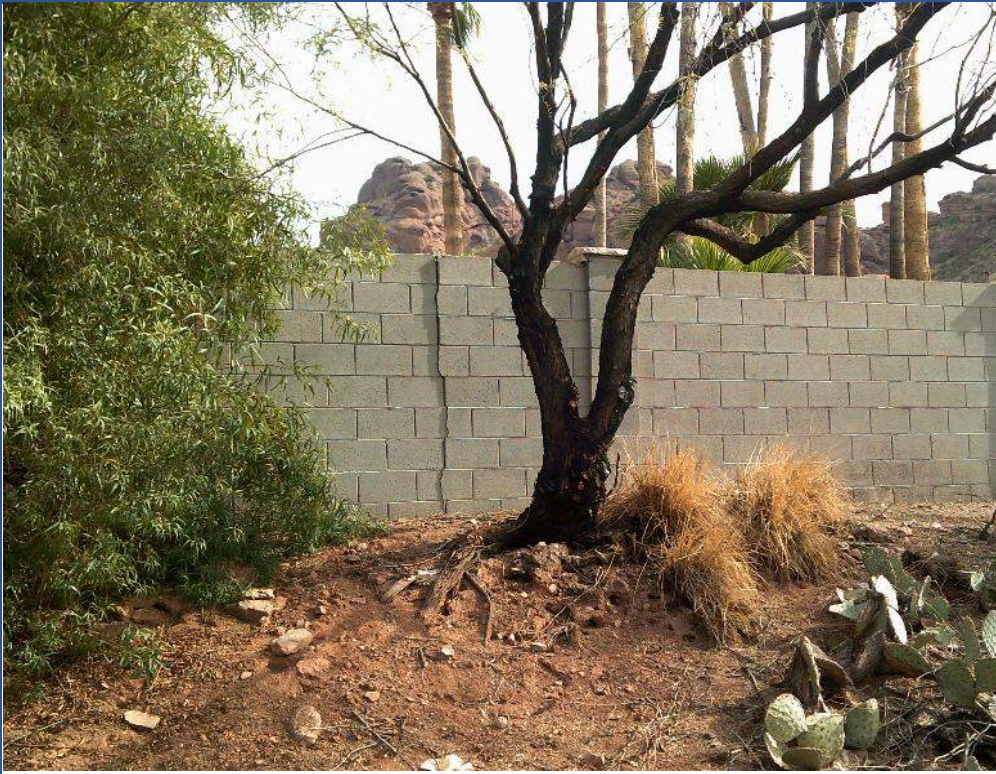
133

Lot 78 - Wall rotation up to approximately 3/4" on a 6-foot wall. Vertical crack. Overgrowth. Potential missing lateral bracing.

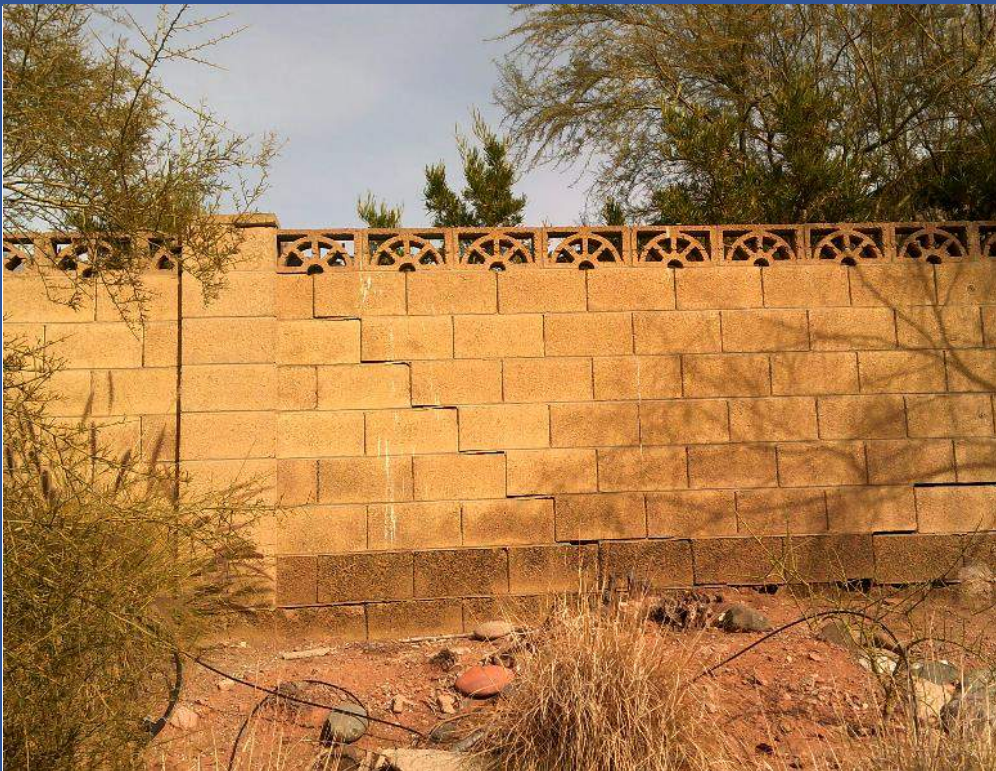
134

Lot 78 - Staircase crack. Potential missing lateral bracing.

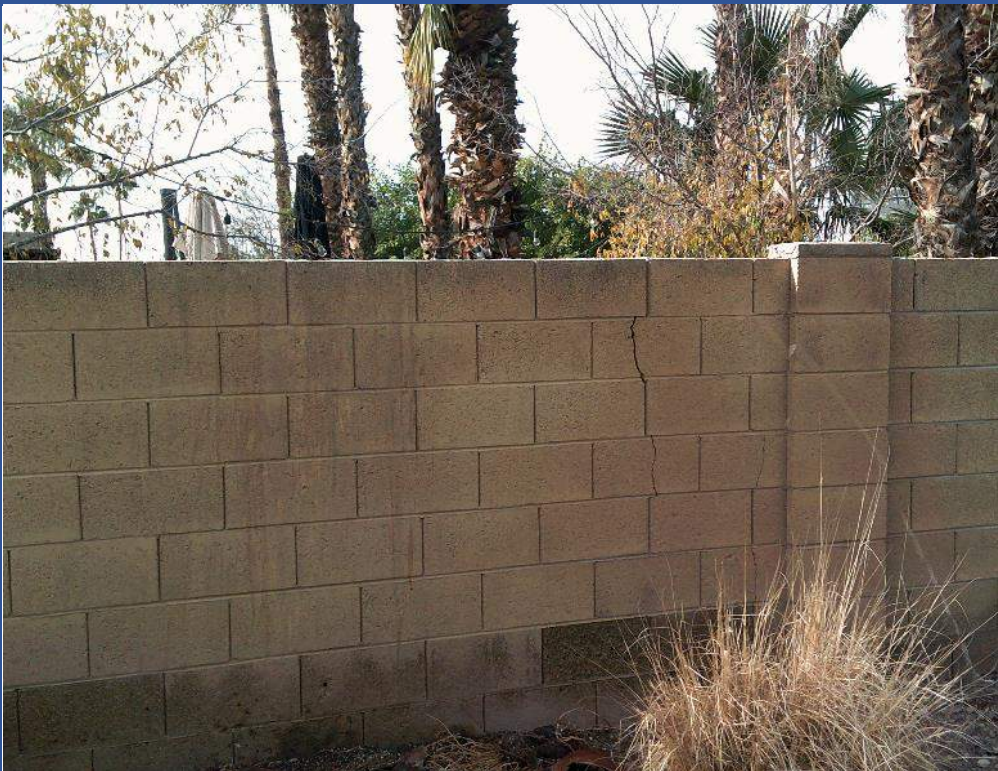
138

Lot 81 - Moderate delamination. Efflorescence. Vertical crack up to approximately 1/16".

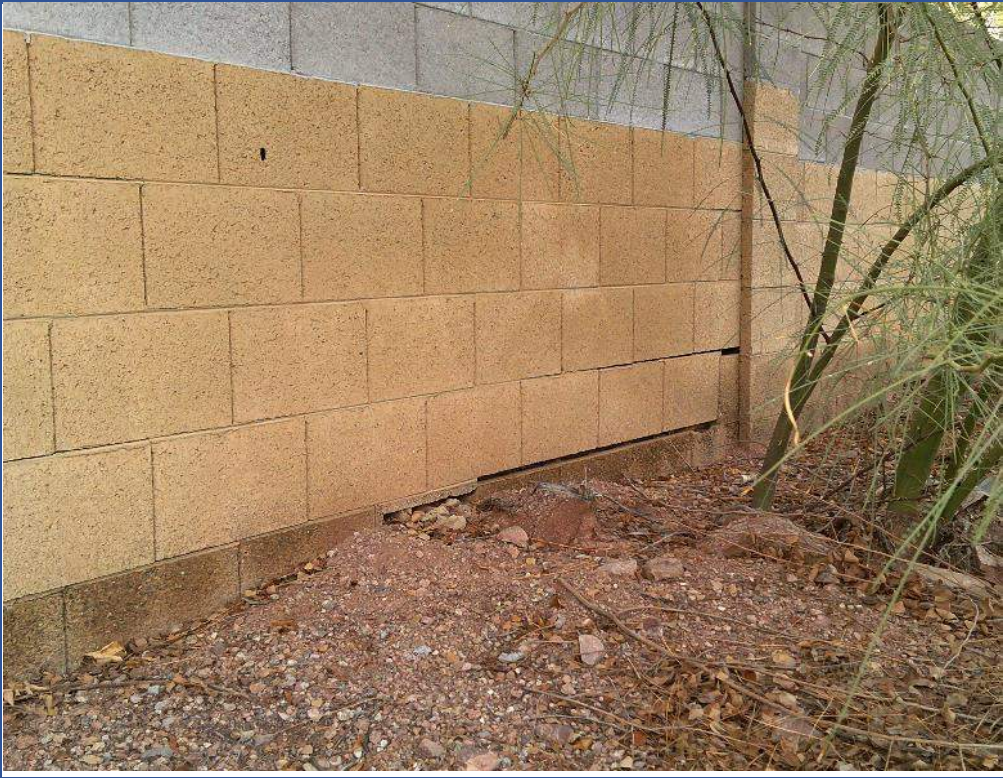
140

Lot 82 - Staircase crack up to approximately 1".

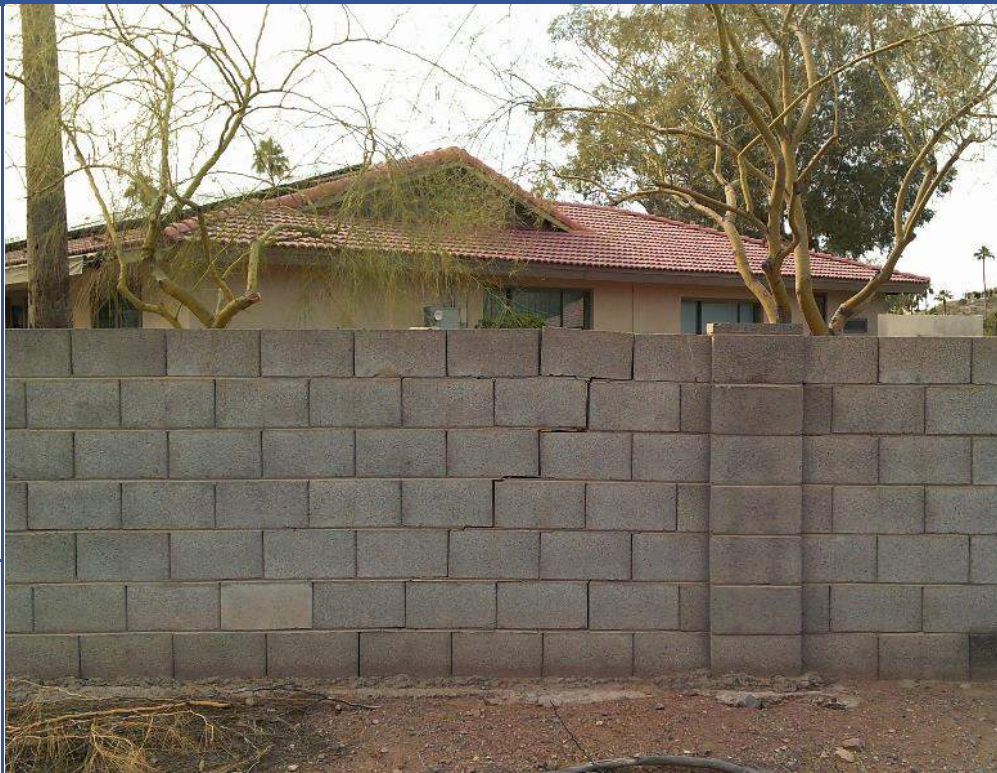
144

Lot 90 - Staircase crack
up to approximately
1/2". Overgrowth.
Exposed footing.

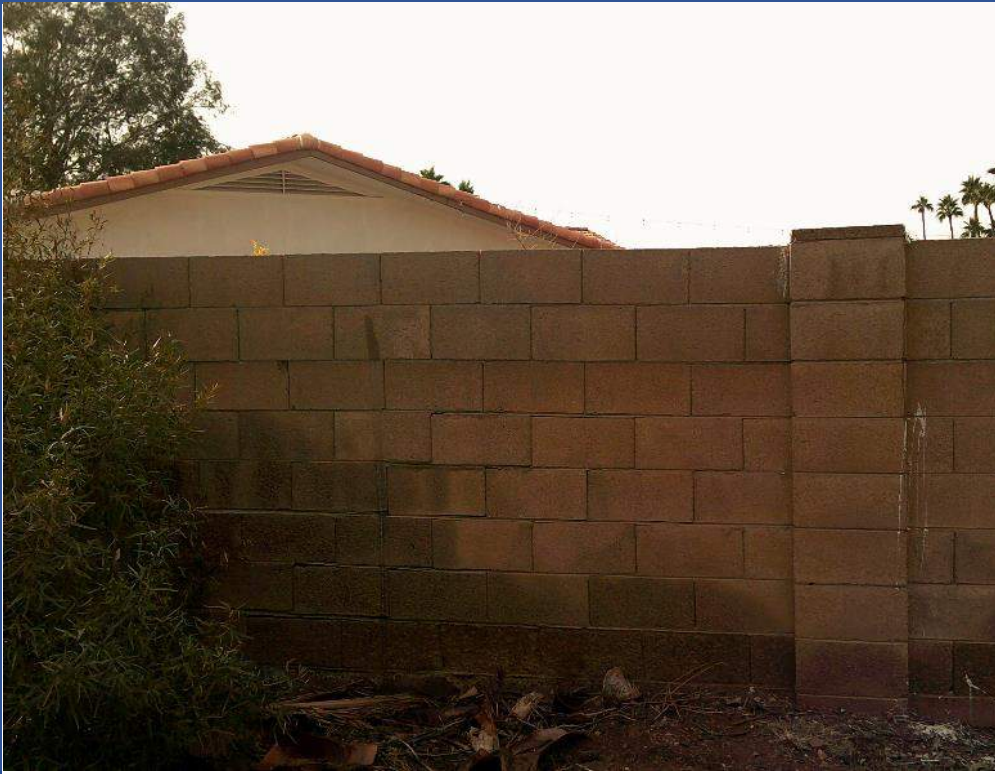
145

Lot 91 - Moderate delamination. Wall rotation up to approximately 1.5" on a 6-foot wall. Column rotation up to approximately 1.5" on a 6-foot column. Staircase crack up to approximately 1/4". Exposed and corroded dur-o-wire.

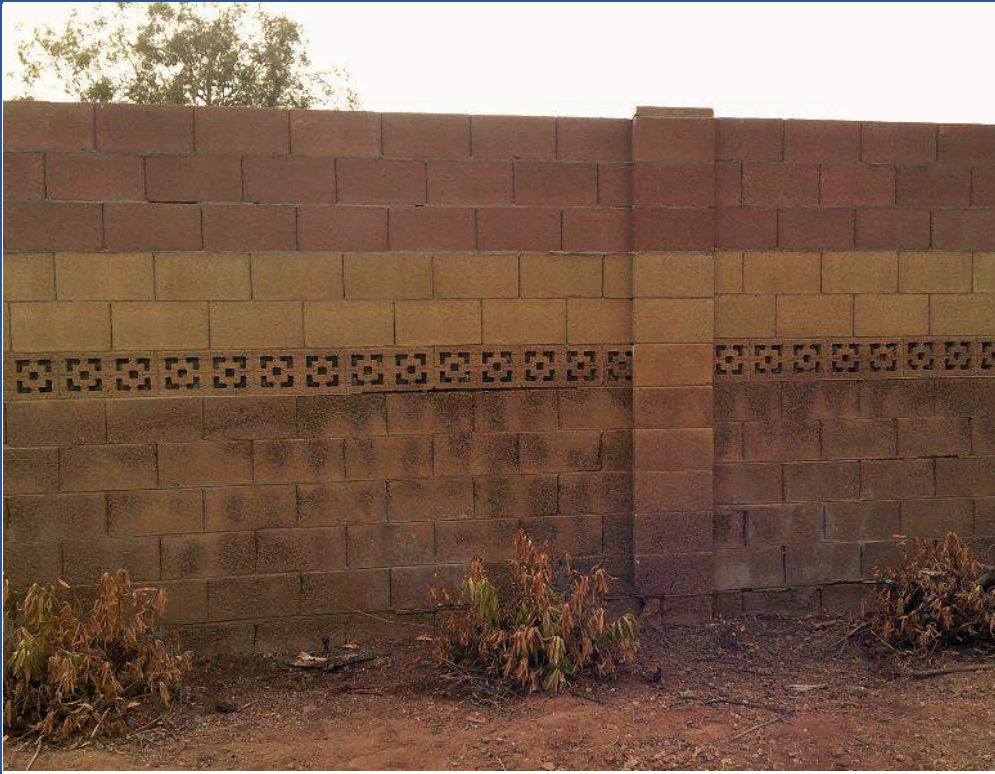
147

Lot 91 - Moderate delamination. Exposed and corroded dur-o-wire.

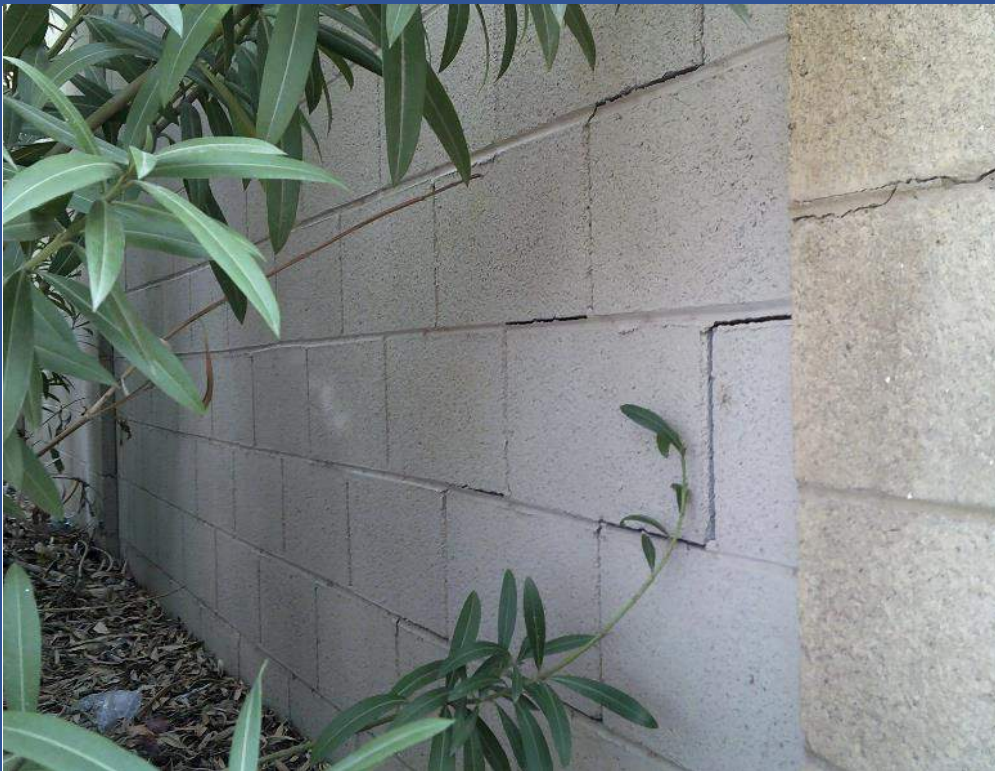
148

Lot 92 - Staircase crack. Overgrowth. Negative slope towards wall.

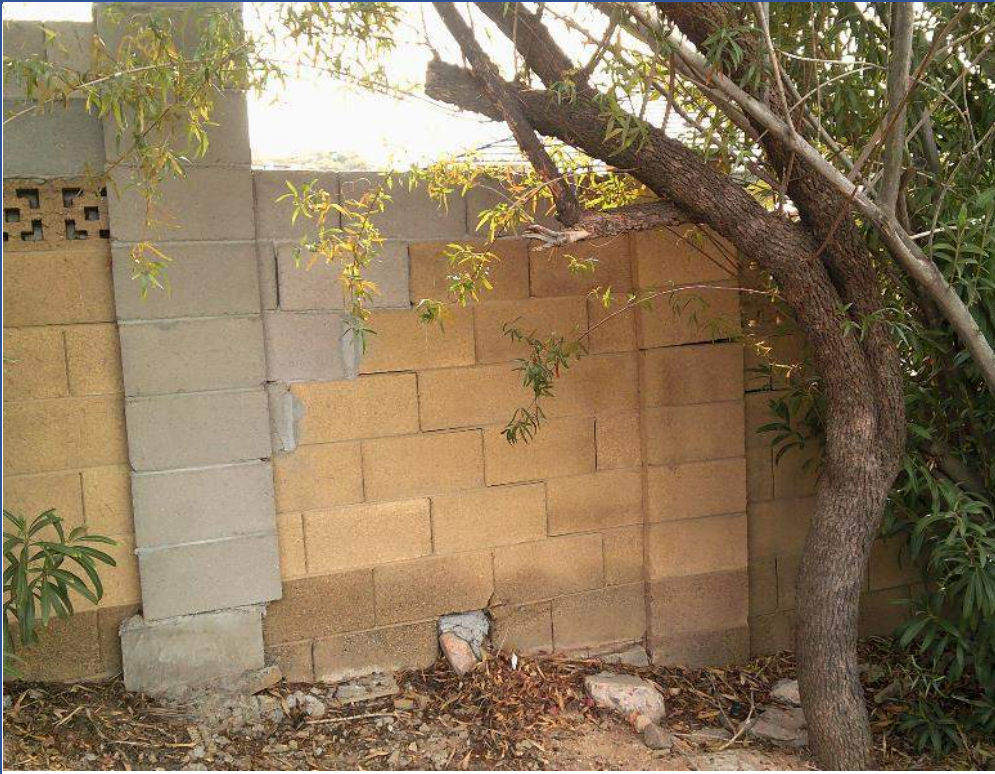
151

Lot 95 - Moderate delamination. Column rotation up to approximately 3/4" on a 6-foot wall. Hairline staircase crack. Overgrowth. Exposed and corroded dur-o-wire. Built up wall.

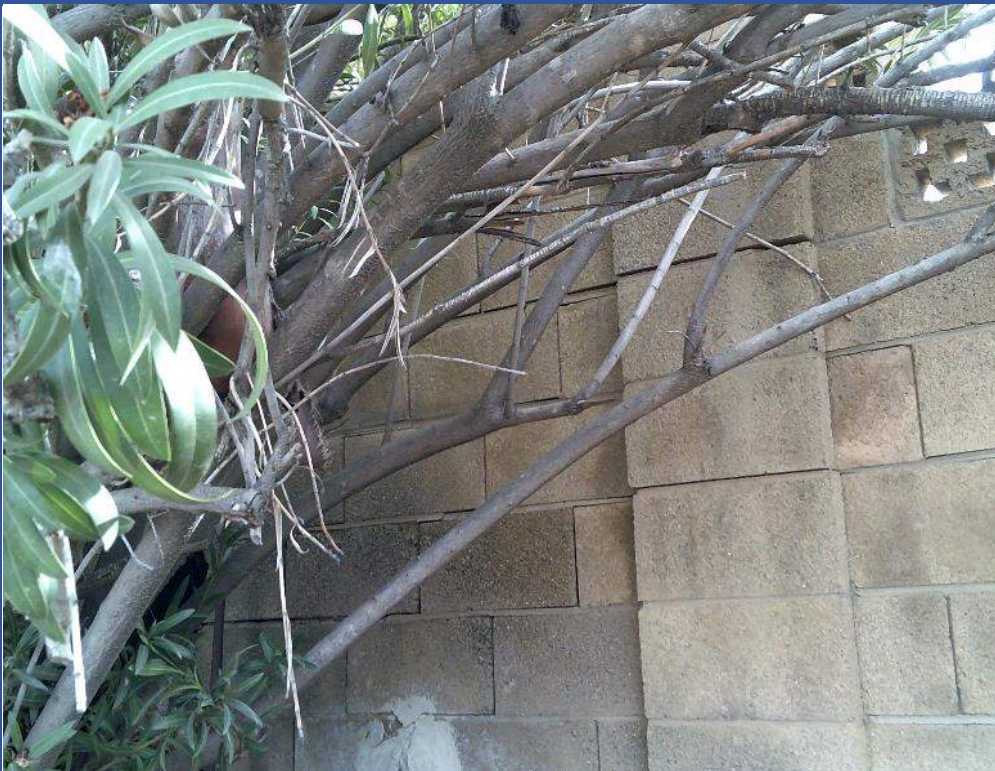
152

Lot 95 - Moderate delamination with delaminated grout. Overgrowth. Previous repair with built up wall.
