CAMELBACK CANYON ESTATES BLOCK WALL EVALUATION

Final Submittal: January 31, 2024

PROPERTY: CAMELBACK CANYON ESTATES COMMUNITY
PHOENIX, ARIZONA

SERVICE: 23-0433 – BLOCK WALL STRUCTURAL EVALUATION

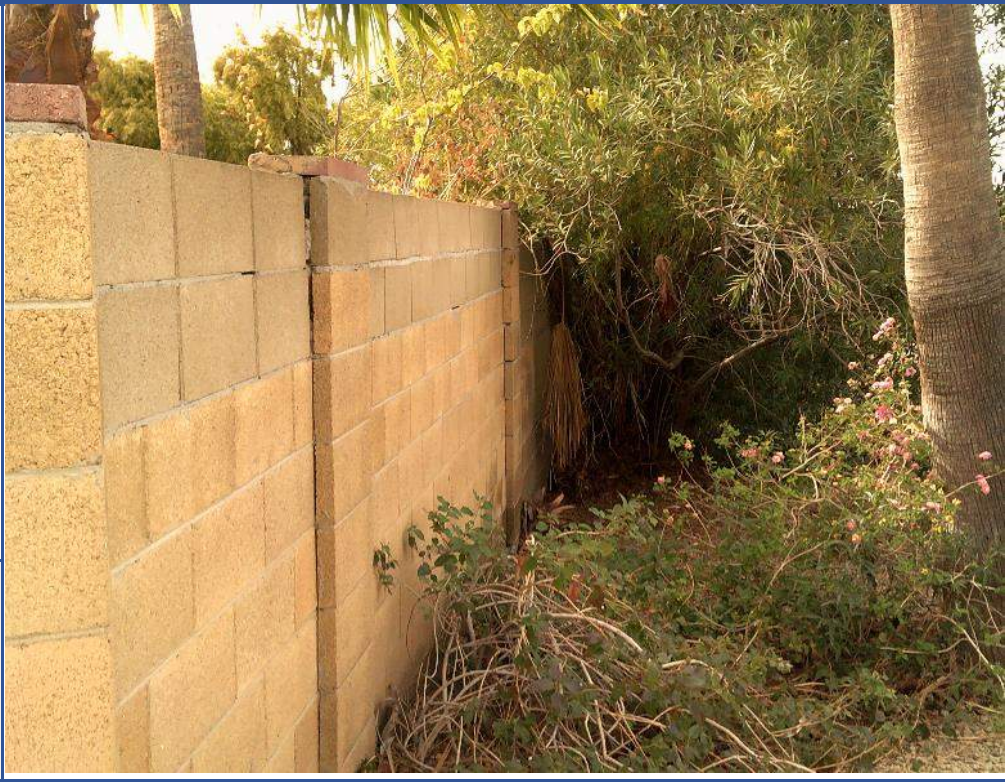
154

Lot 96 - Overgrowth.
Previous repair with
built up wall.

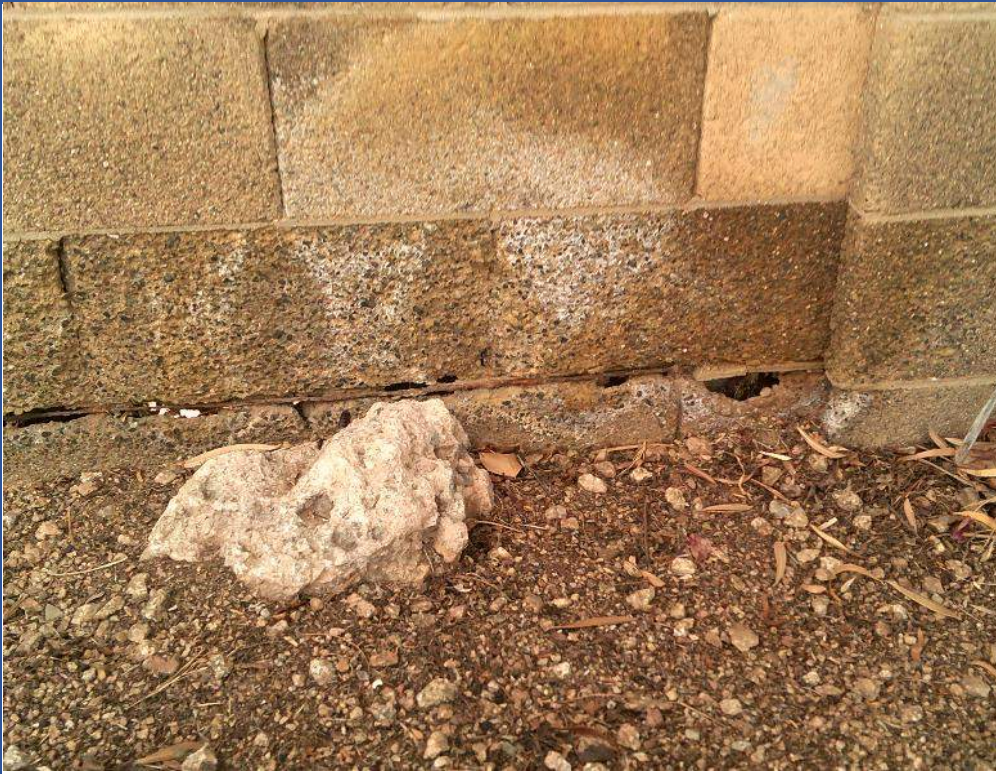
Lot 96 - Moderate delamination with delaminated grout. Exposed and corroded dur-o-wire.

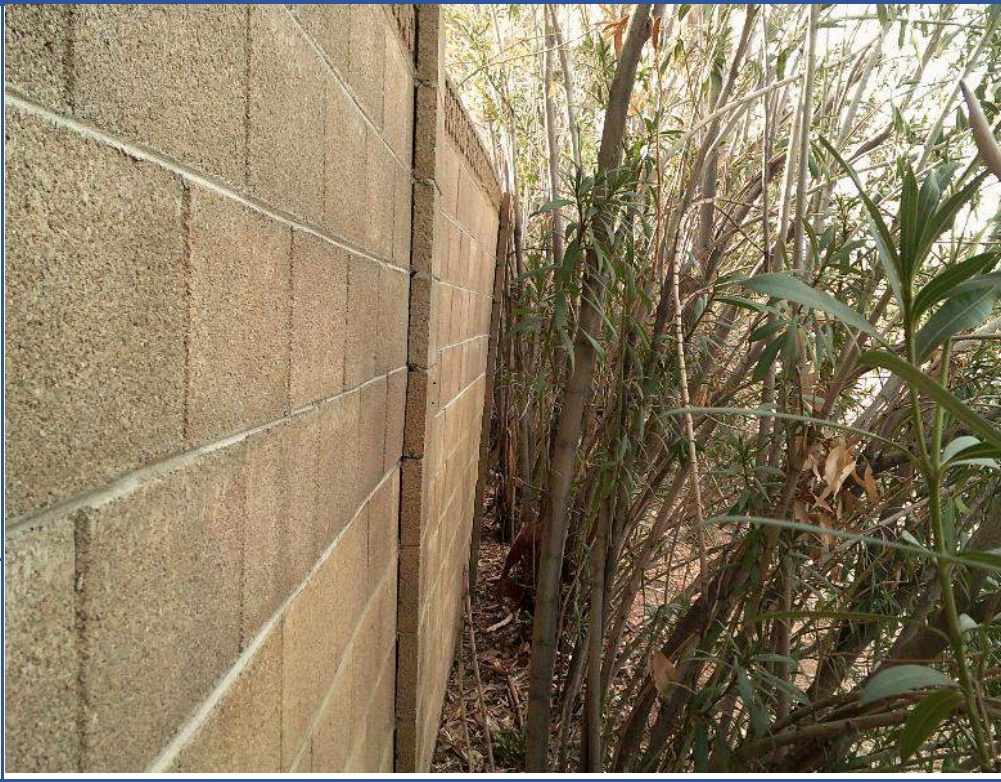
157

Lot 99 - Multiple hairline staircase cracks. Two columns with rotation up to approximately 10" and one column with 6" near trees on an 8-foot wall. Overgrowth.

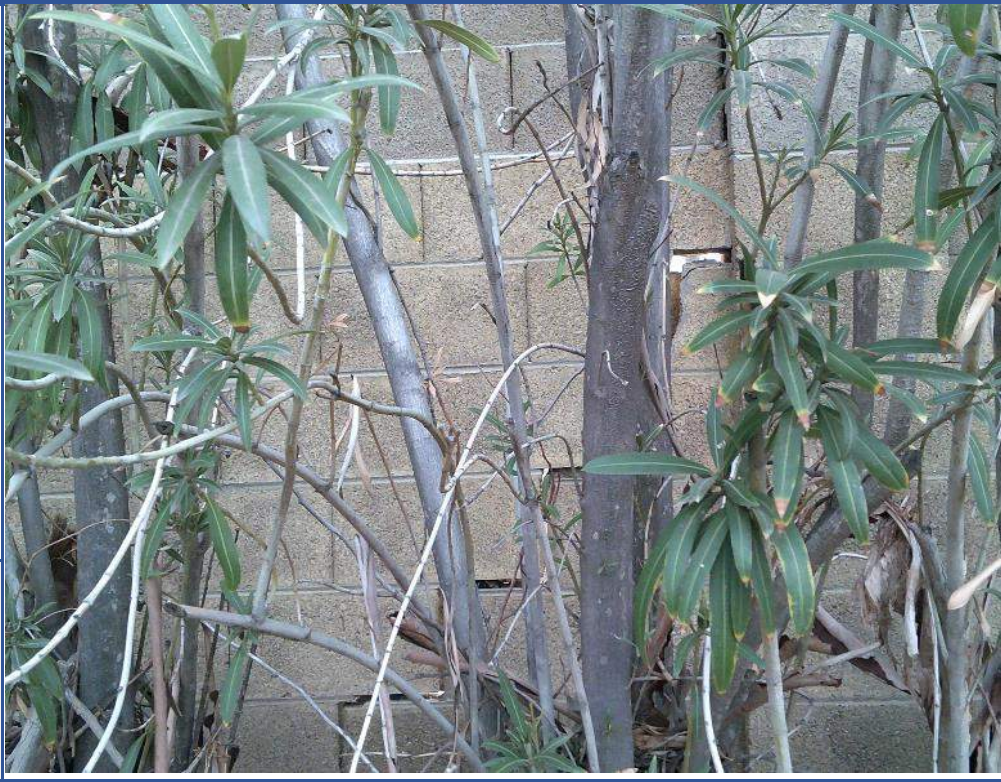
158

Lot 99 - Multiple staircase cracks.

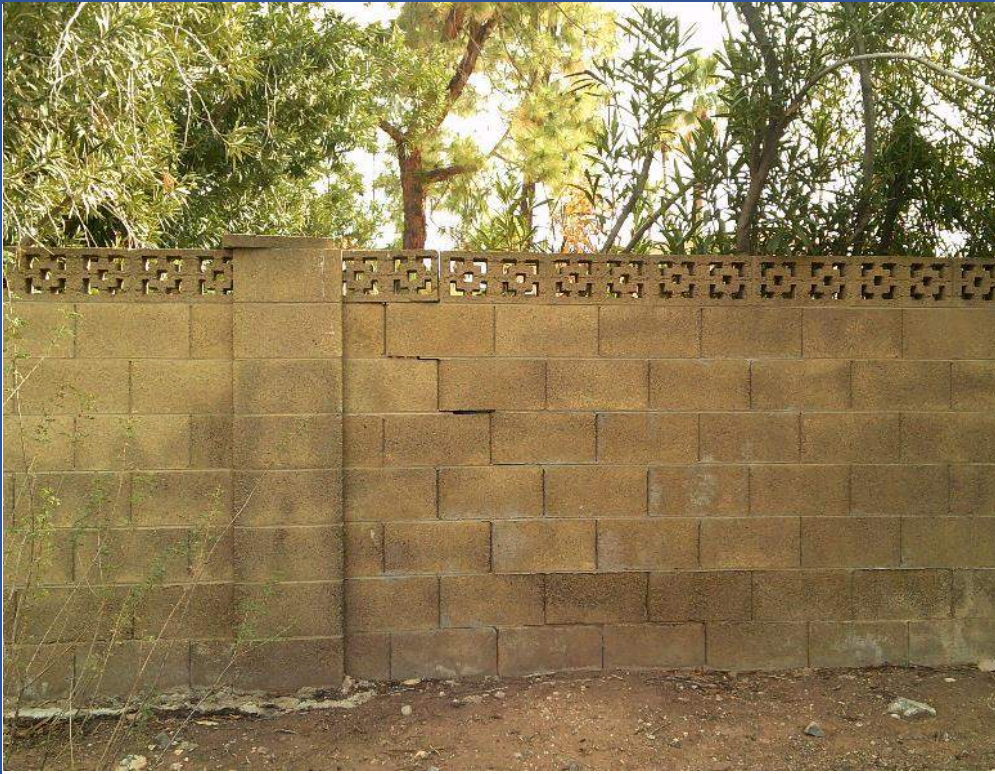
159

Lot 101 - Staircase
crack up to
approximately 1/4".

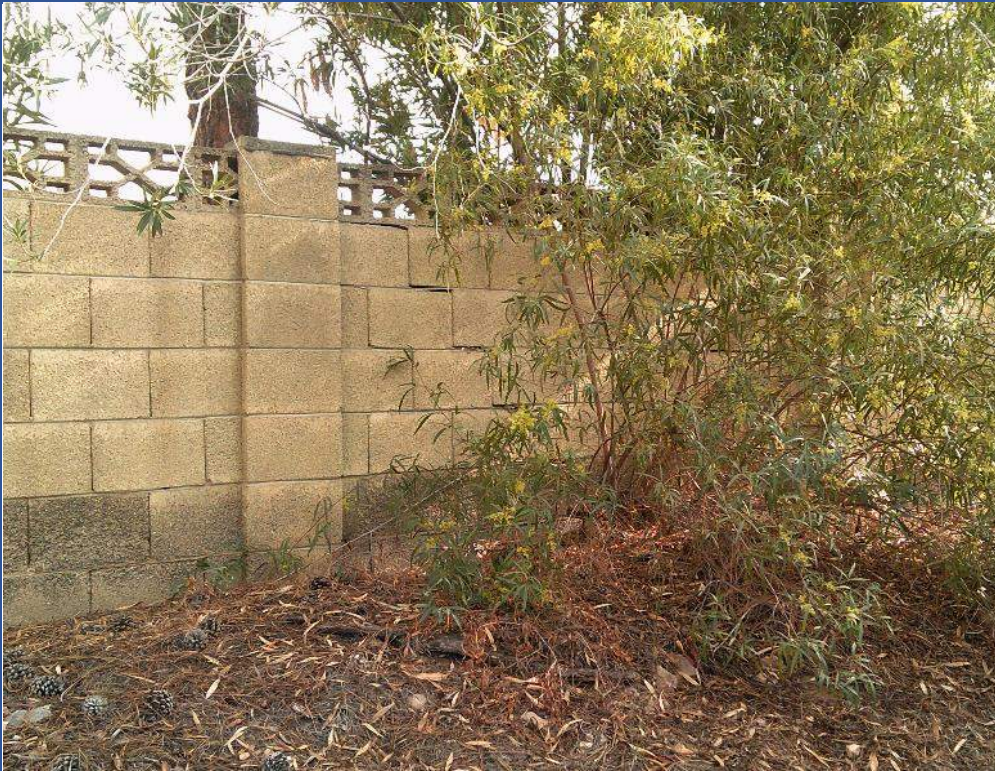
162

Lot 101 - Staircase crack up to approximately 1/4". Overgrowth. Exposed and corroded dur-o-wire. Panel offset up to approximately 1/2".

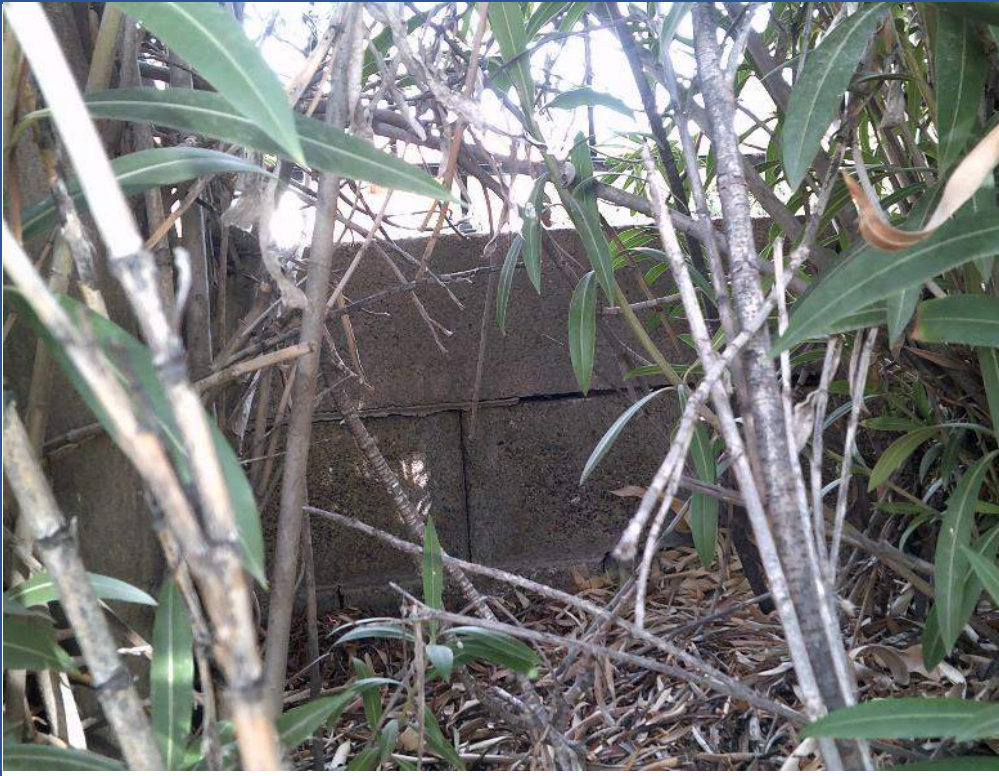
167

Lot 102 - Moderate delamination. Staircase crack. Overgrowth.

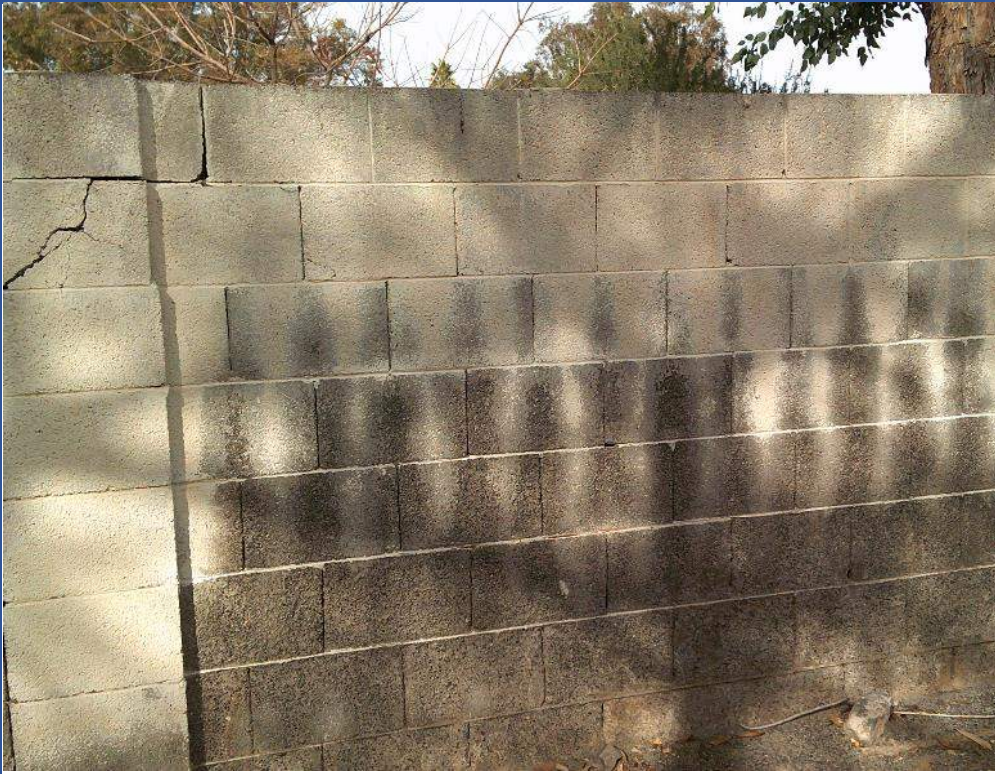
Lot 104 -
Delamination. Diagonal
crack on column.

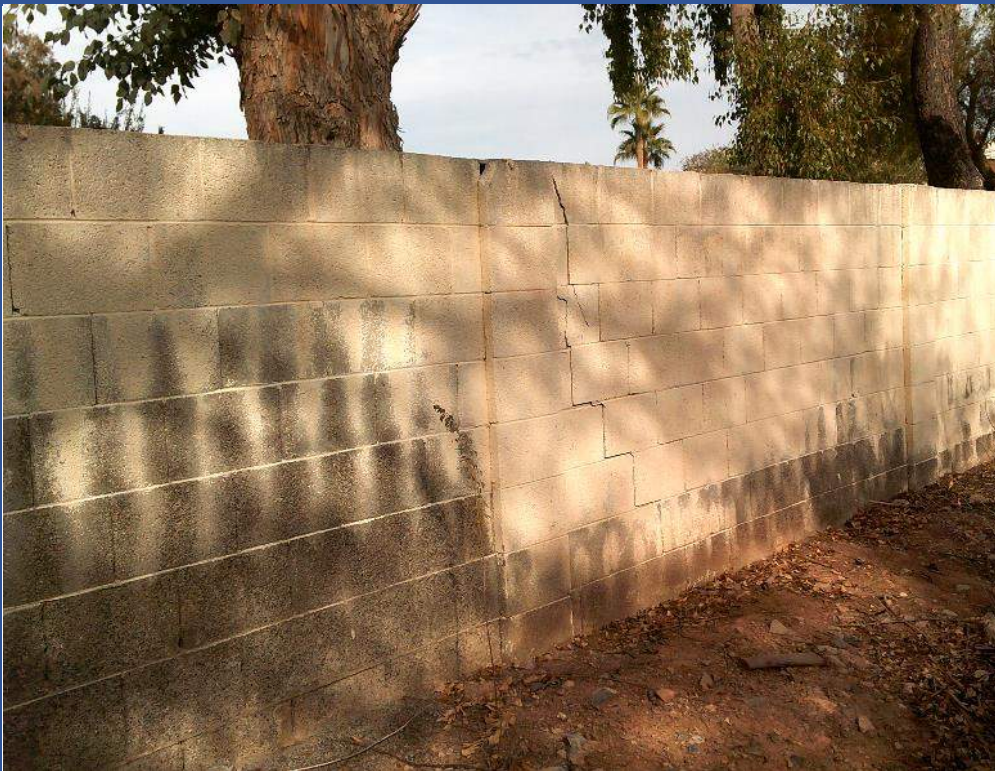
Lot 104 - Staircase
crack up to
approximately 1/4".

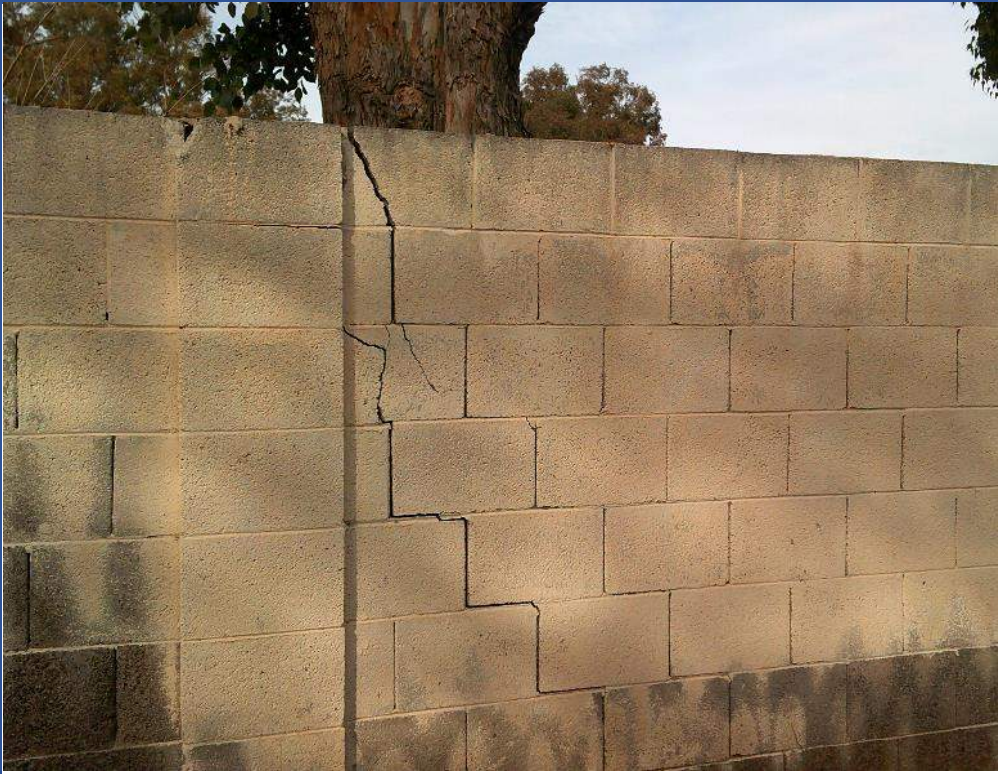
Lot 104 - Staircase
crack up to
approximately 1/4".

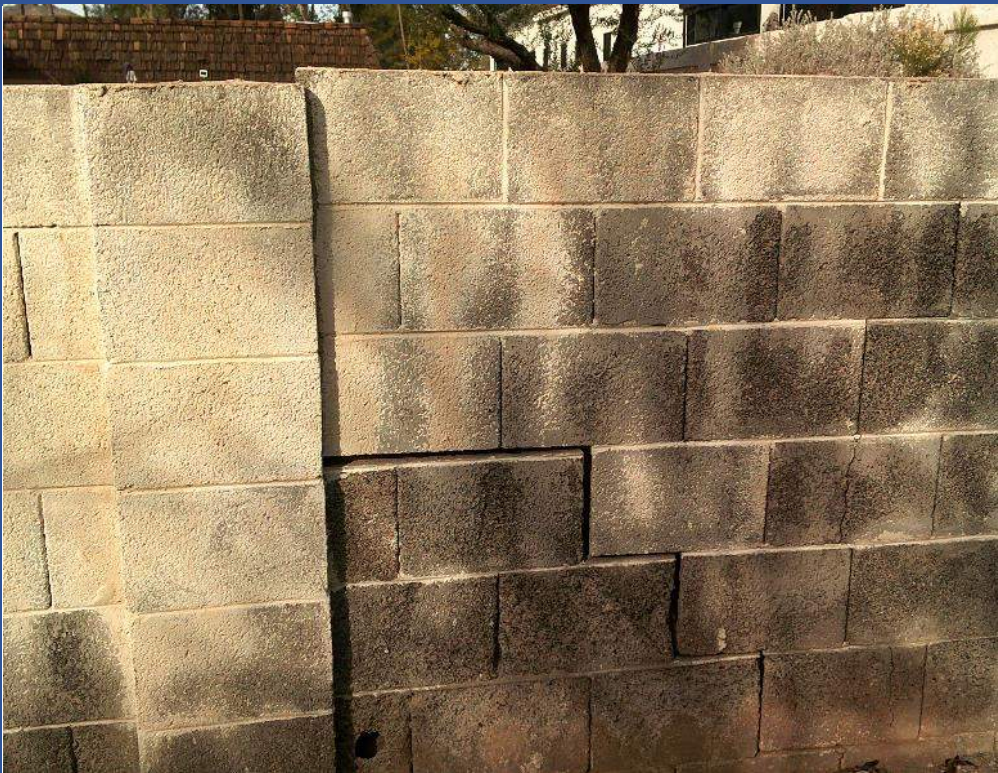
Lot 104 - Significant
delamination. Exposed
and corroded dur-o-
wire. Uplift.
