CAMELBACK CANYON ESTATES BLOCK WALL EVALUATION

Number: 23-0433

Final Submittal: January 31, 2024

SERVICE: 23-0433 – BLOCK WALL STRUCTURAL EVALUATION

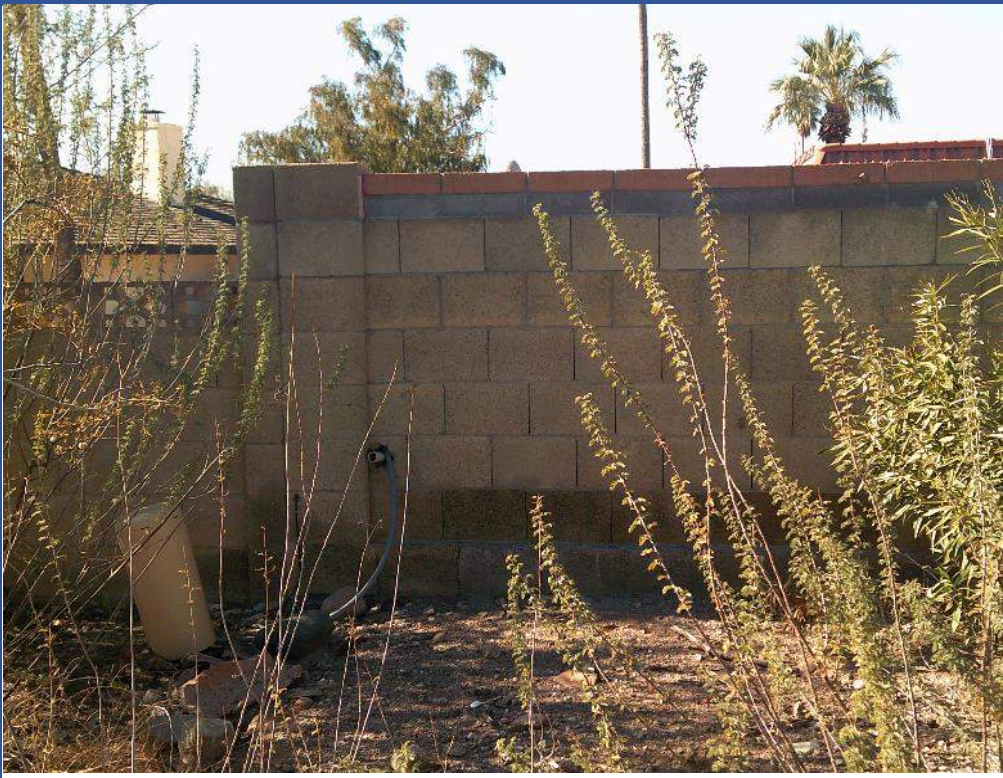
Lot 5 - Moderate delamination. Hole in course with pipe.

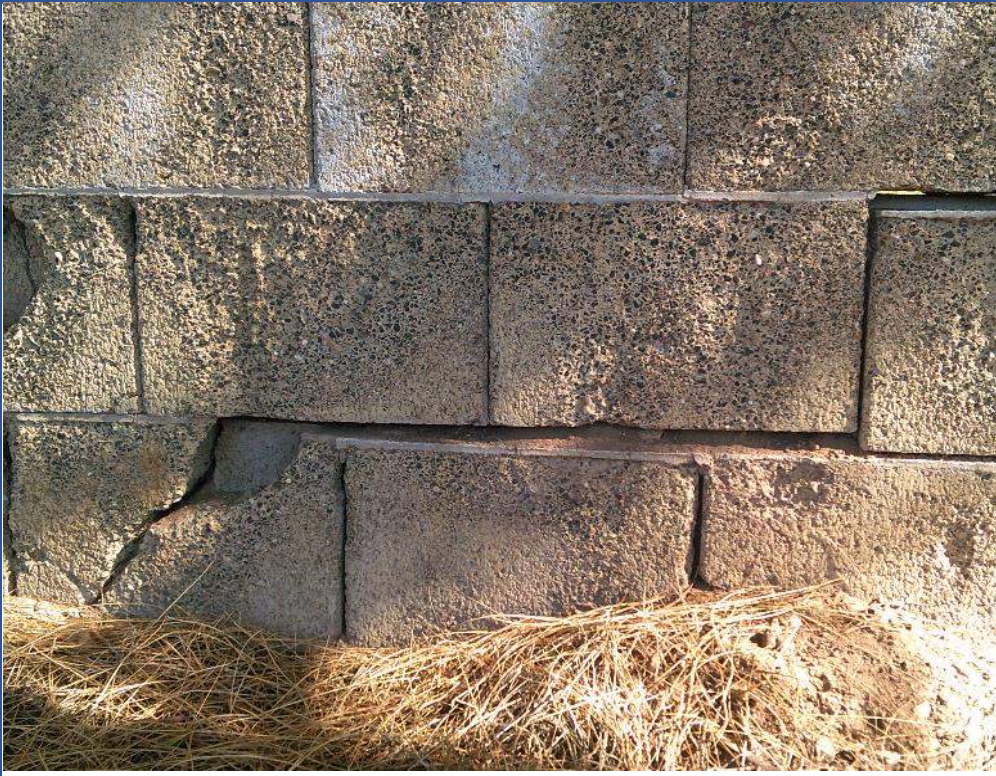
Lot 8S - Significant delamination.

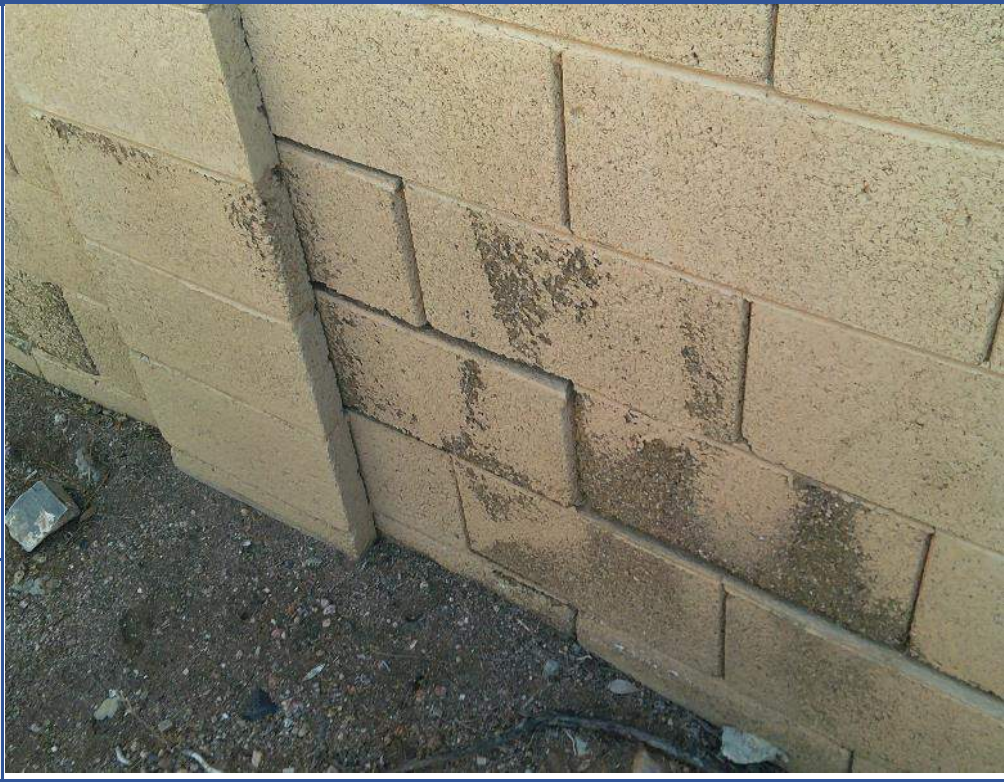
<p>Description:</p> <p>Lot 12 - Delamination. Offset 1".</p>
<p>23</p>

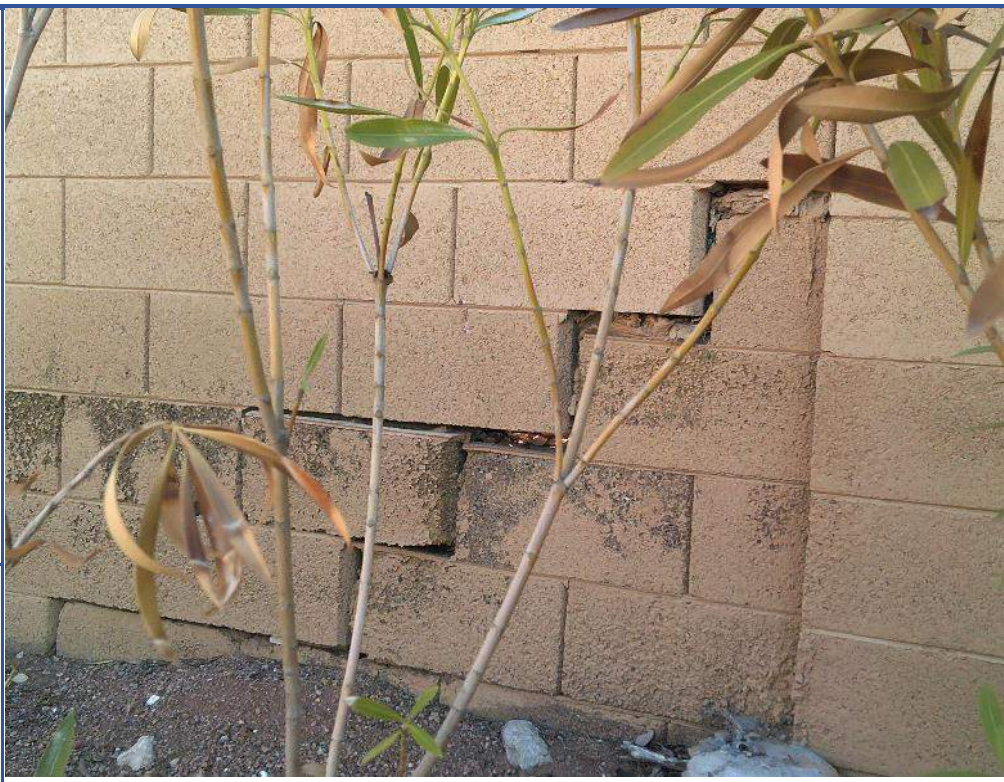
<p>Description:</p> <p>Lot 12 - Delamination. Uplift 2".</p>
<p>26</p>

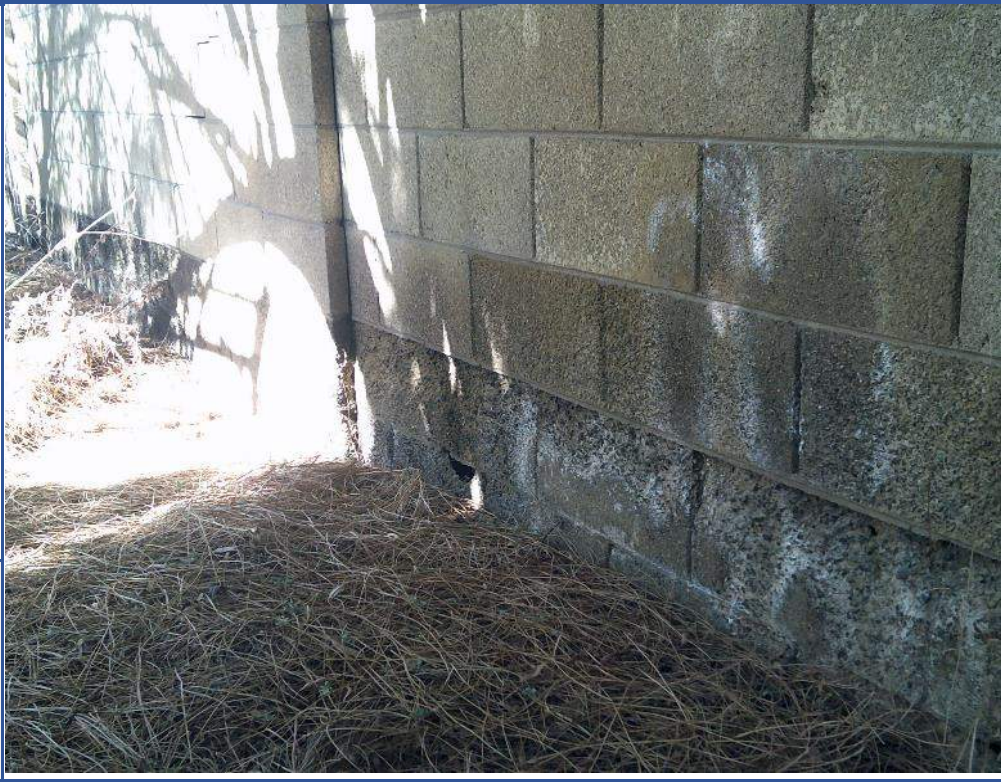
34

Lot 14 - Significant delamination.

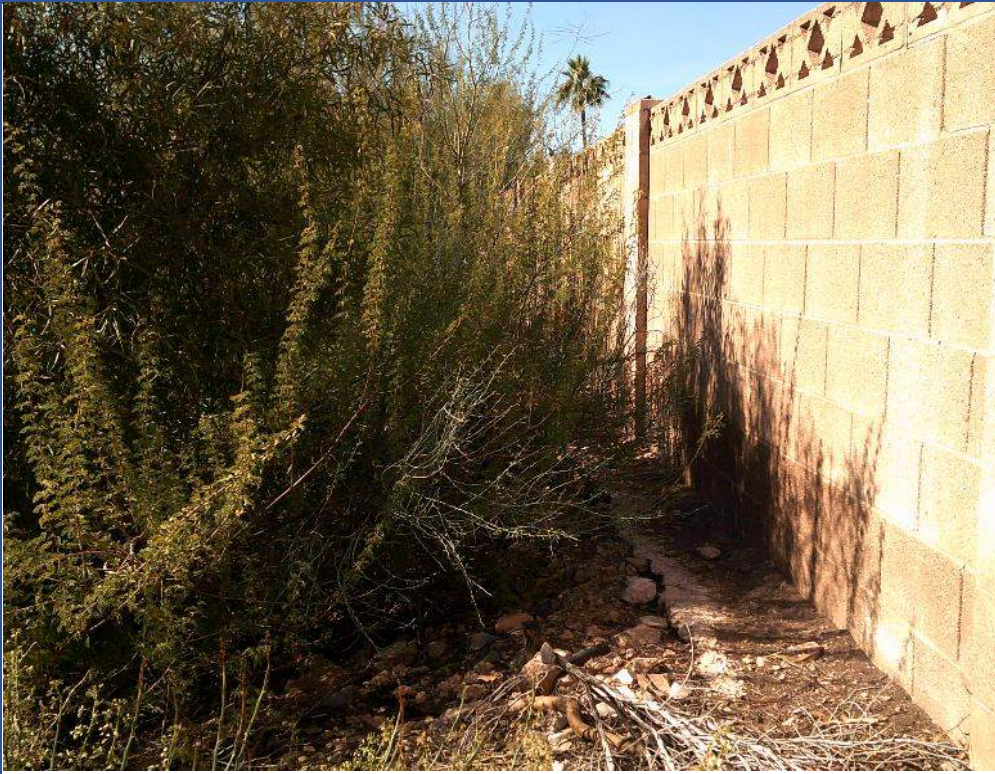
41

Lot 17 - Moderate delamination. Overgrowth. Exposed footing. Scour near wall.

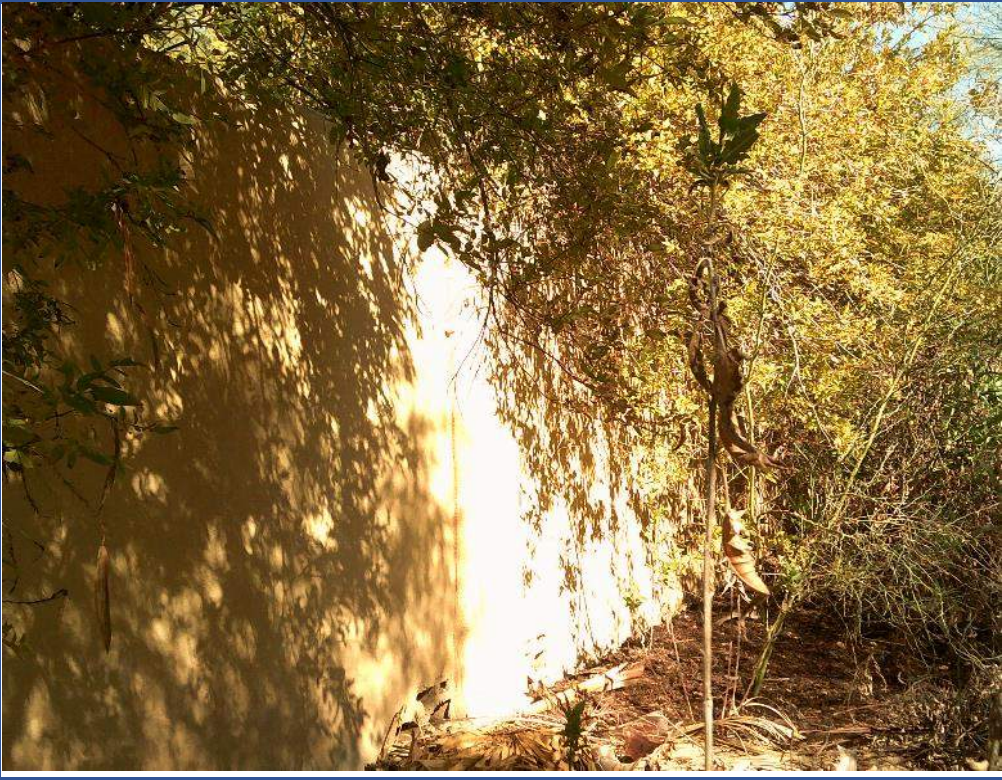
45

Lot 20 - Overgrowth.

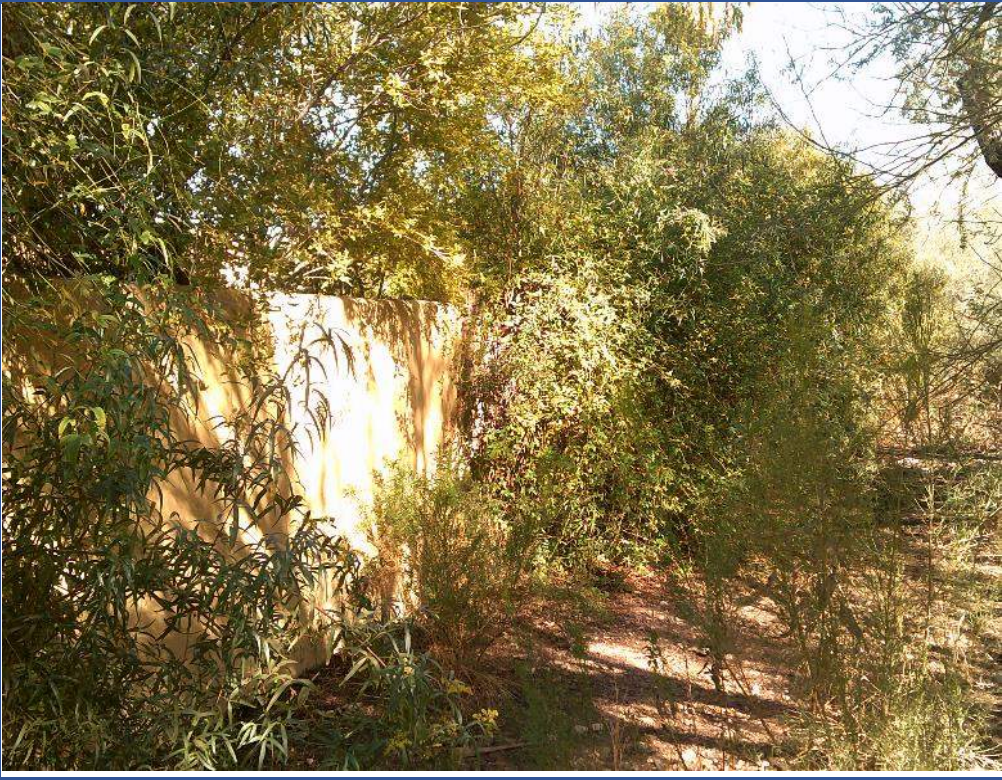
46

Lot 21 - Delamination.
Overgrowth.

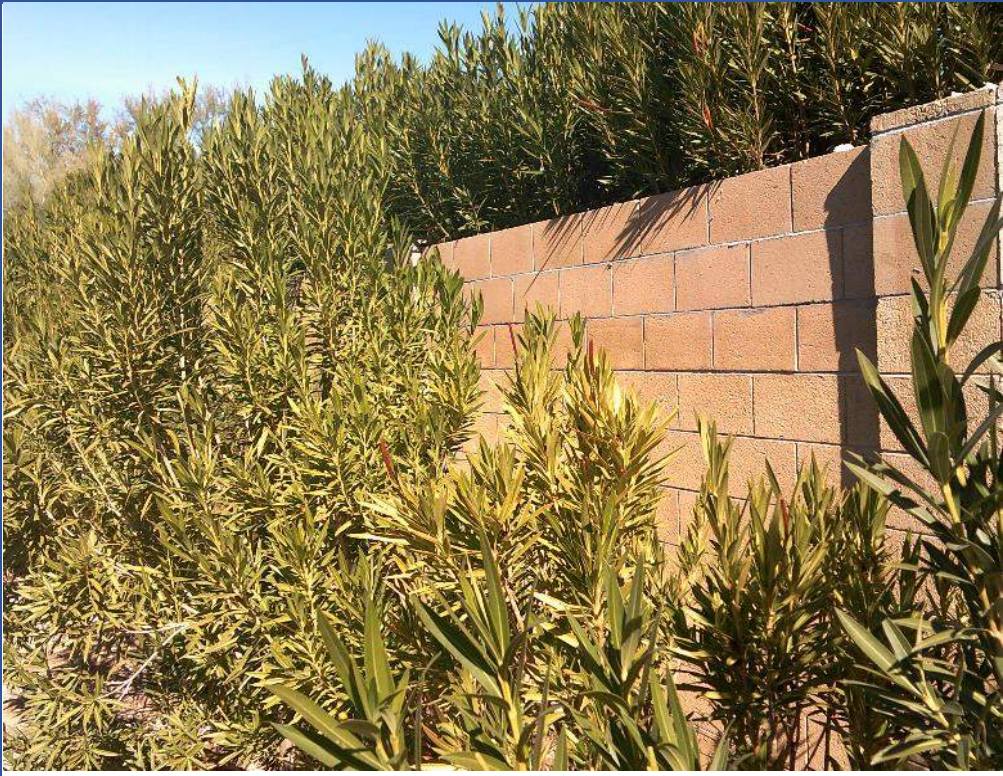
55

Lot 27 - Overgrowth.

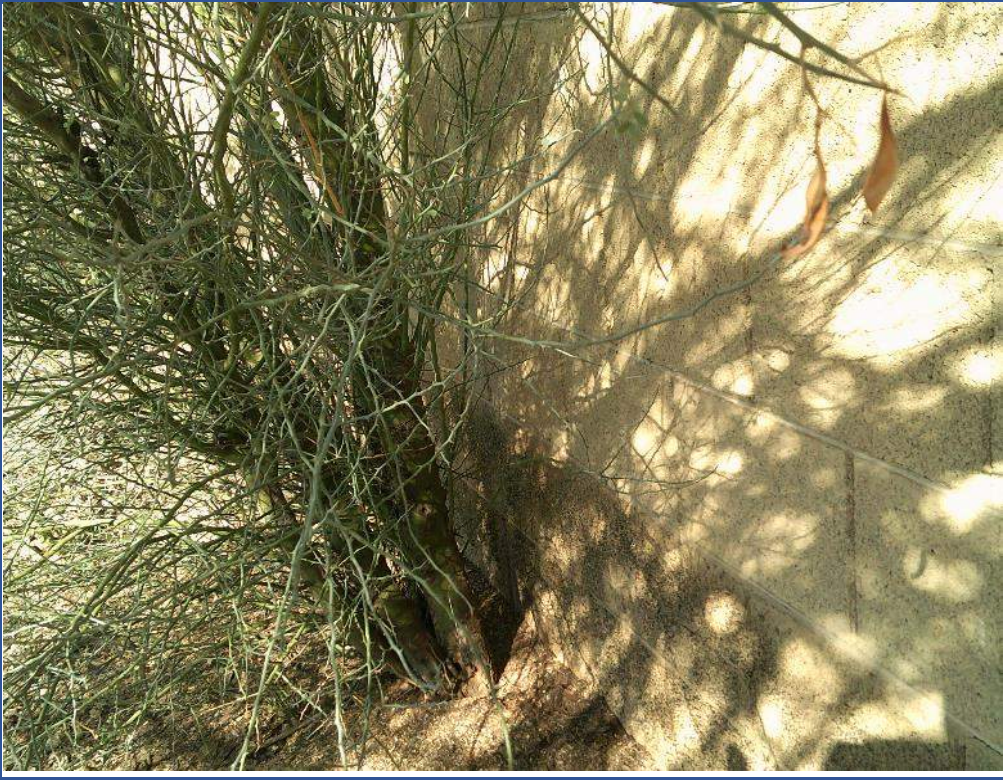
75

Lot 36S - Delamination.
Overgrowth.

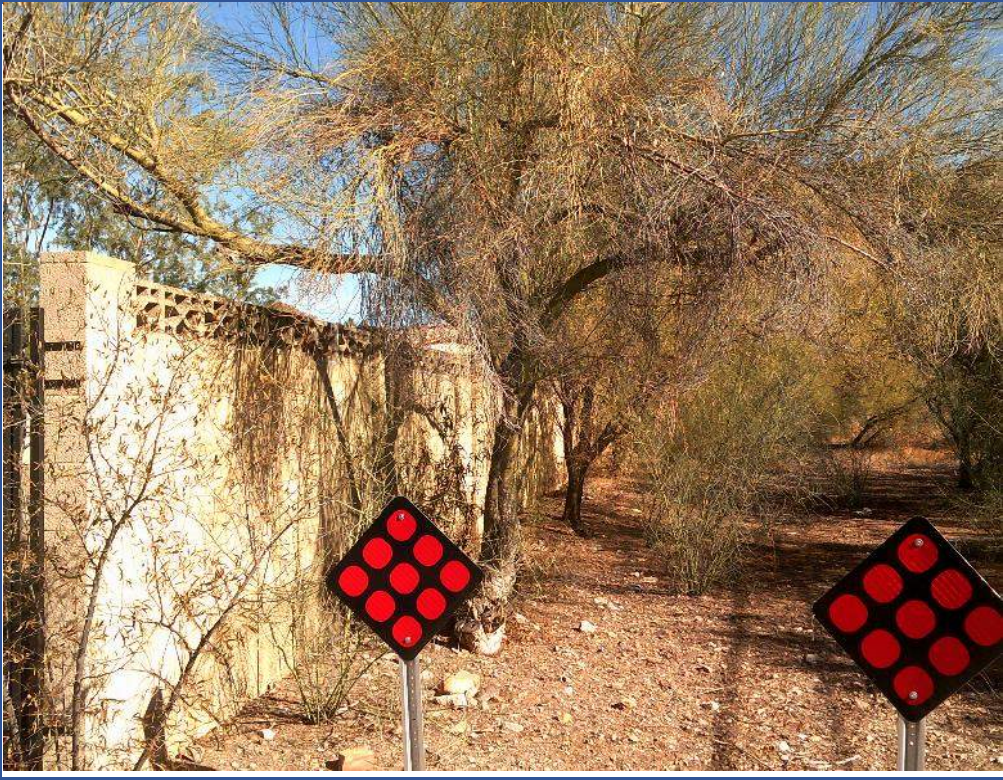
76

Lot 36 - Elevation.

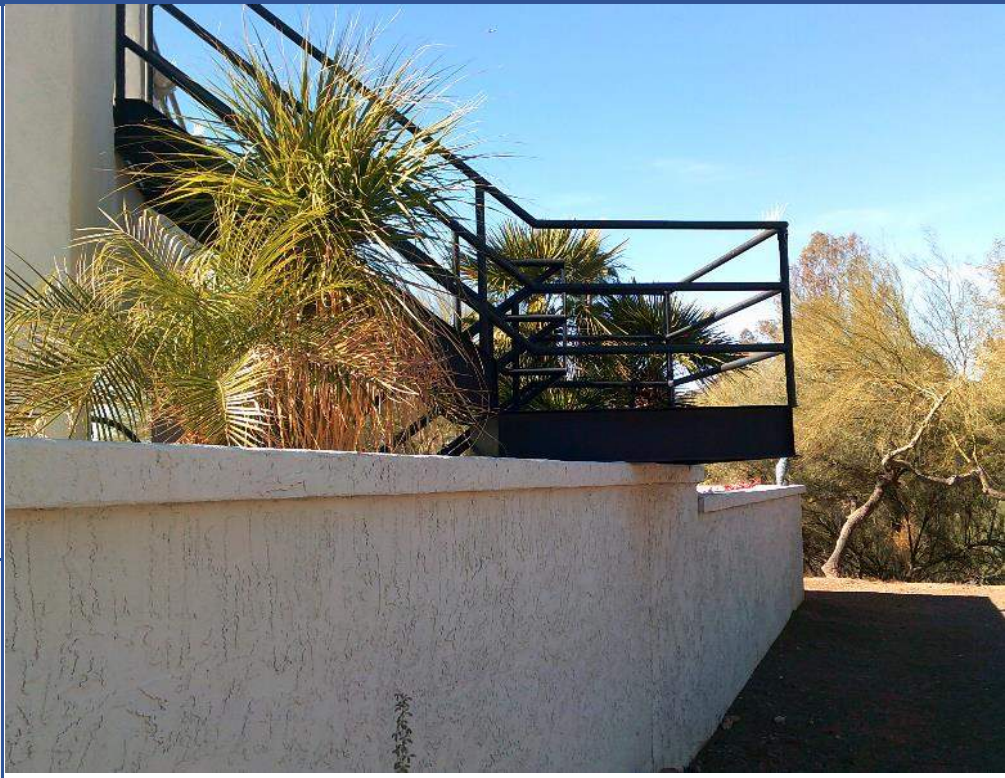
83

Lot 42 - Staircase may bear upon wall.

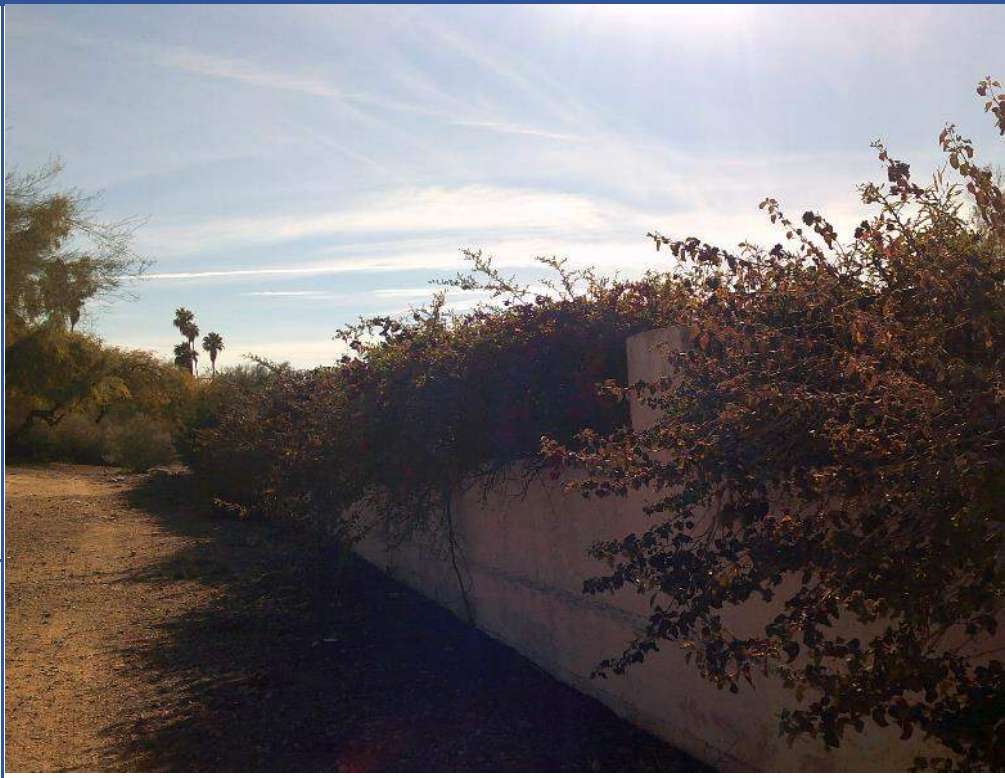
Lot 43 - Delamination. Overgrowth.

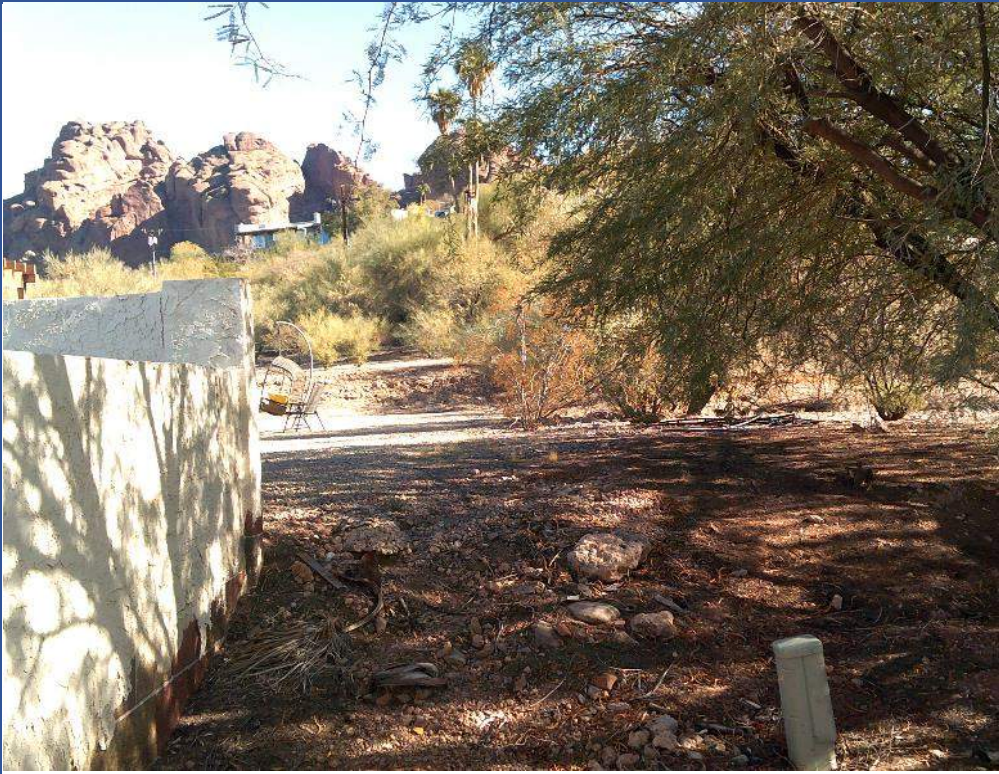
88

Lot 45 - Delamination.

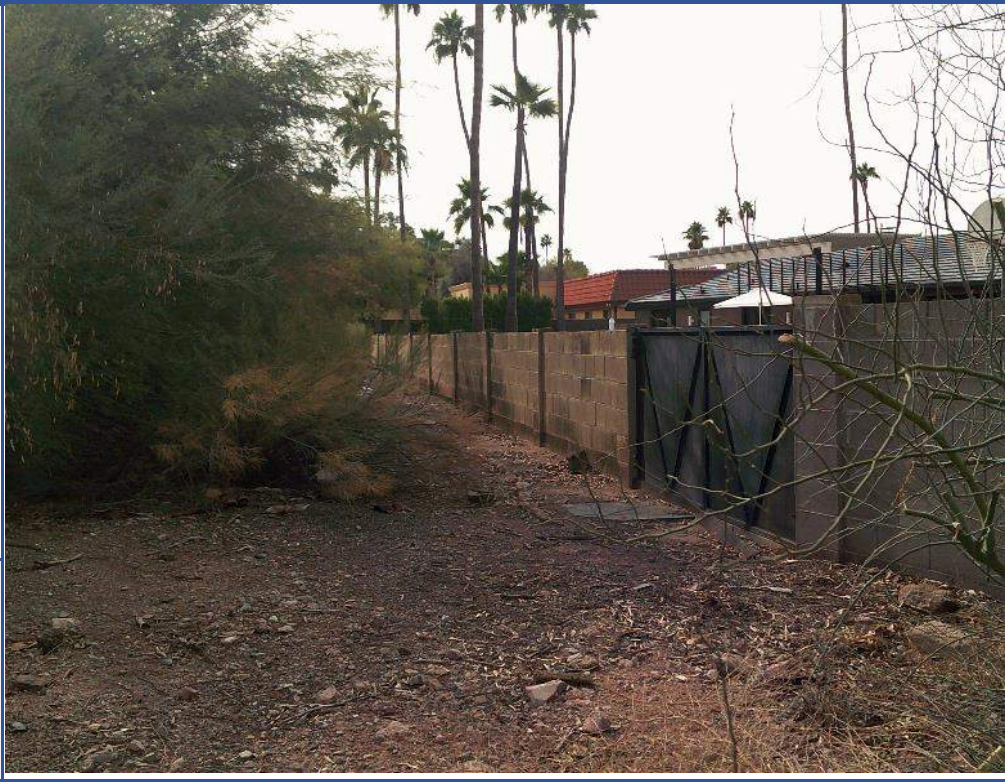
99

Lot 53 - Elevation.
Moderate delamination.

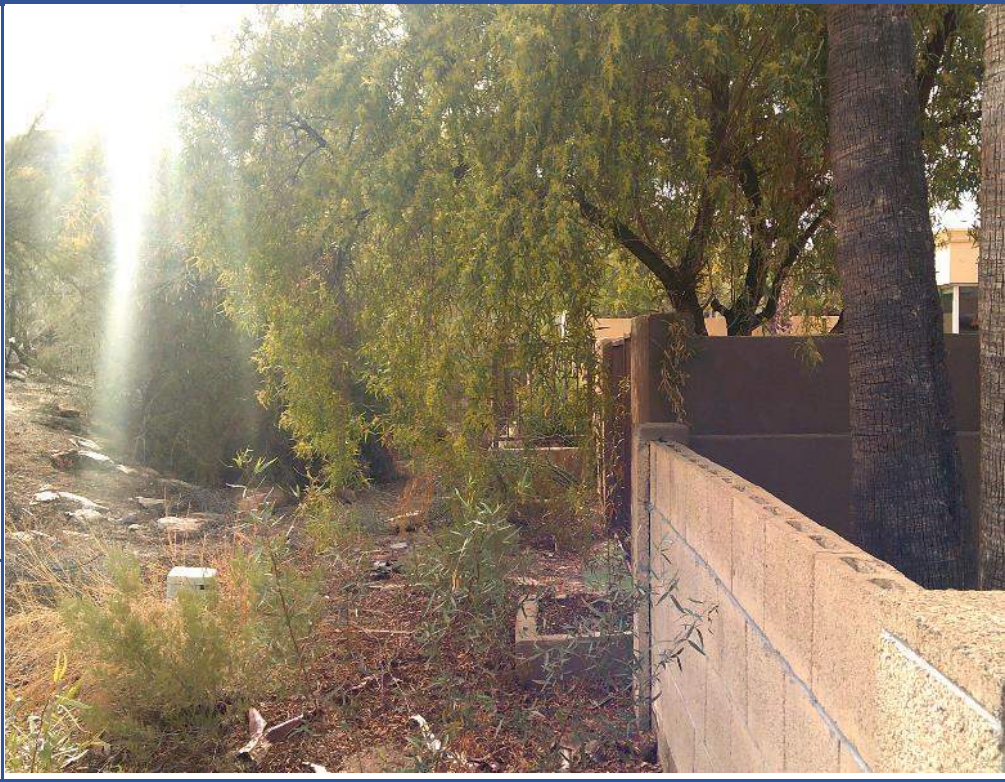
100

Lot 53 - Column
rotation up to
approximately 3" on a 5-
foot wall. Negative slope
towards wall. Multiple
panel with exposed
courses.

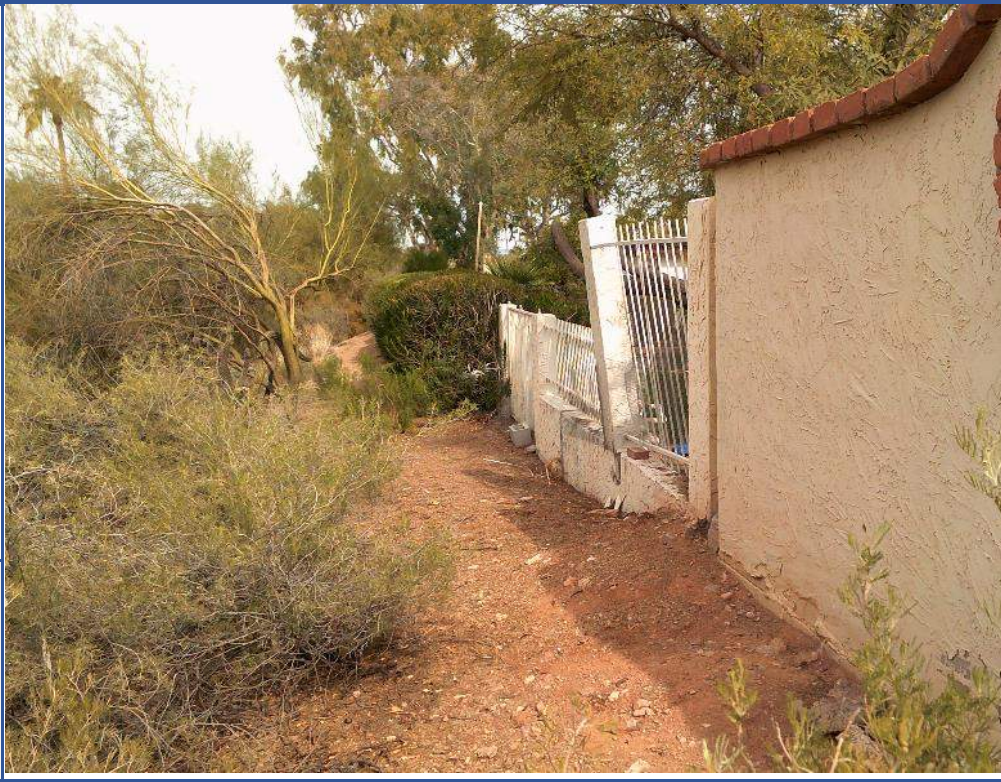
PHOTO NUMBER
106

Lot 63 - Elevation.

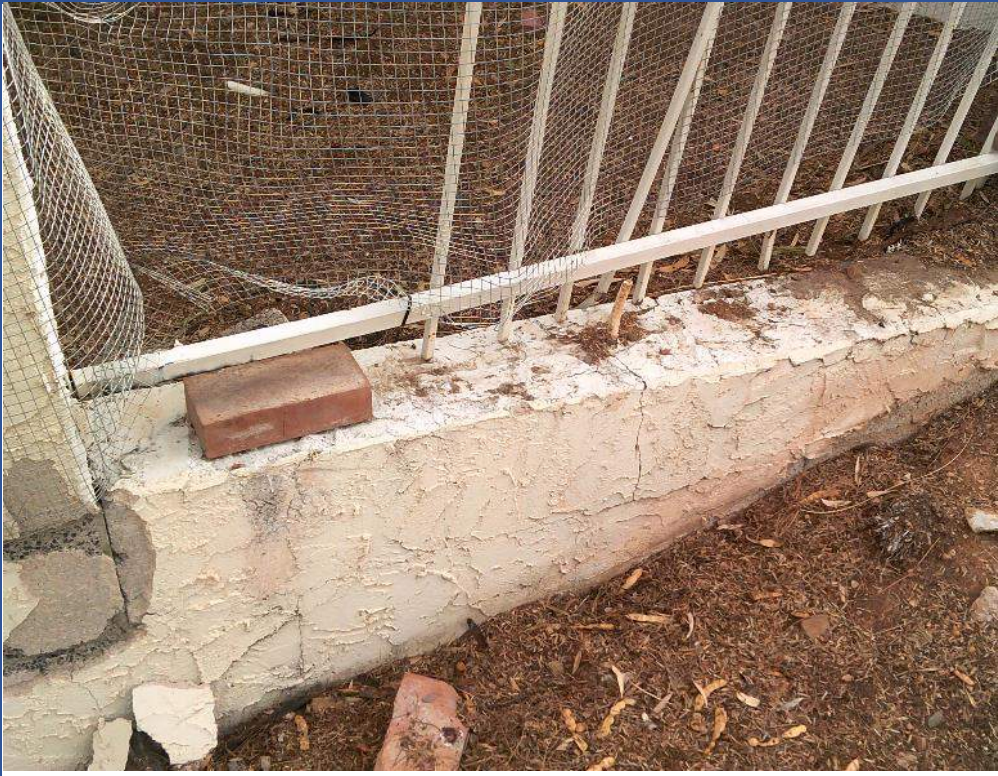
107

Lot 63 - Exposed rebar.

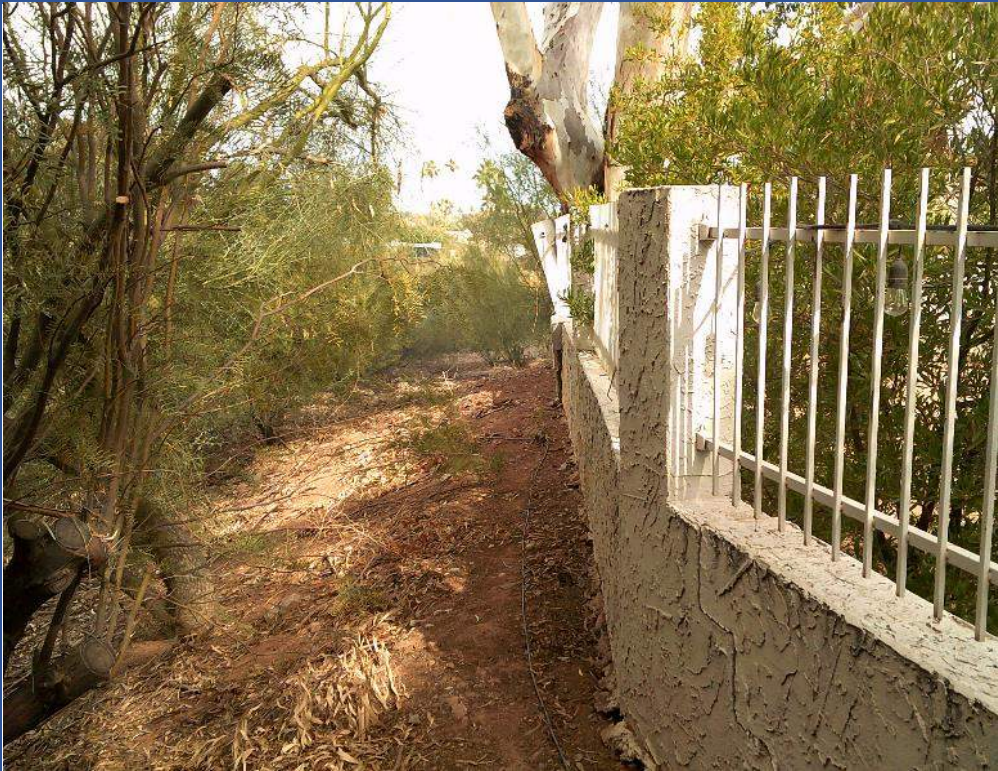
Lot 63 - Column rotation elevation.

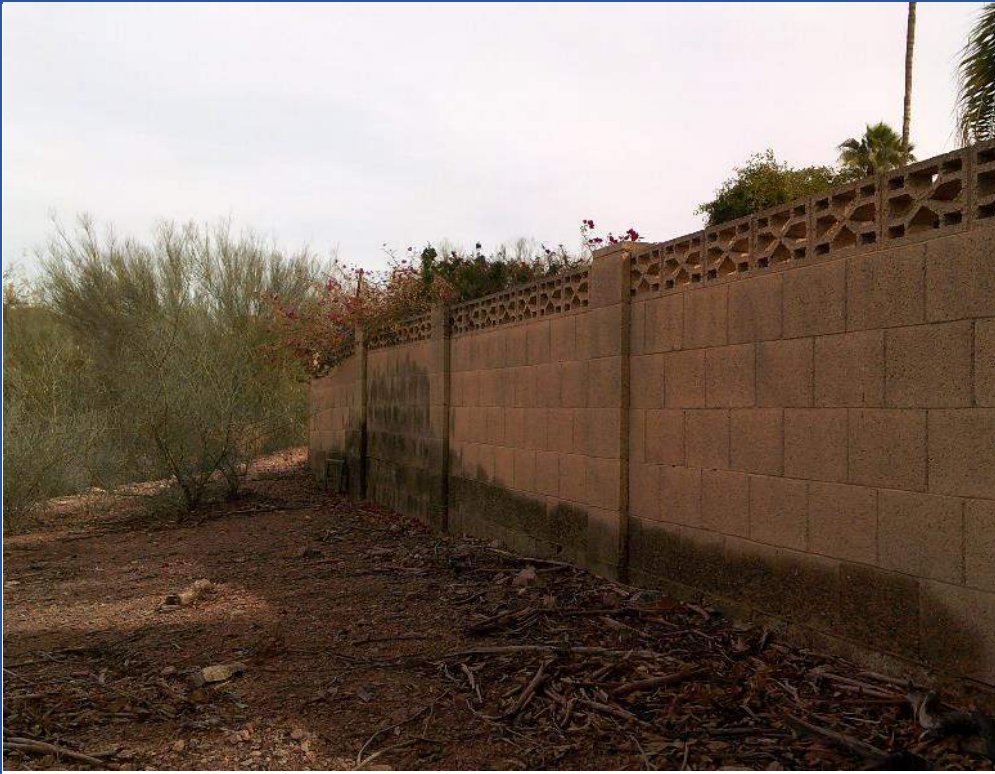
111

Lot 64 - Elevation.
Significant delamination.
Overgrowth.

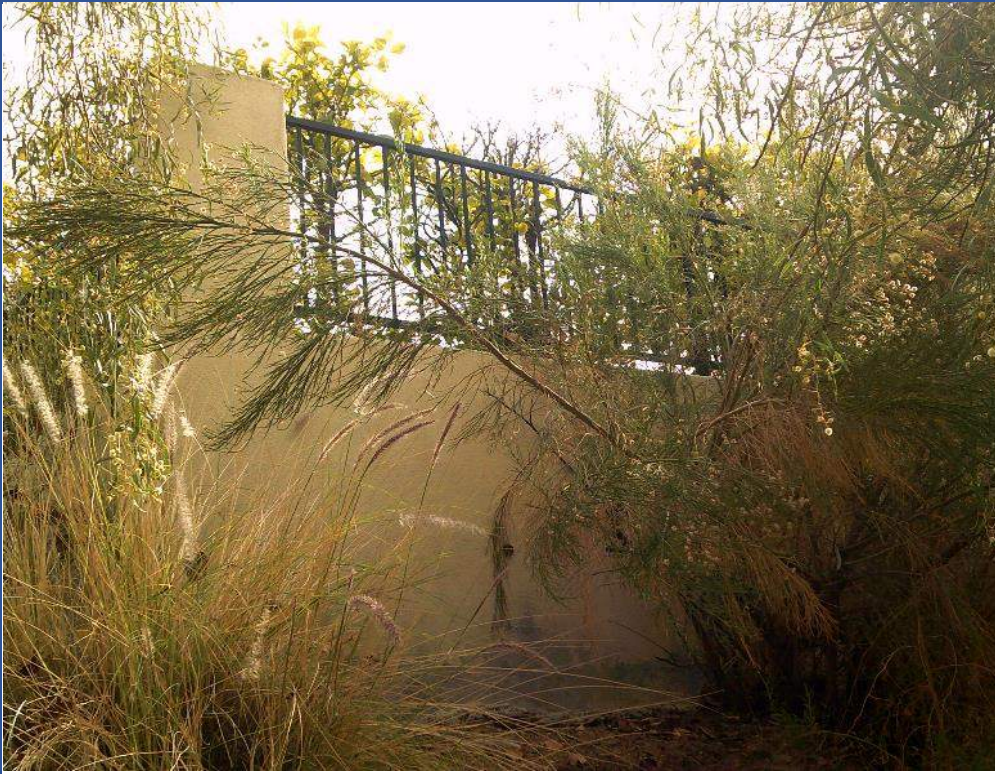
115

Lot 65 - Column rotation up to approximately up to approximately 1" on a 6-foot wall.

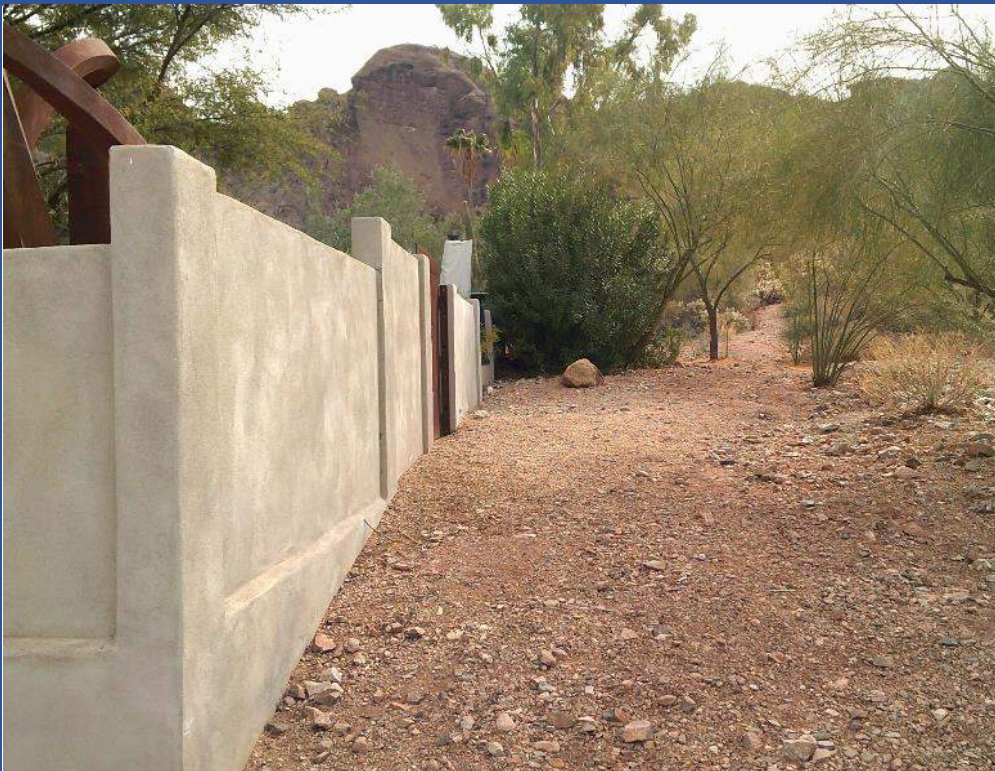
Lot 67 - Elevation. Column rotation up to approximately 2.75" on a 5.5-foot column on 3 panels at rear. Overgrowth. Painted stucco.

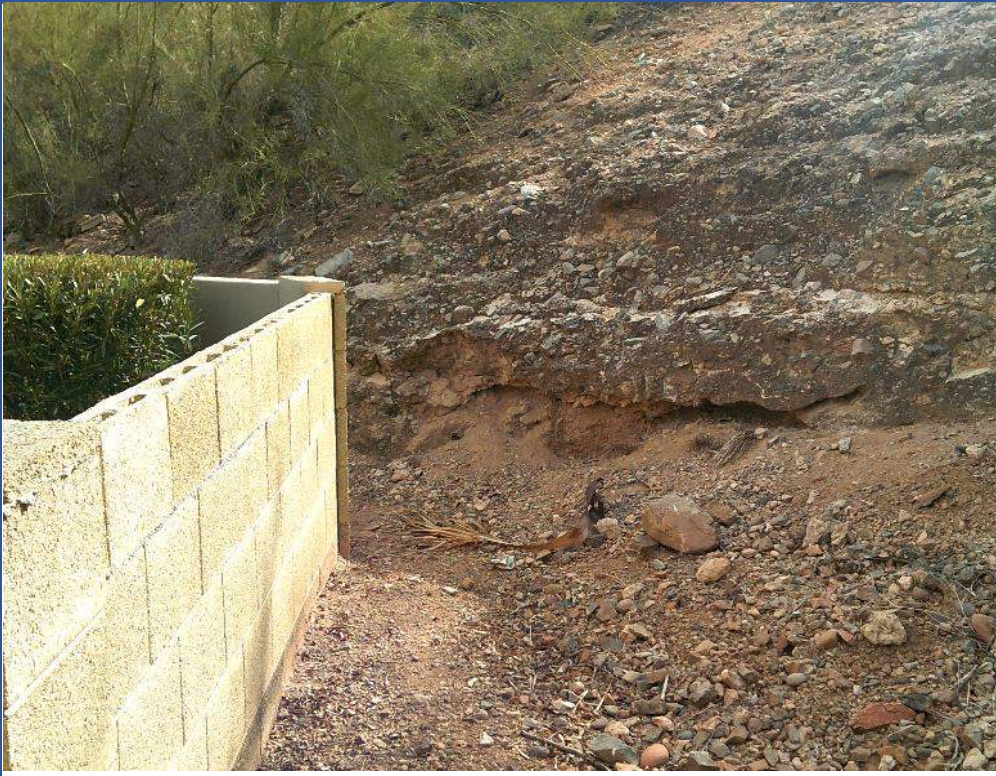
123

Lot 70 - Exposed top cell.

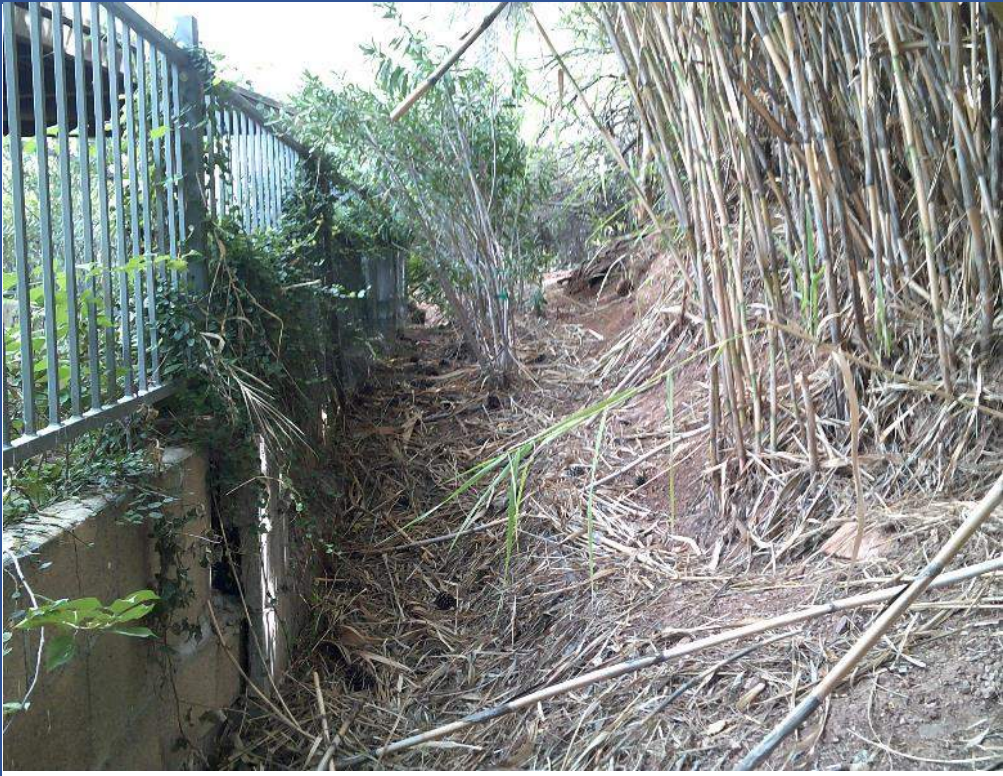
Lot 71 - Multiple locations of overgrowth. Negative slope towards wall. Very limited access in multiple locations.

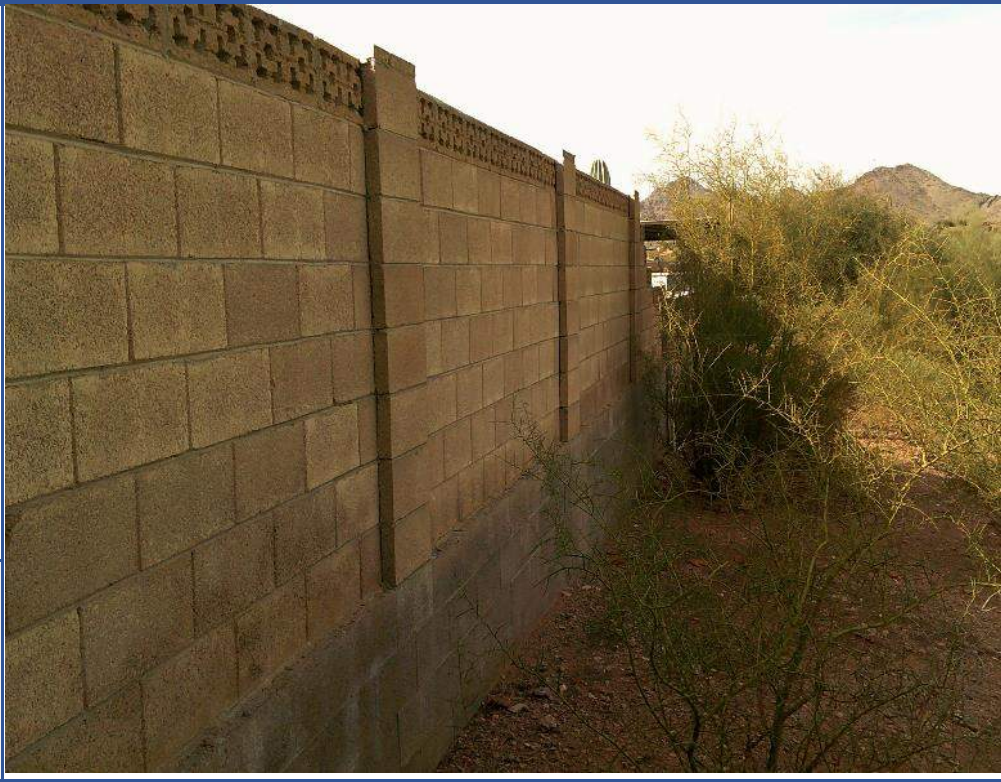
128

Lot 73 - Delamination and efflorescence. Wet grade while on site.

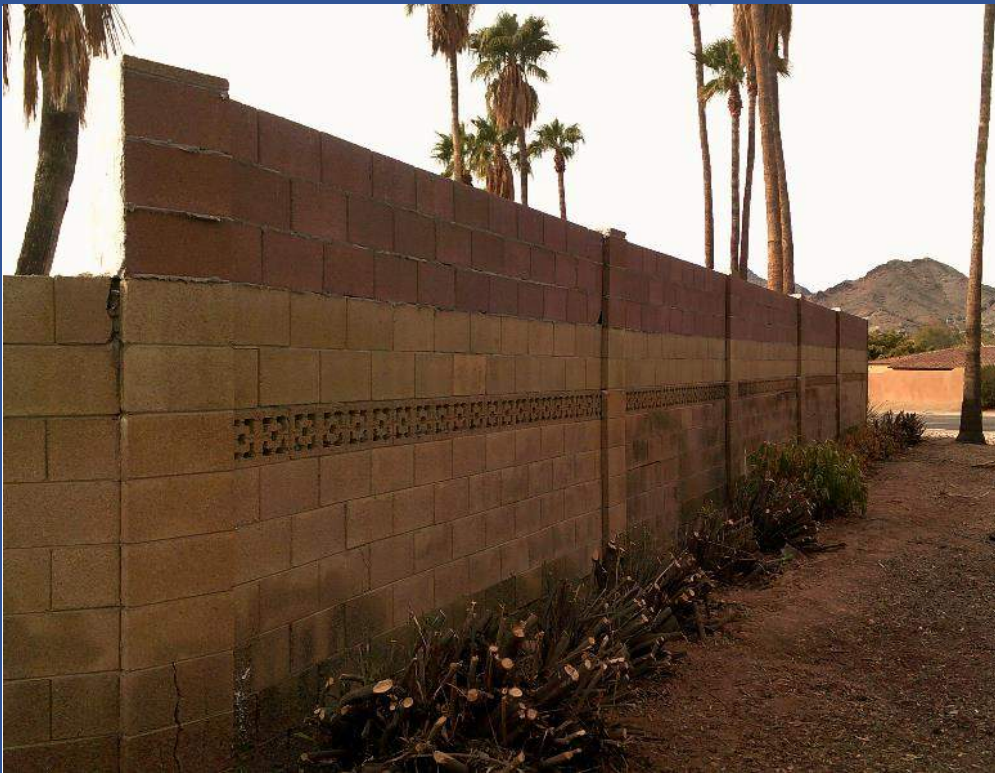
146

Lot 91 - Built up wall.

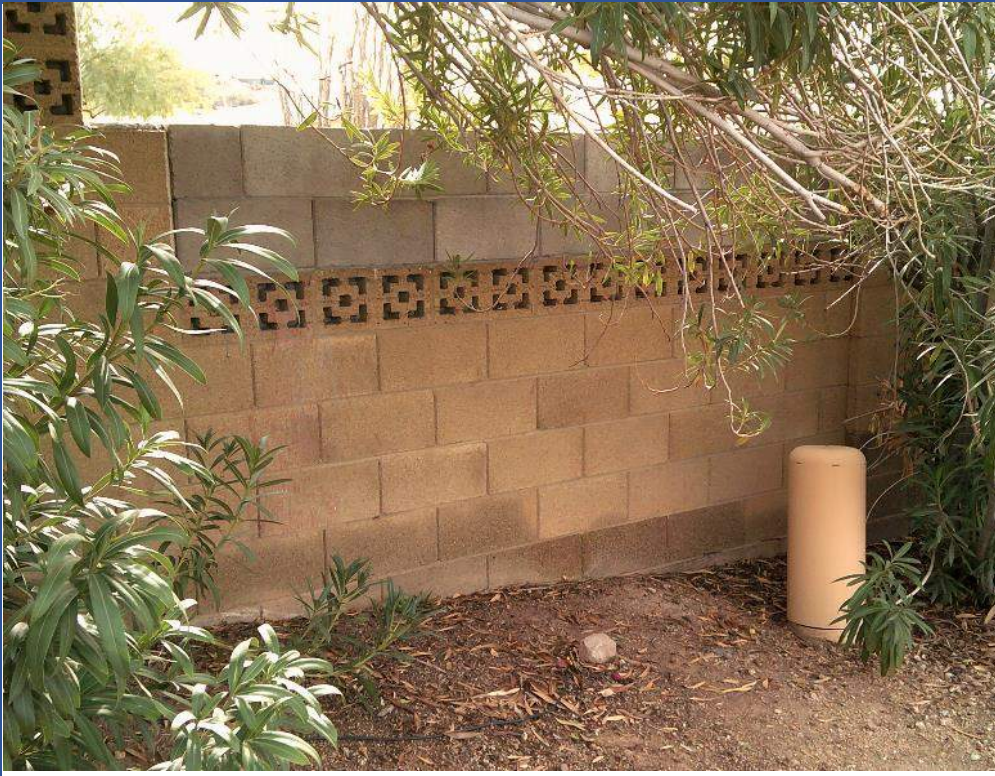
149

Lot 93 - Built up wall.

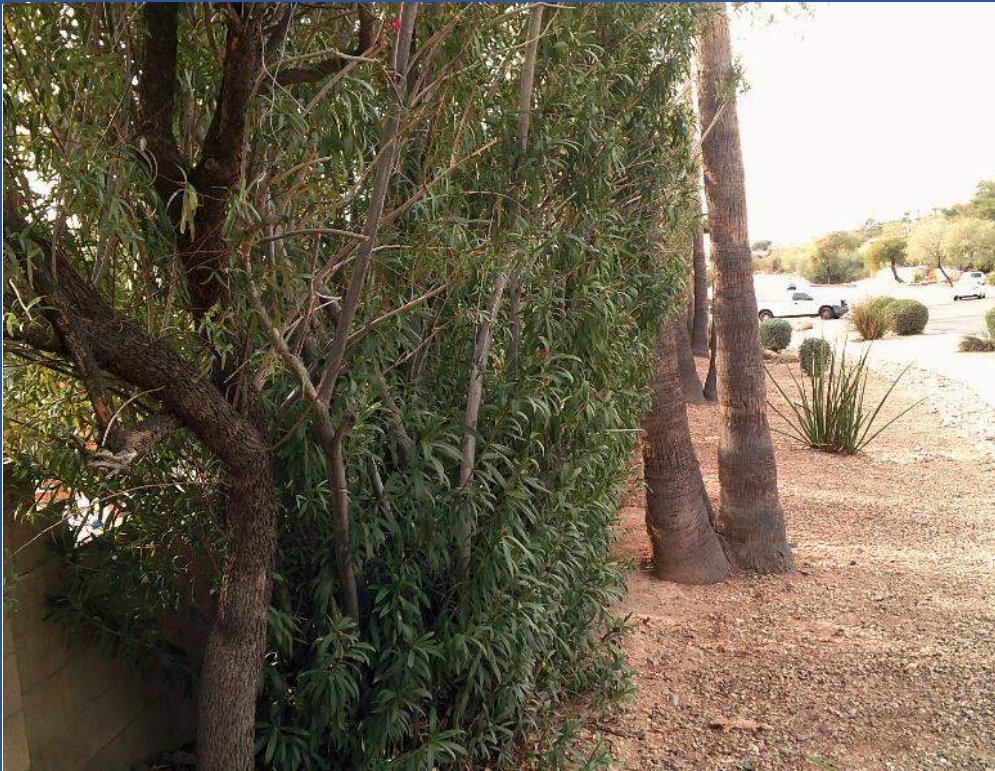
150

Lot 94 - Delamination.
Overgrowth. Negative
slope towards wall.

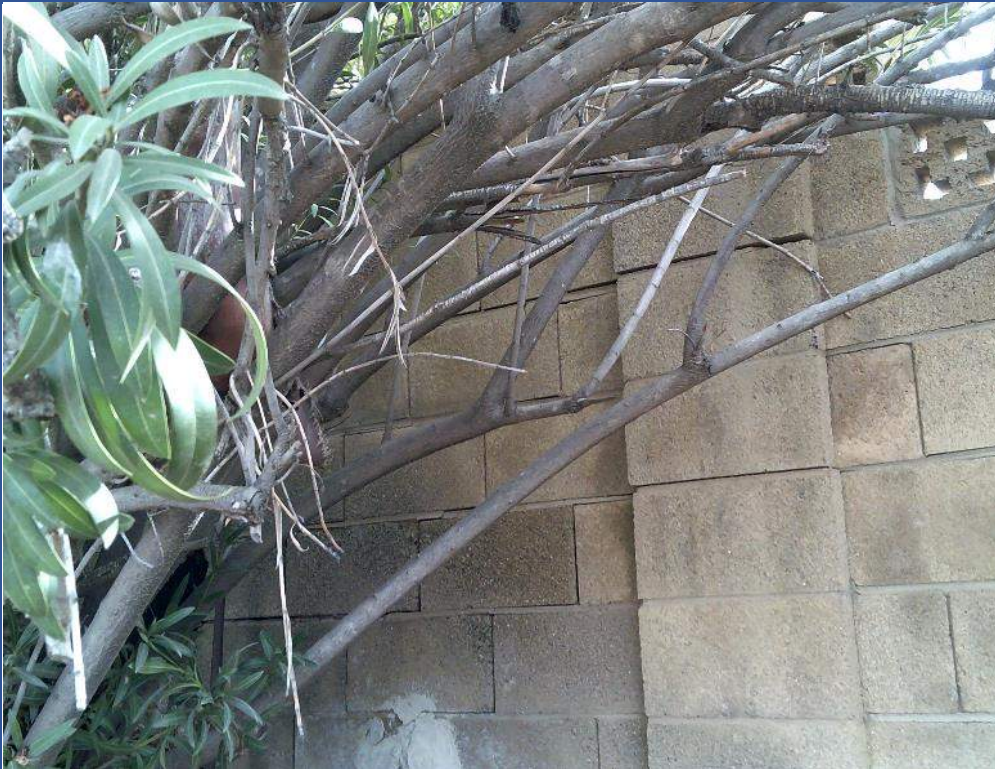
152

Lot 95 - Moderate delamination with delaminated grout. Overgrowth. Previous repair with built up wall.
