CAMELBACK CANYON ESTATES BLOCK WALL EVALUATION

Number: 23-0433

Final Submittal: January 31, 2024

SERVICE: 23-0433 – BLOCK WALL STRUCTURAL EVALUATION

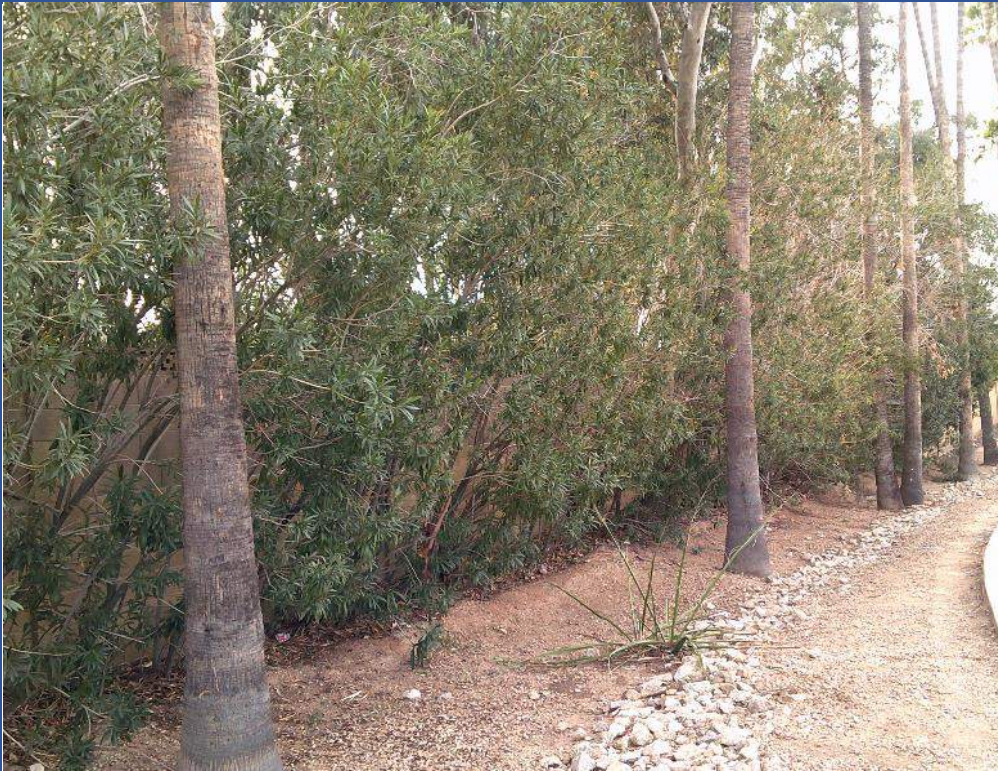
155

Lot 99 - Elevation.

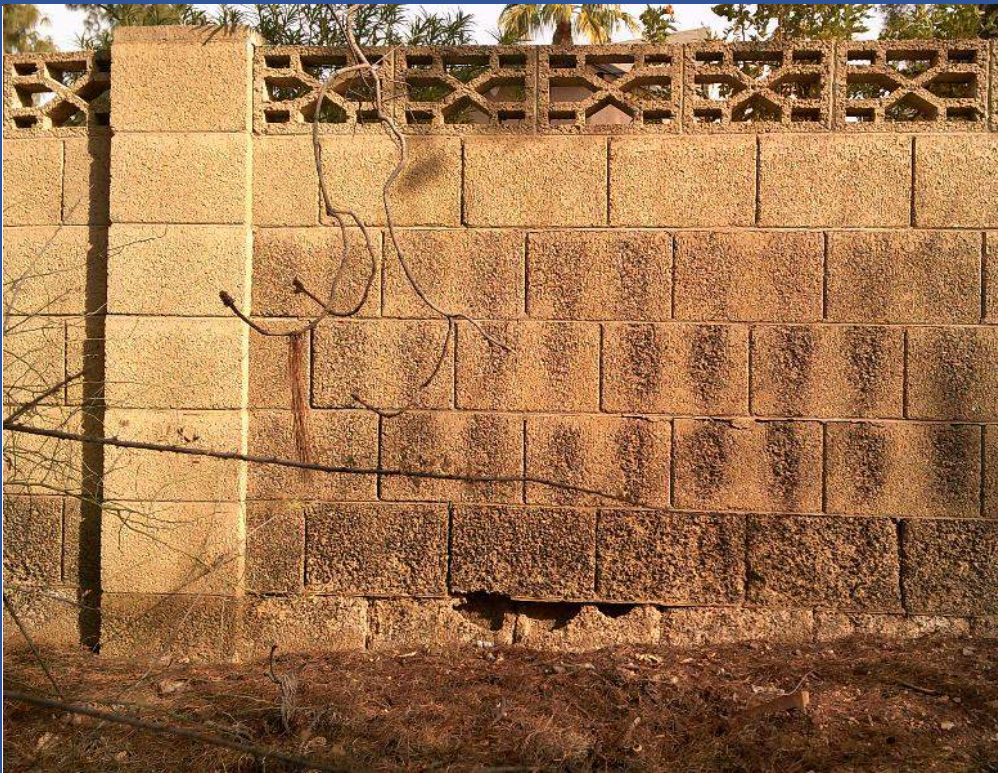
164

Lot 101 - Significant delamination. Holes in course.

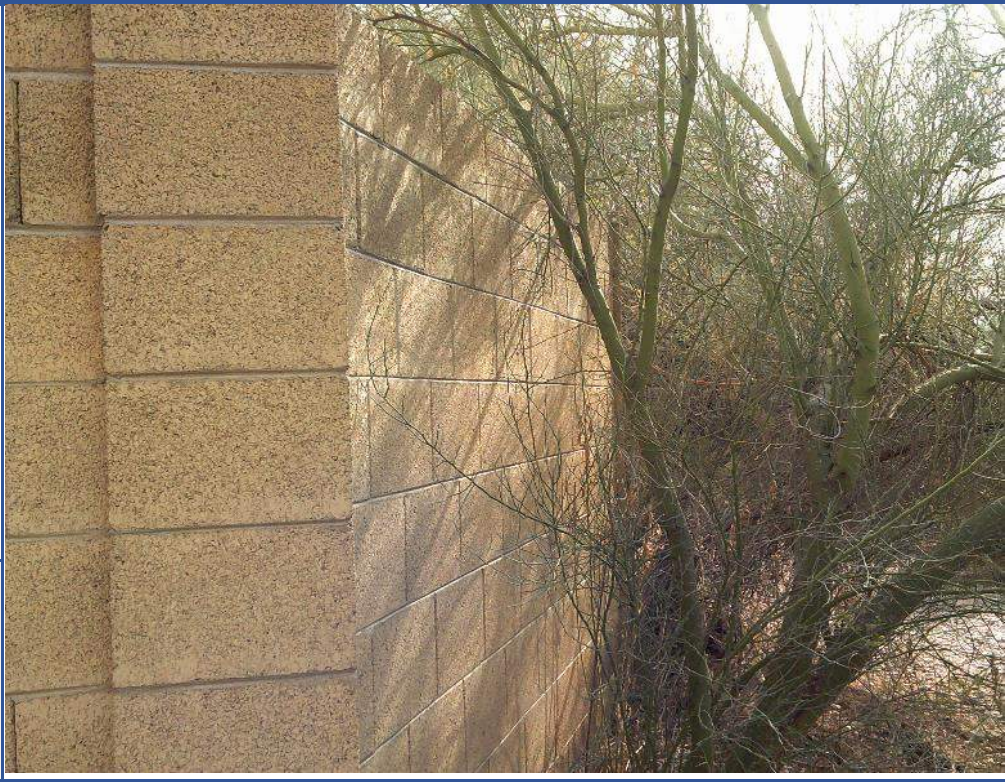
166

Lot 102 - Elevation. Overgrowth. Potential uplift.

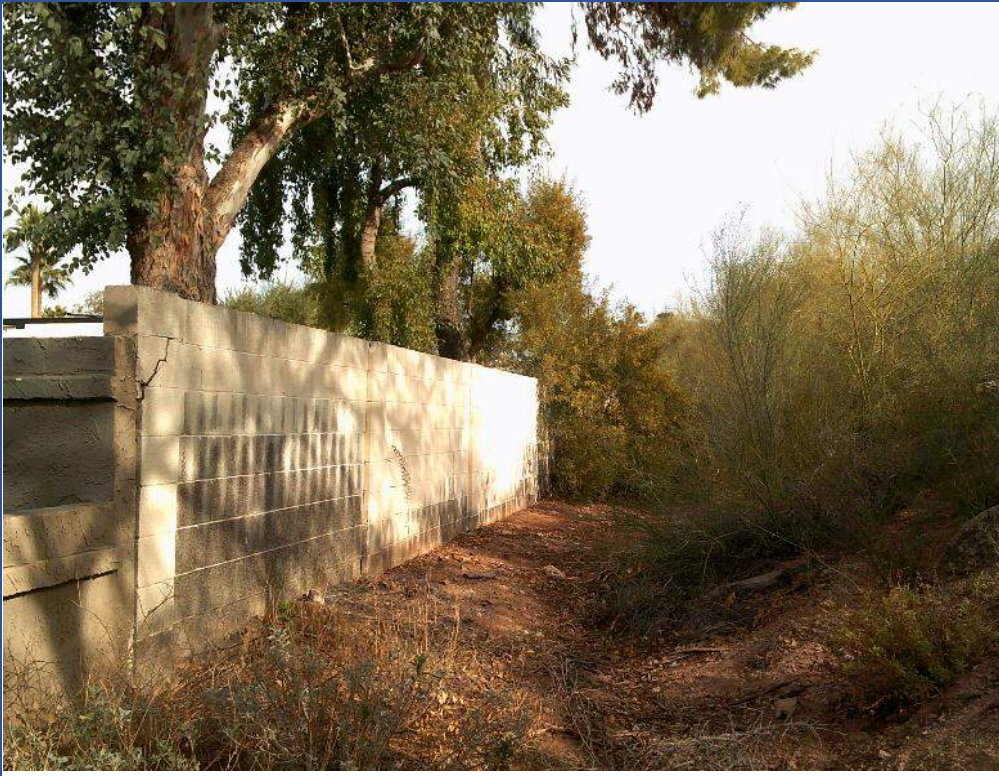
167

Lot 104 - Elevation.

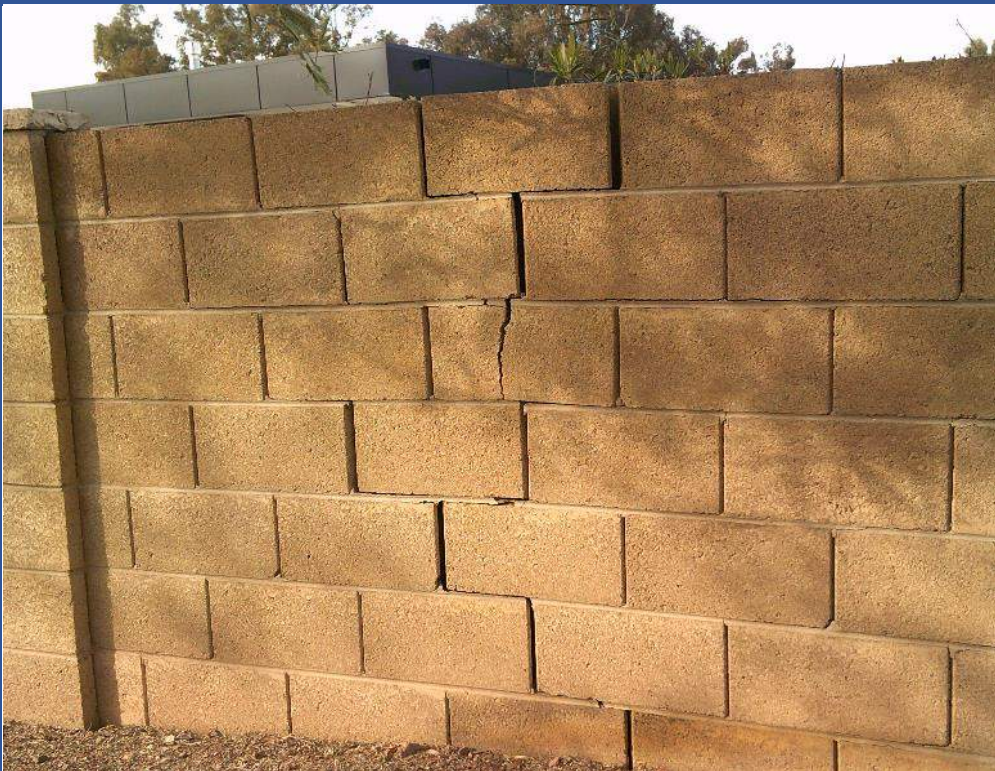
174

Lot 105 - Column rotation up to approximately 3/4" on a 5-foot column. Uplift up to approximately 1/2".
