CAMELBACK CANYON ESTATES BLOCK WALL EVALUATION

Final Submittal: January 31, 2024

PROPERTY: CAMELBACK CANYON ESTATES COMMUNITY
PHOENIX, ARIZONA

SERVICE: 23-0433 – BLOCK WALL STRUCTURAL EVALUATION

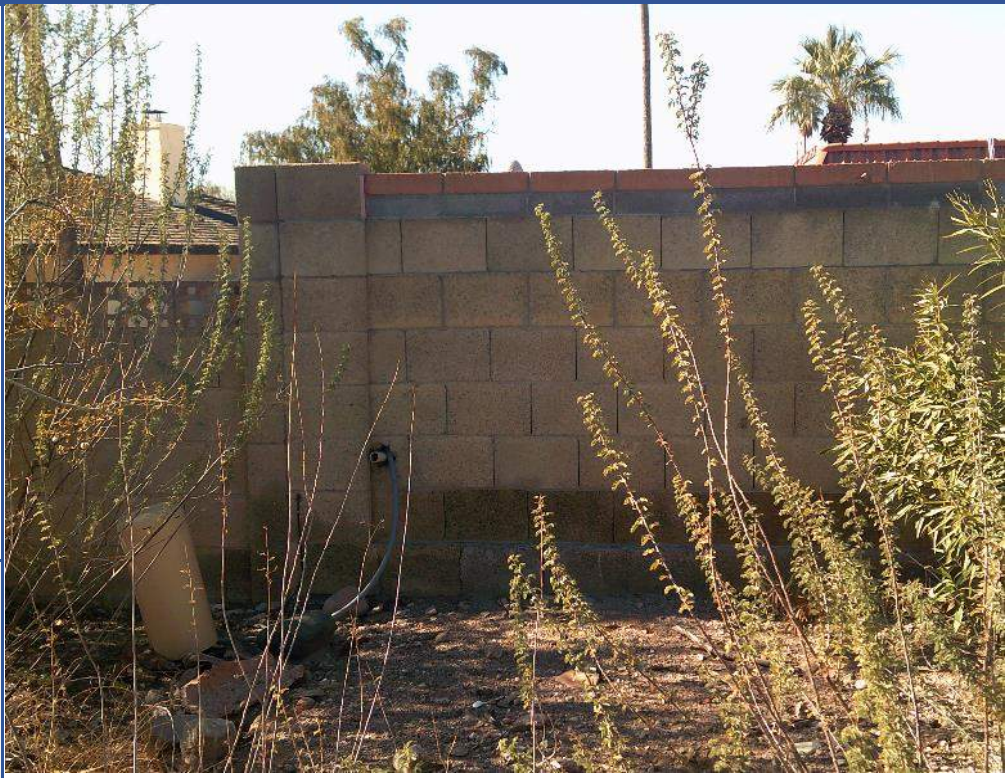
Lot 5 - Moderate delamination. Hole in course with pipe.

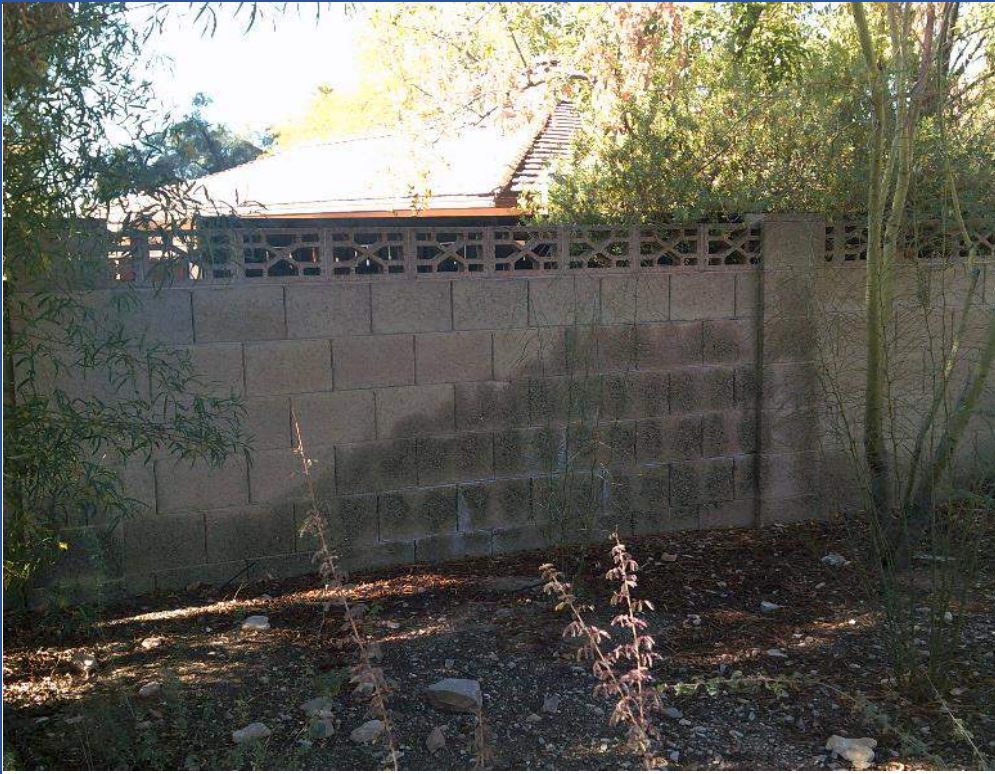
9

Lot 6 - Moderate delamination.

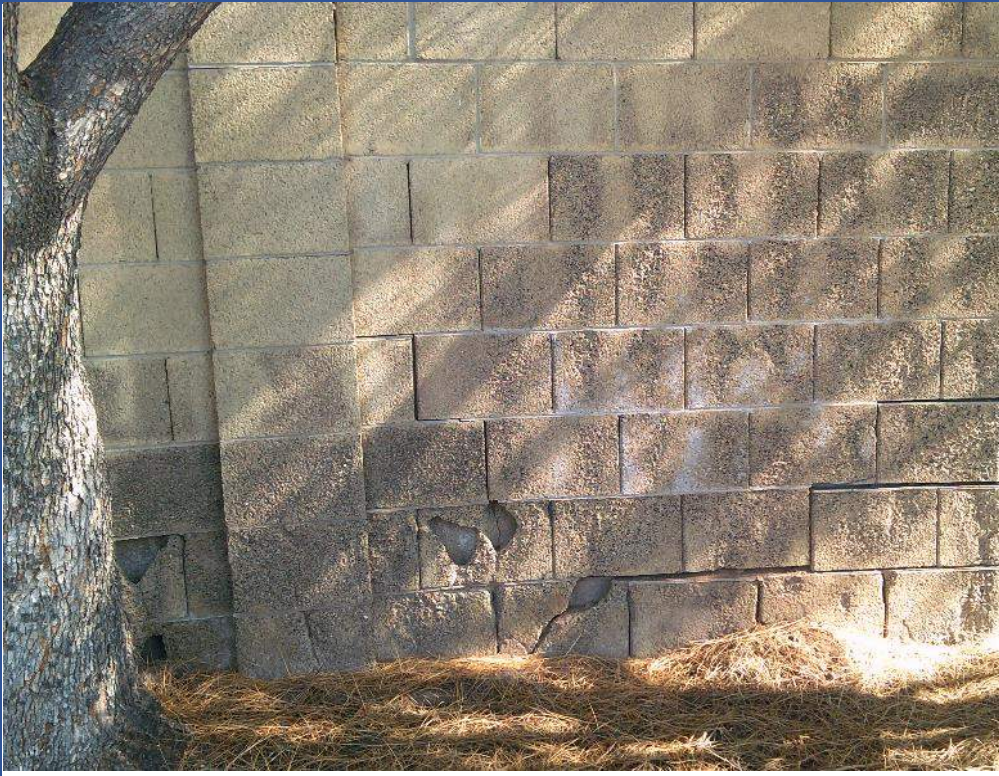
13

Lot 8 - Significant delamination.

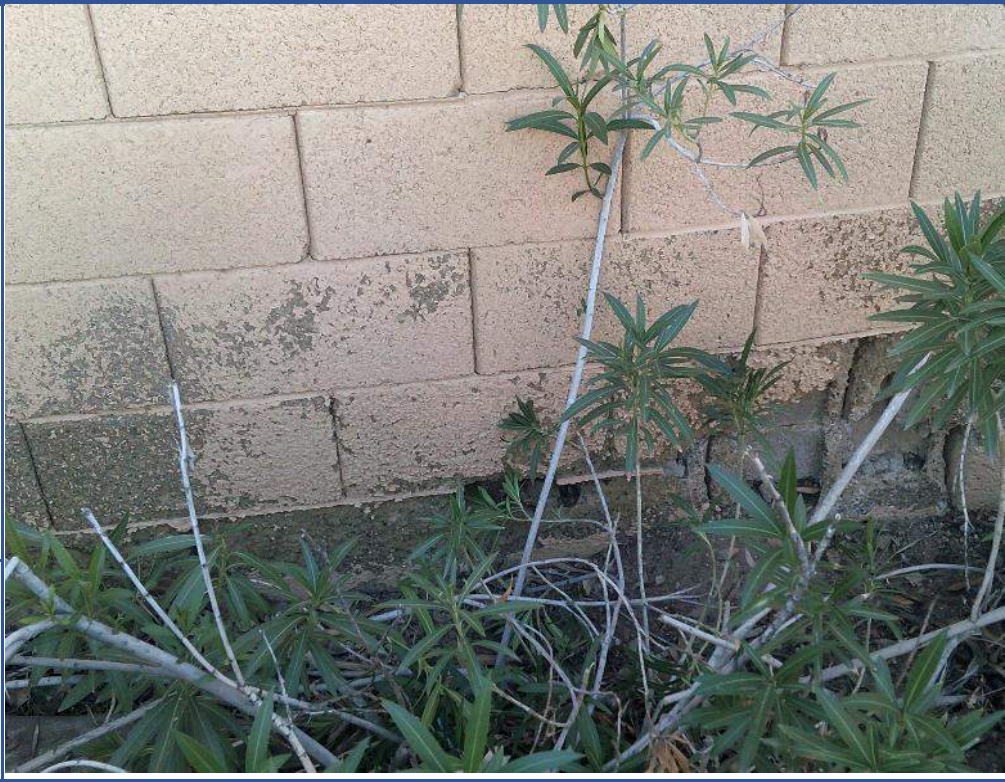
18

Lot 12 - Significant delamination. Holes in course.

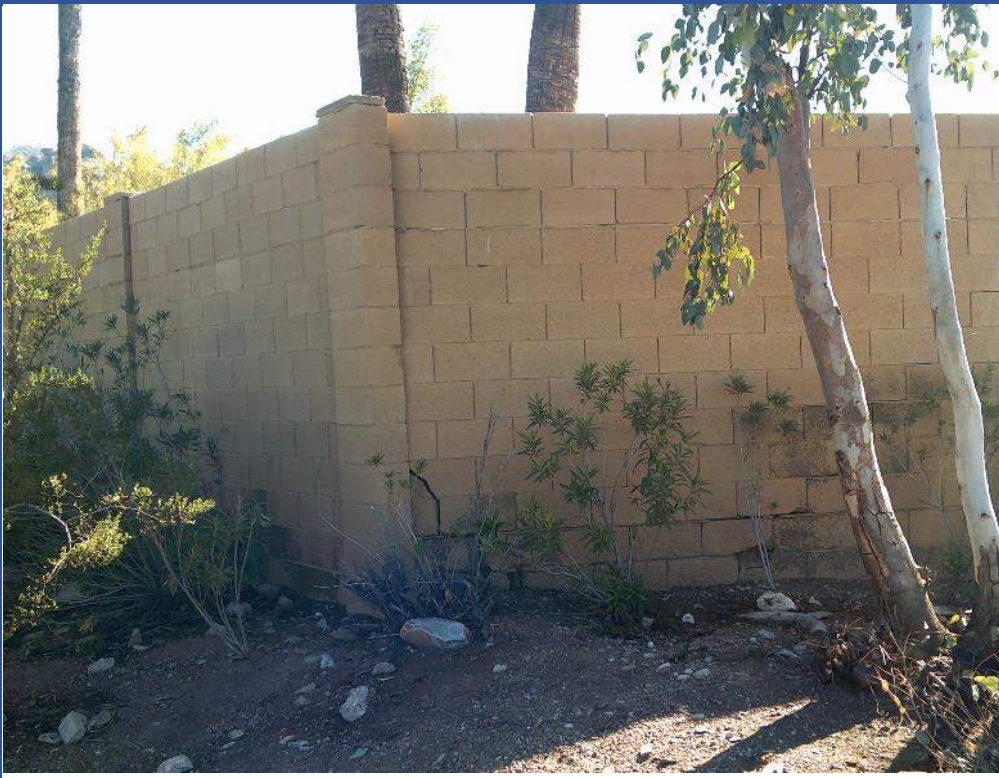
19

Lot 12 - Delamination. Column rotation up to approximately 2 1/4".

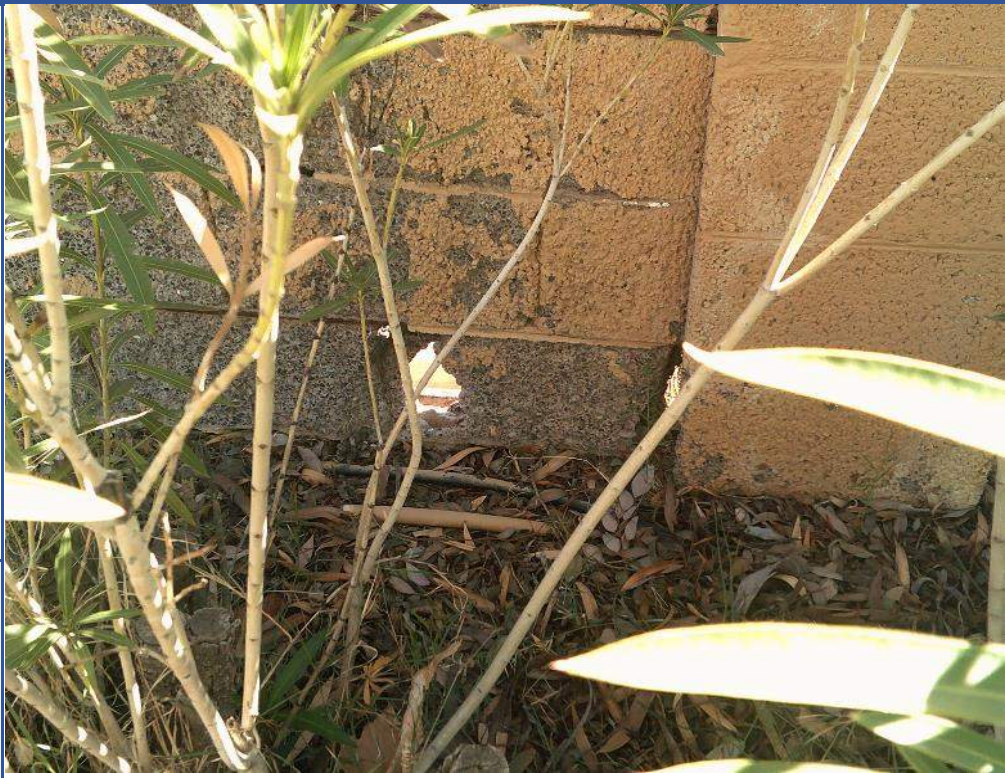
Lot 13 - Delamination.
Hole in course.

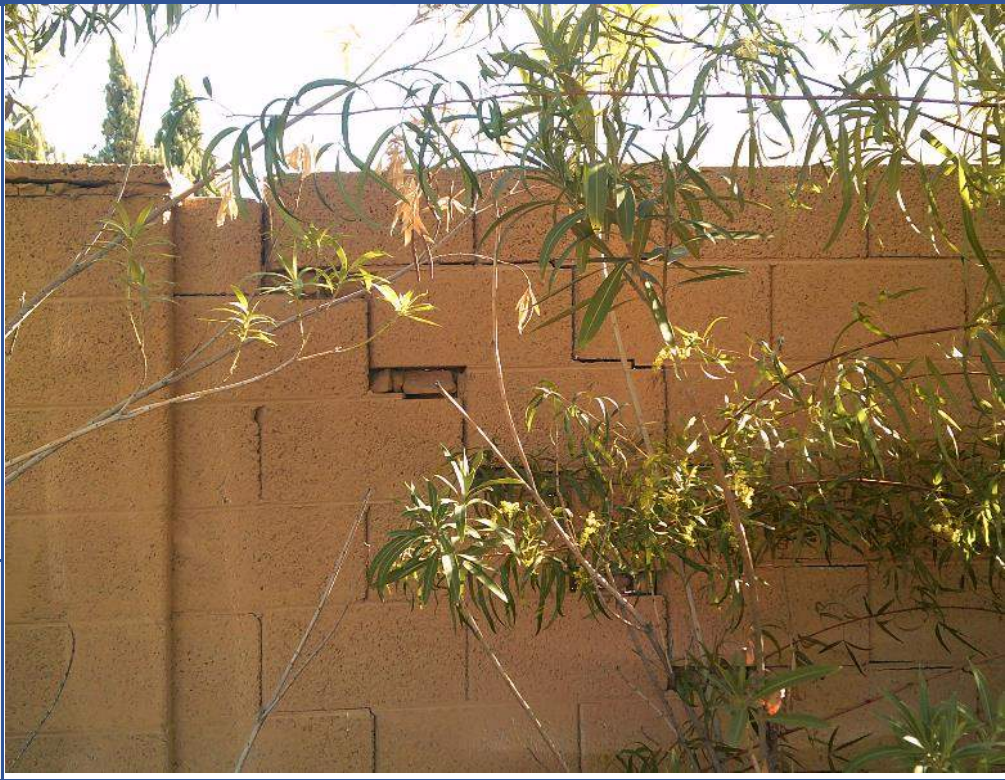
Lot 13 - Uplift at 2-
1/2".

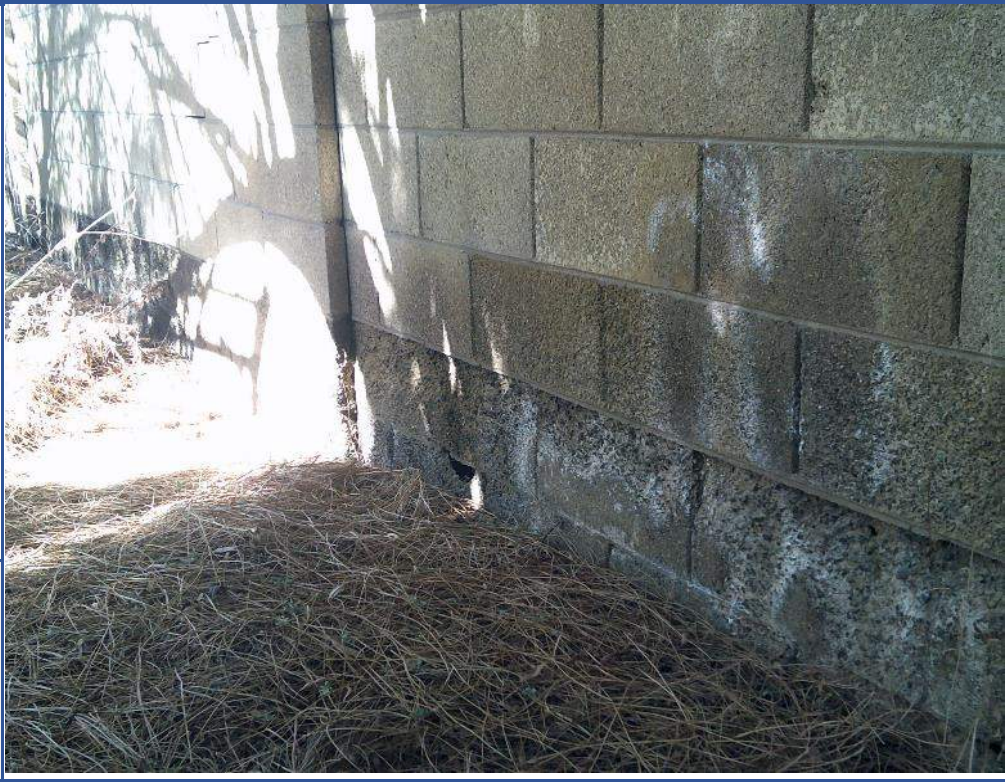
34

Lot 14 - Significant delamination.

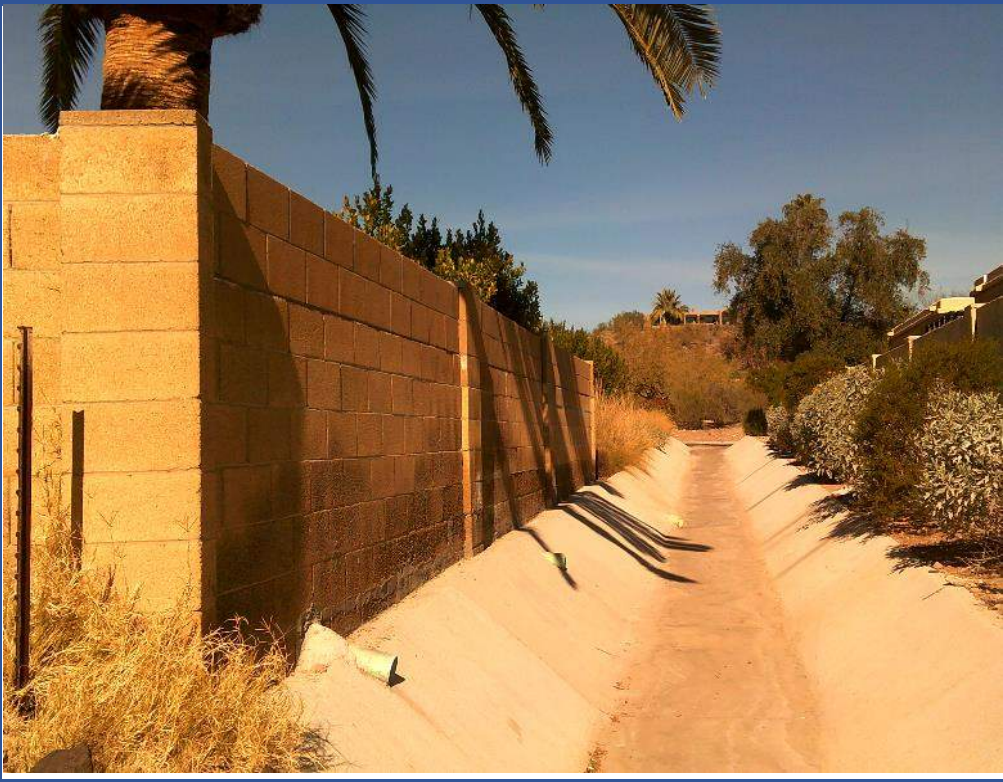
35

Lot 15S - Moderate delamination. Overgrowth.

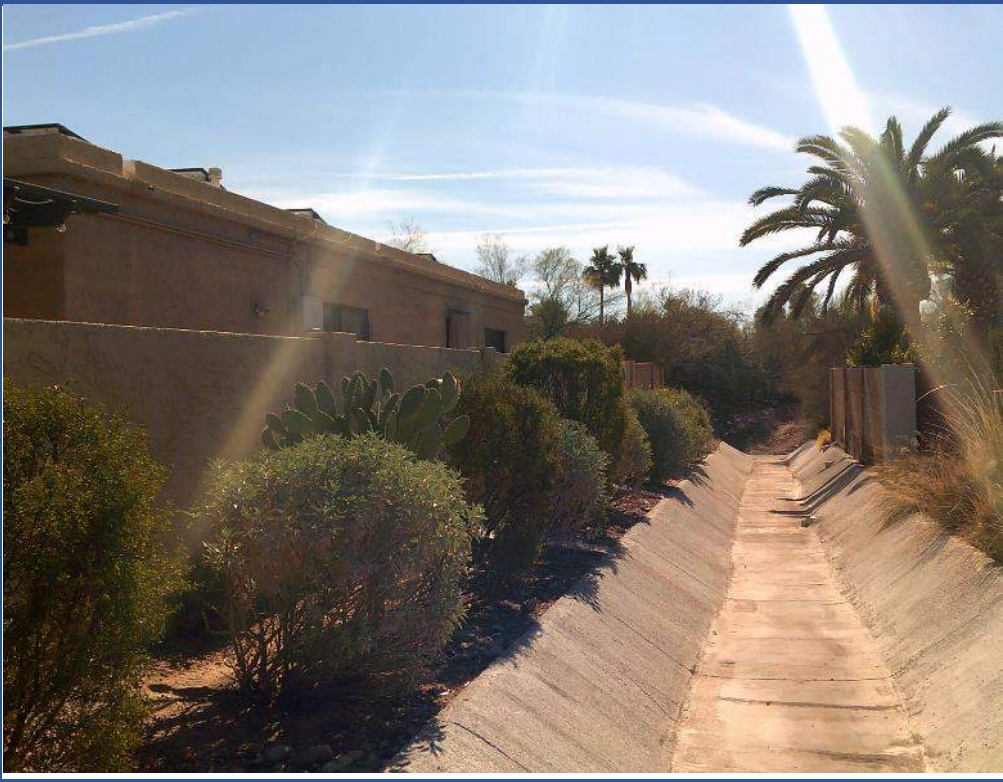
36

Lot 16S - Elevation. Delamination. Overgrowth.

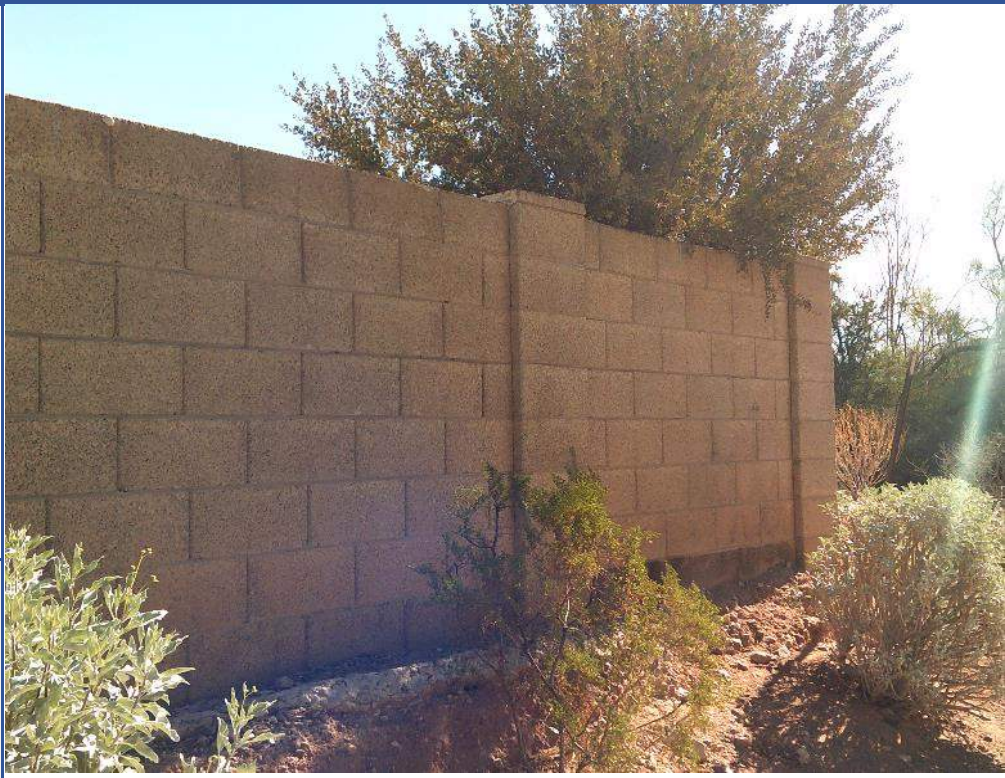
37

Lot 16S - Delamination.
Overgrowth. Exposed
footing.

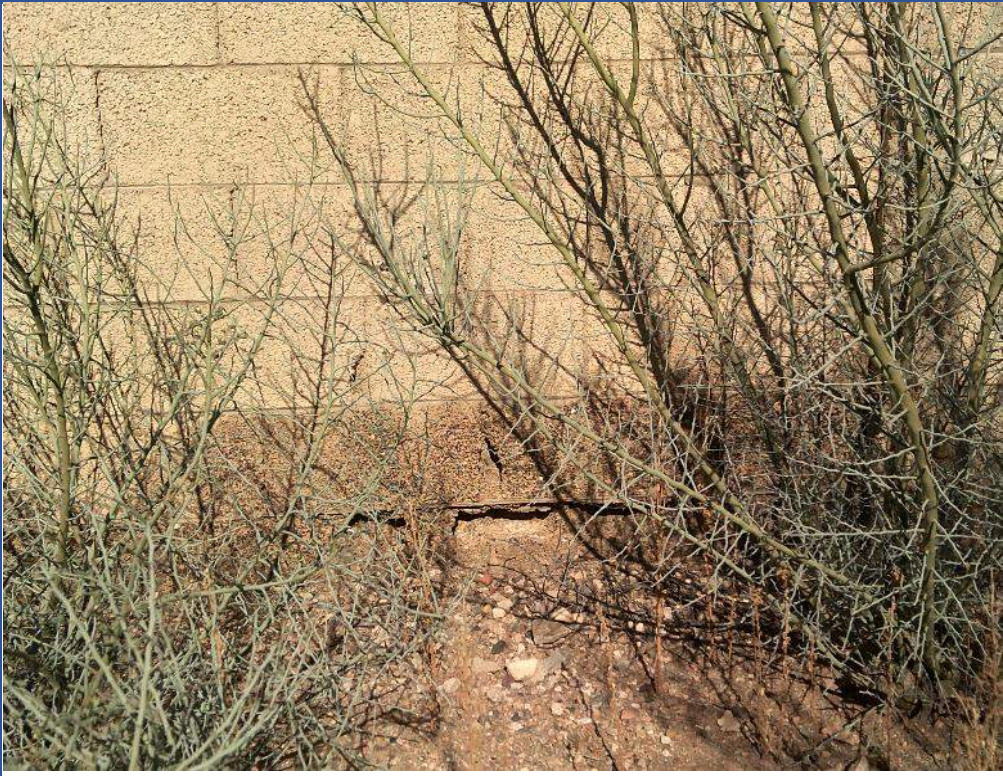
39

Lot 16 - Significant delamination.

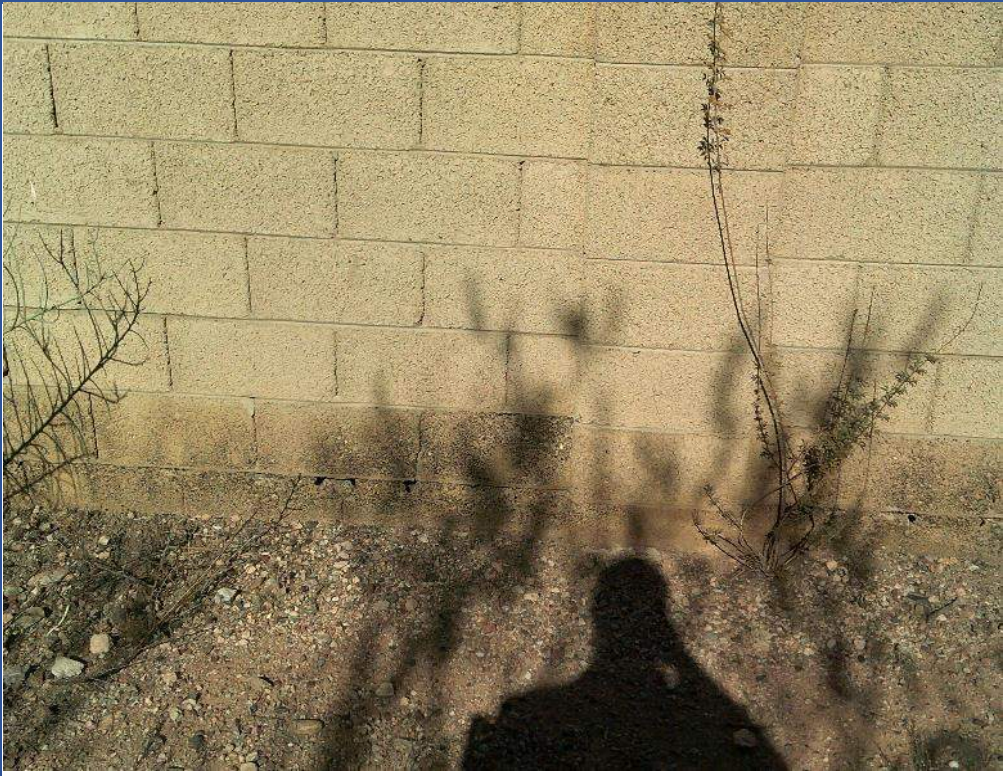
40

Lot 16 - Delamination.

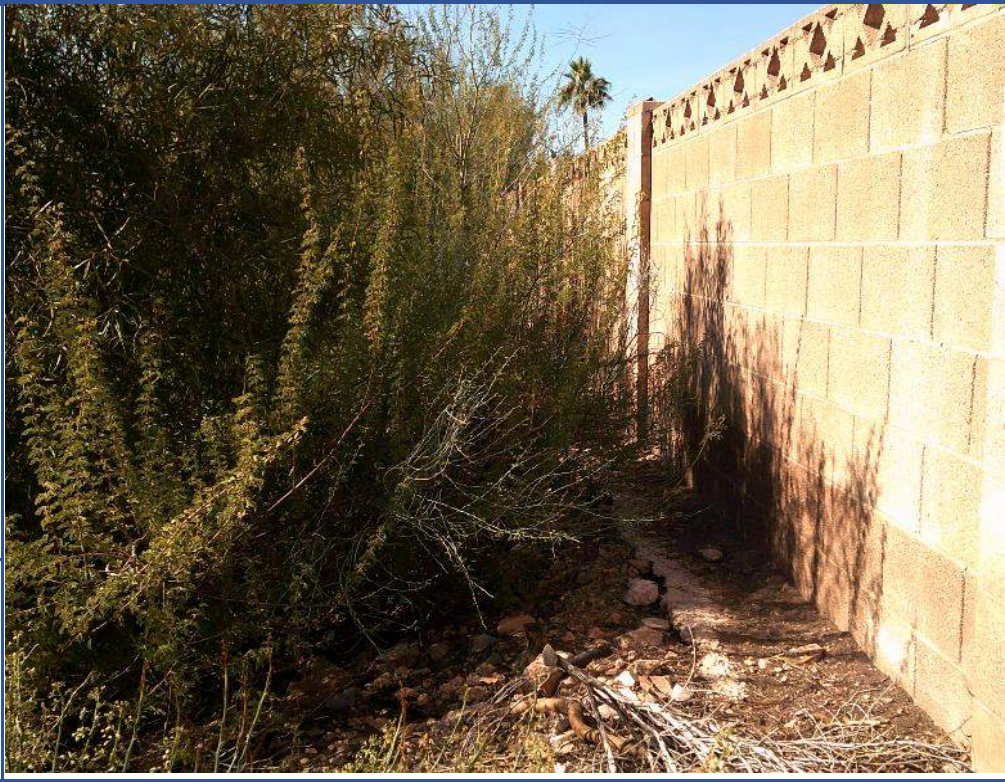
41

Lot 17 - Moderate delamination. Overgrowth. Exposed footing. Scour near wall.

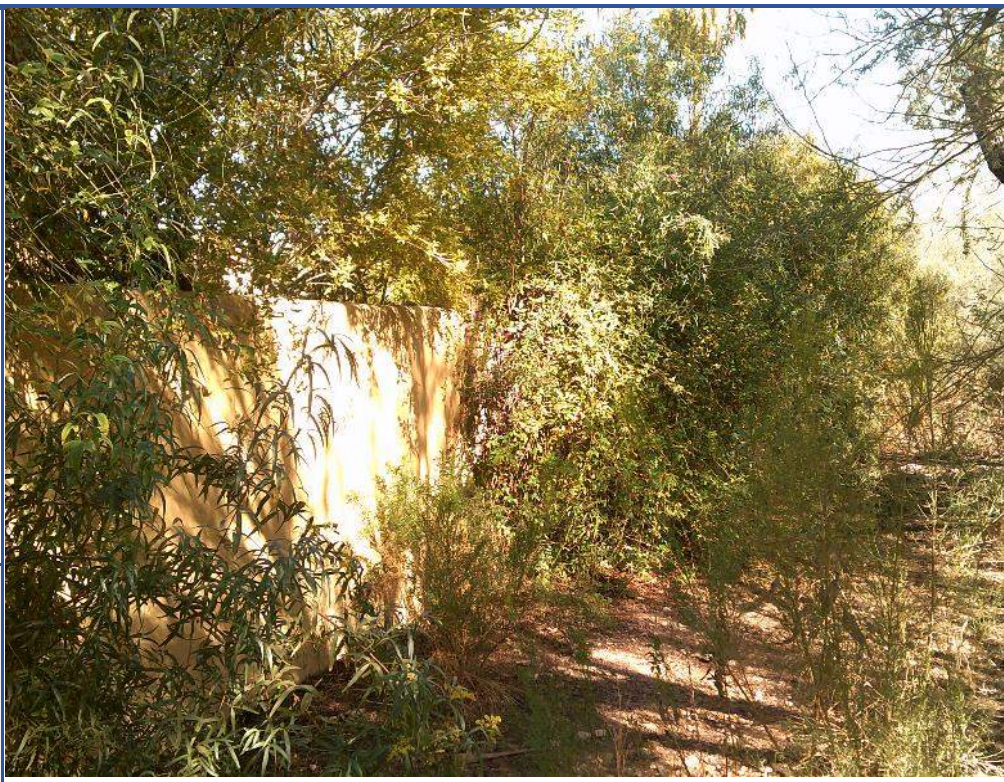
<p>Description:</p> <p>Lot 21 - Delamination. Overgrowth.</p>
<p>46</p>

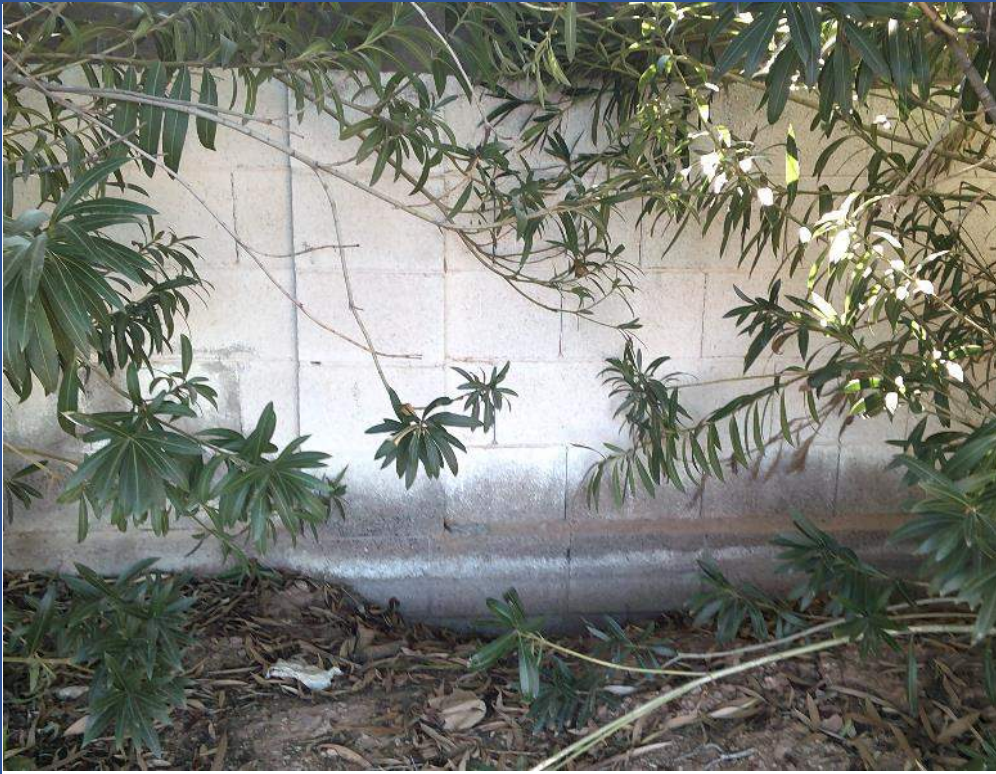
51

Lot 24S - Moderate delamination.

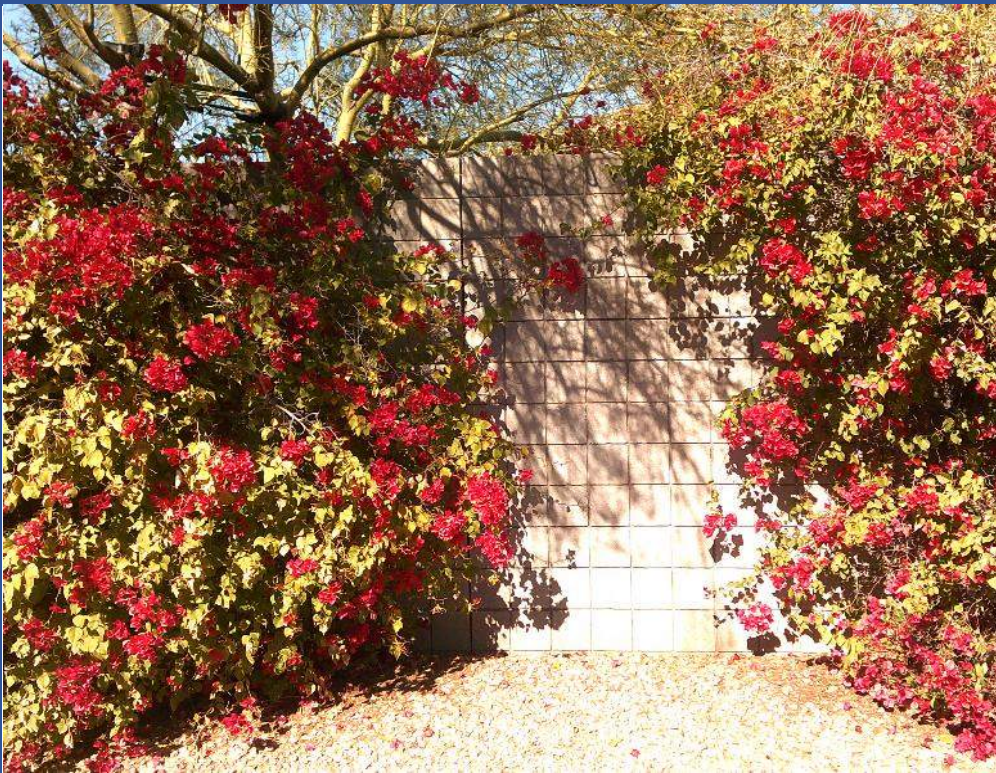
52

Lot 25S - Overgrowth.

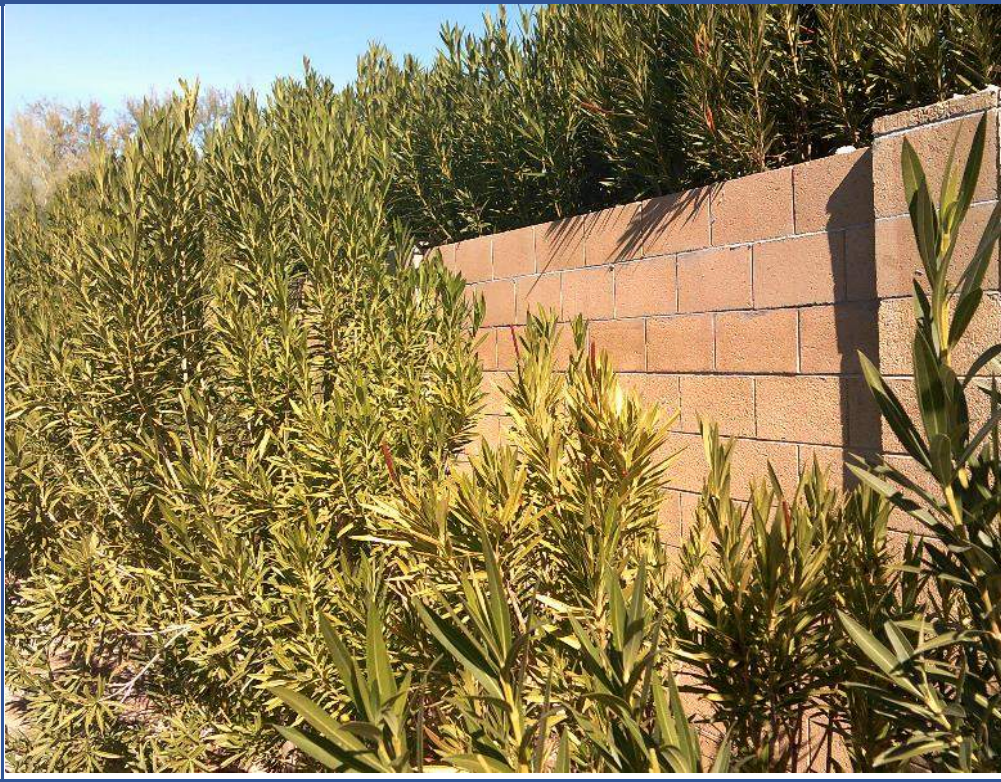
55

Lot 27 - Overgrowth.

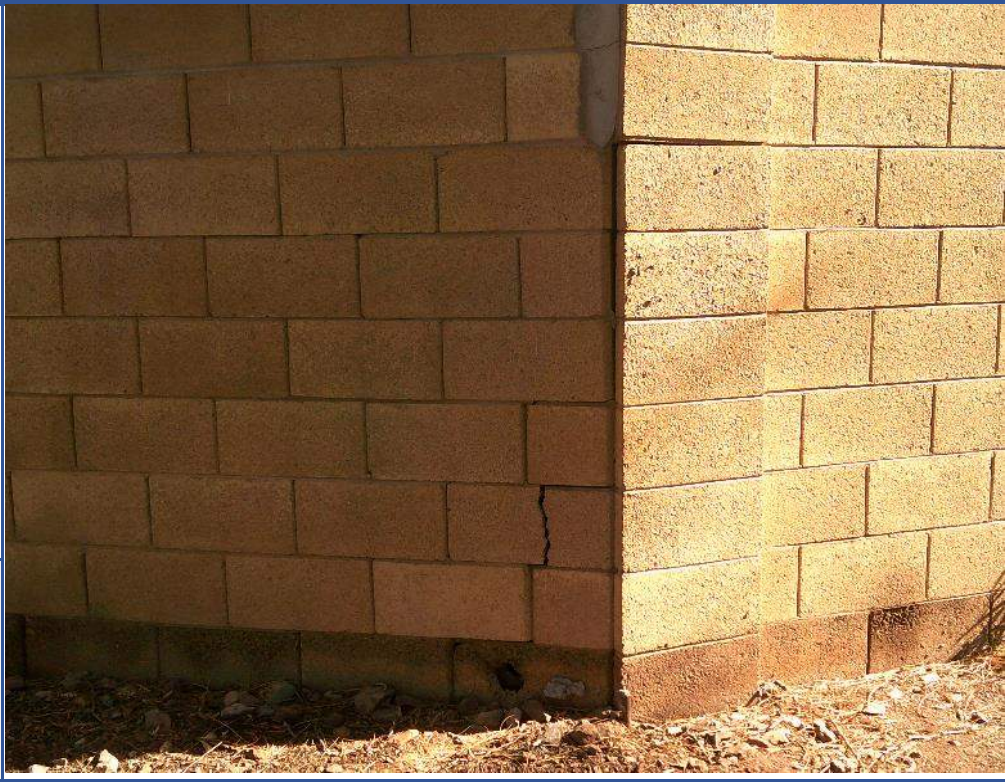
57

Lot 27 - Delamination. Overgrowth. Hole in course.

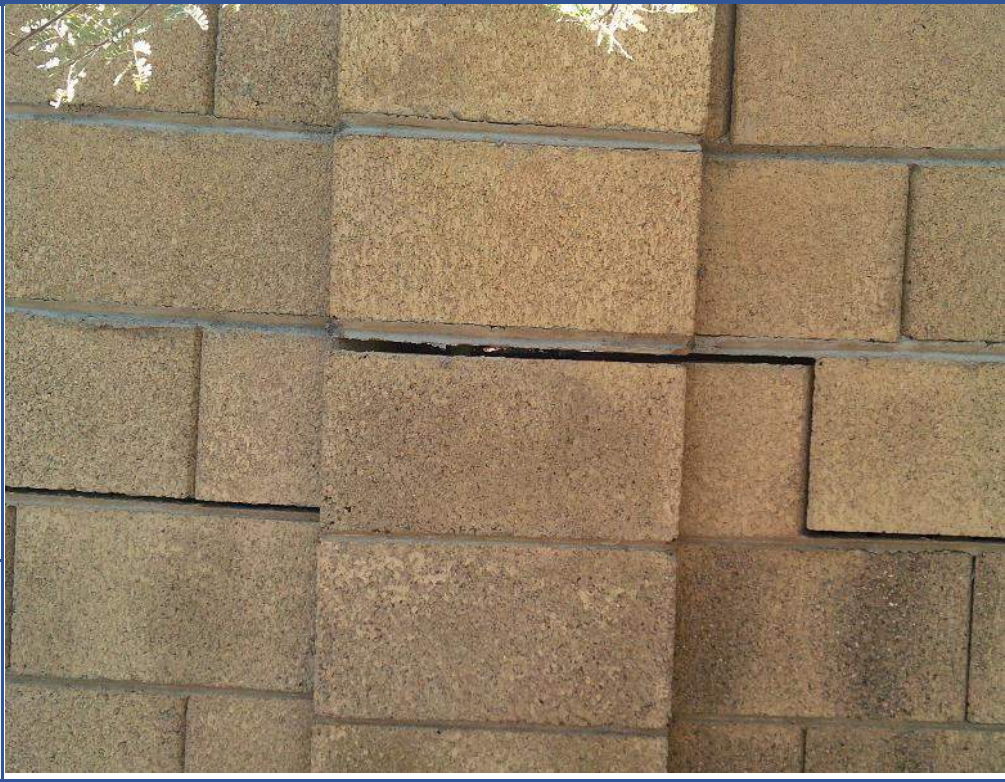
58

Lot 27 - Separation of column courses.

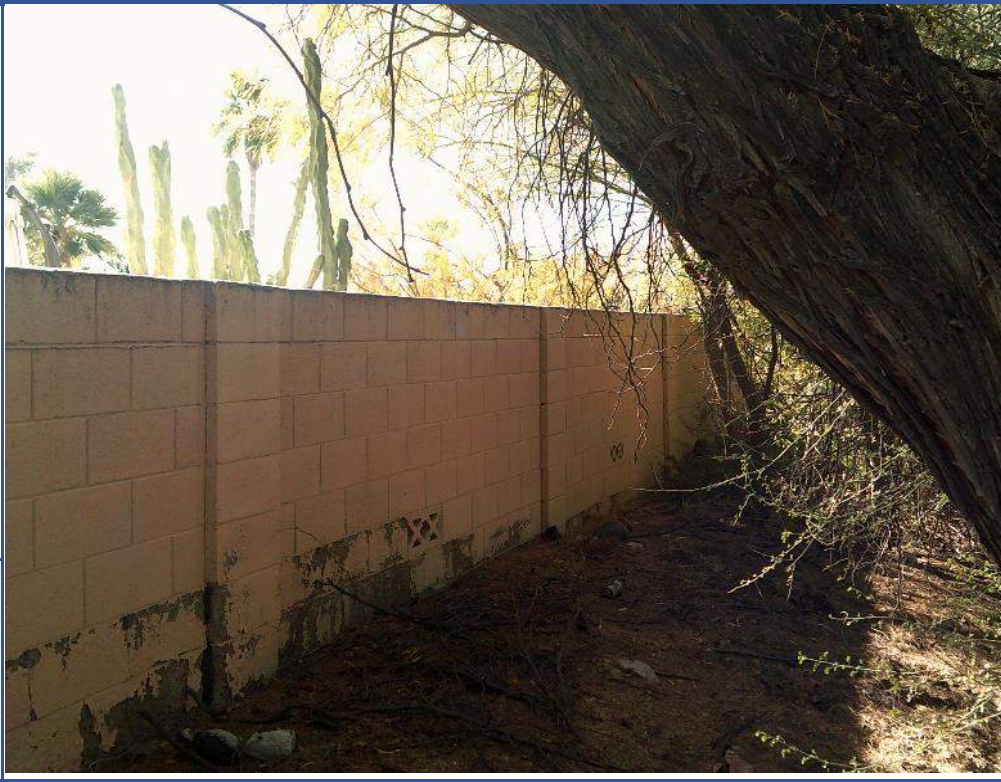
69

Lot 33 - Elevation.

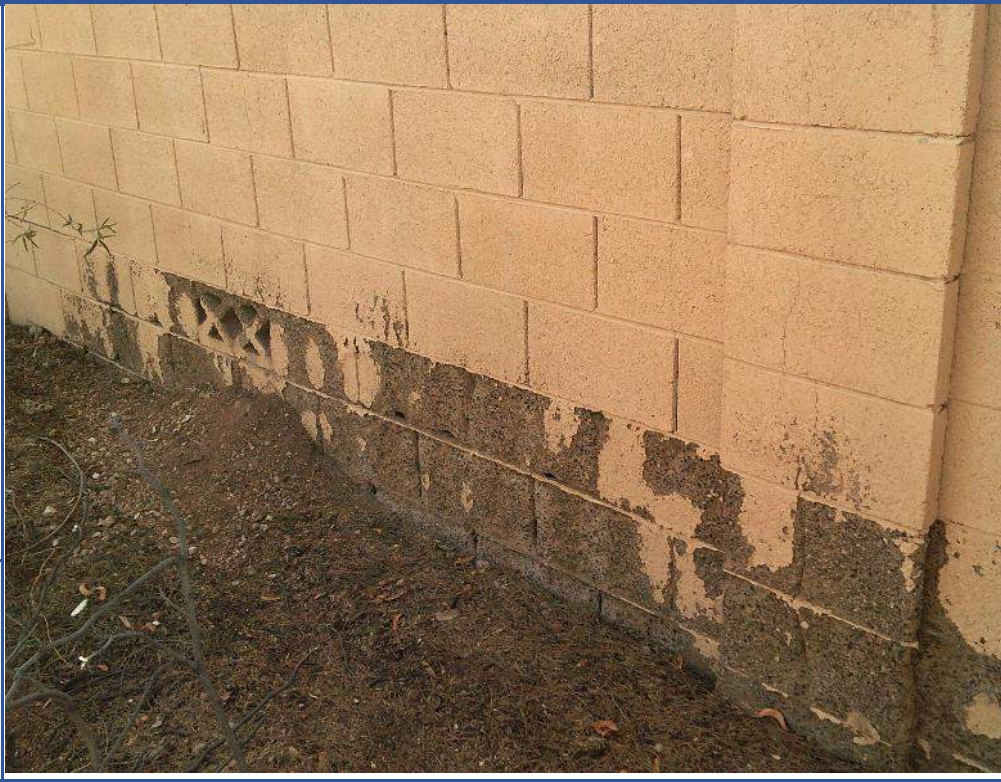
70

Lot 33 - Moderate delamination.

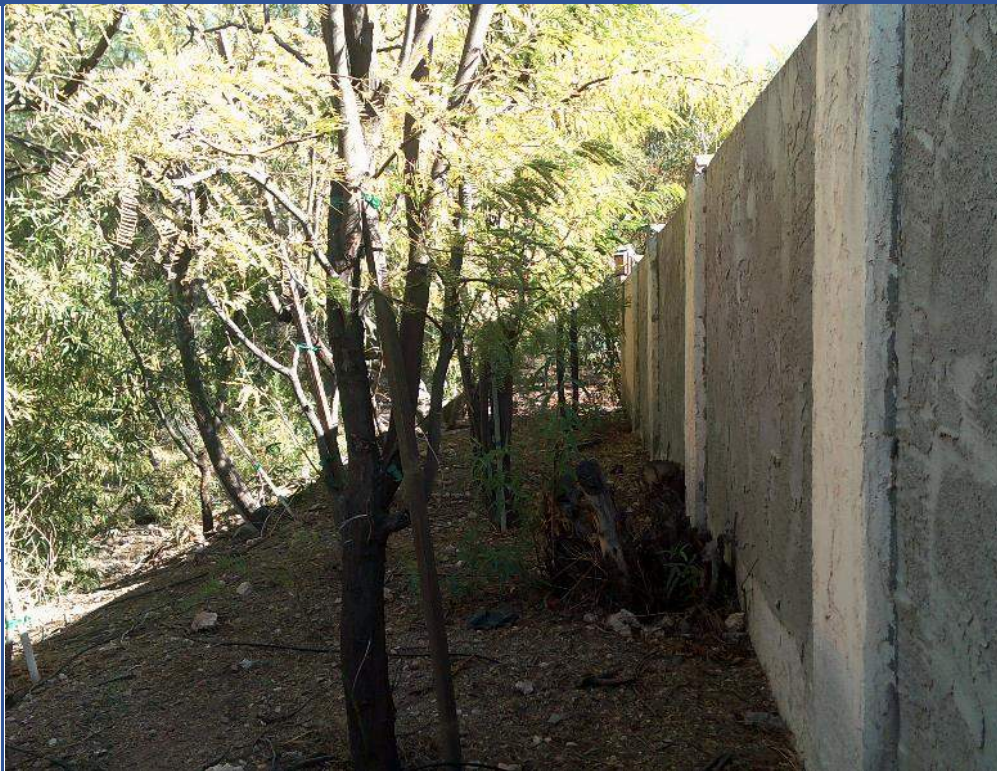
72

Lot 34 - Column rotation up to approximately 1.5" on a 7-foot wall. Overgrowth.

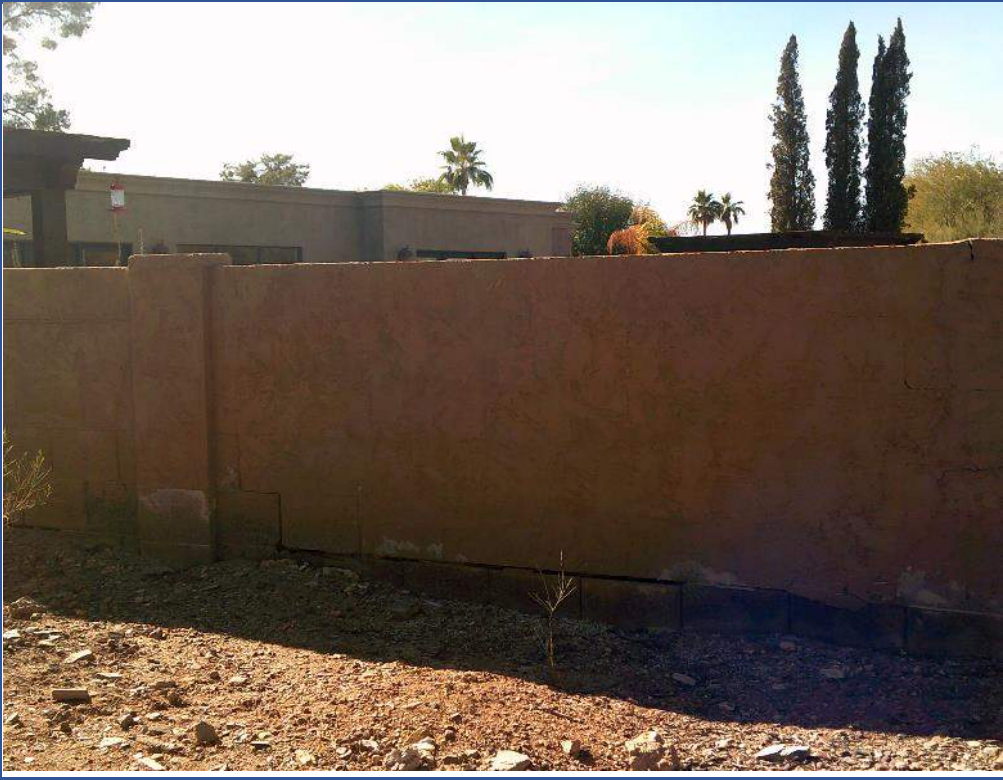
73

Lot 34 - Moderate delamination.

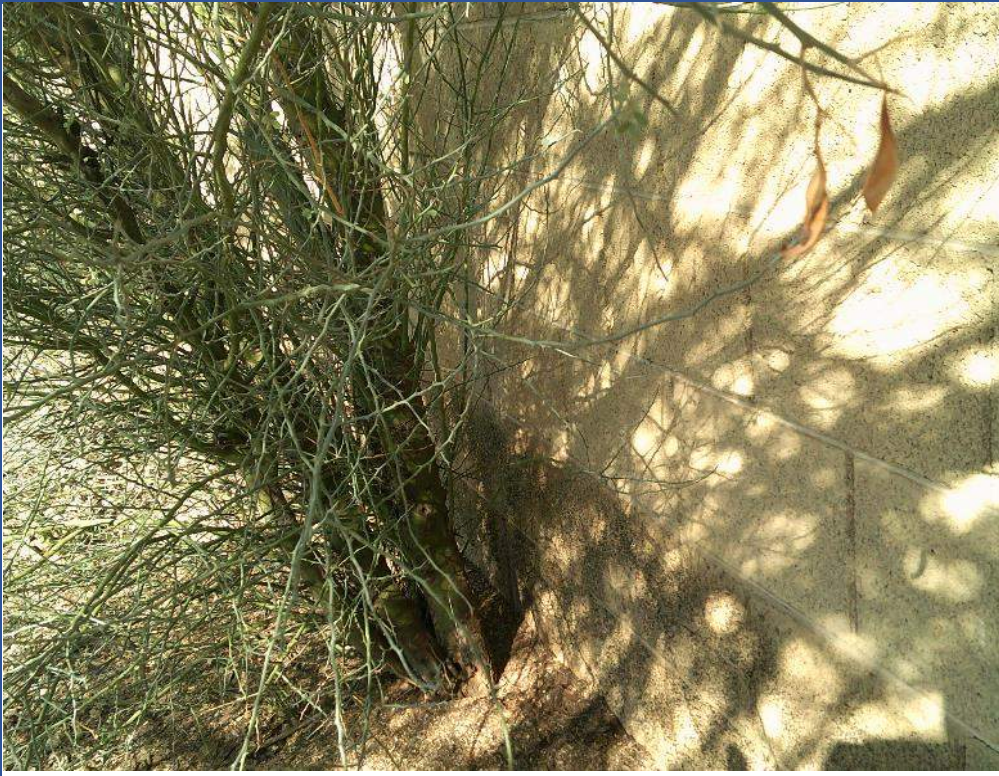
75

Lot 36S - Delamination.
Overgrowth.

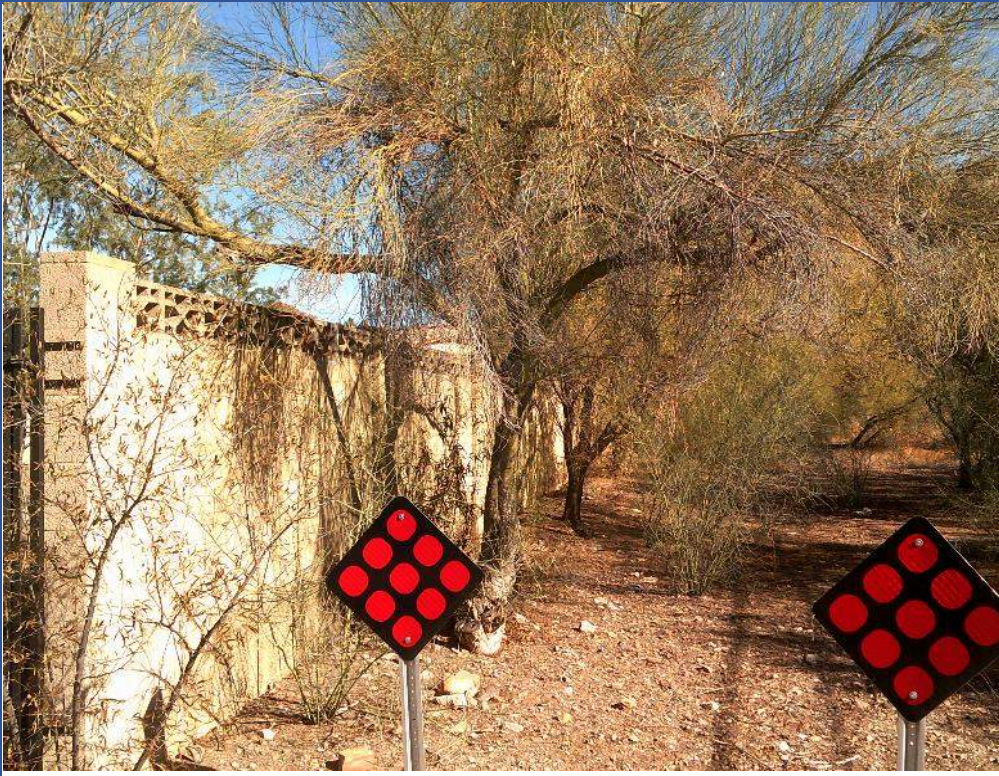
76

Lot 36 - Elevation.

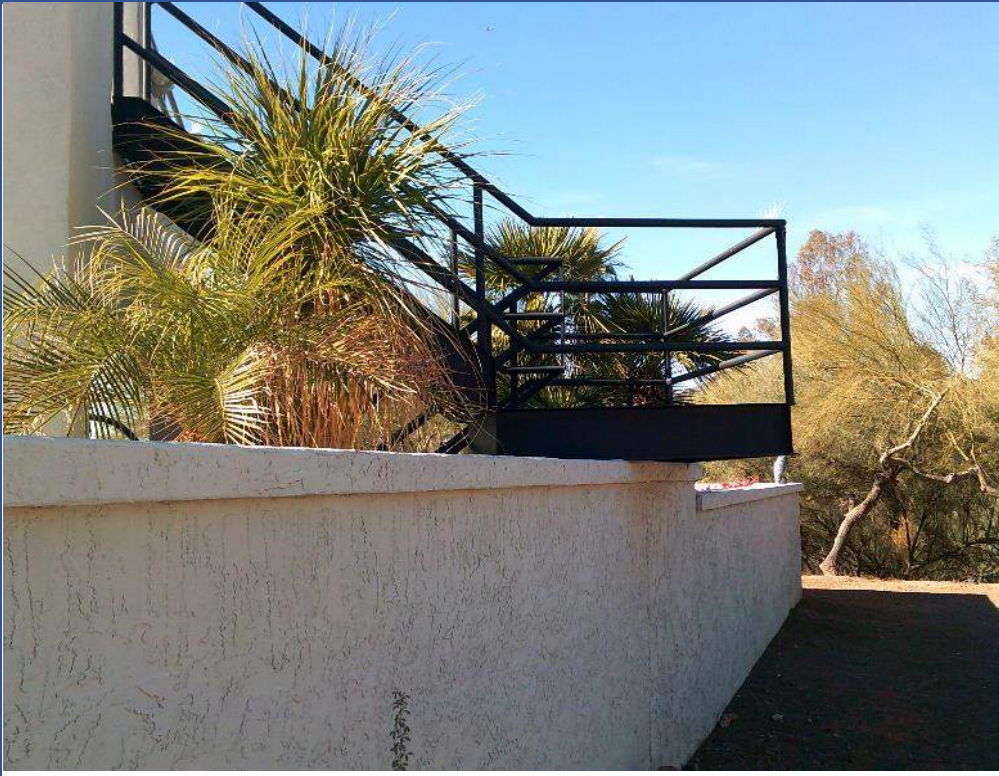
Lot 42 - Staircase may bear upon wall.

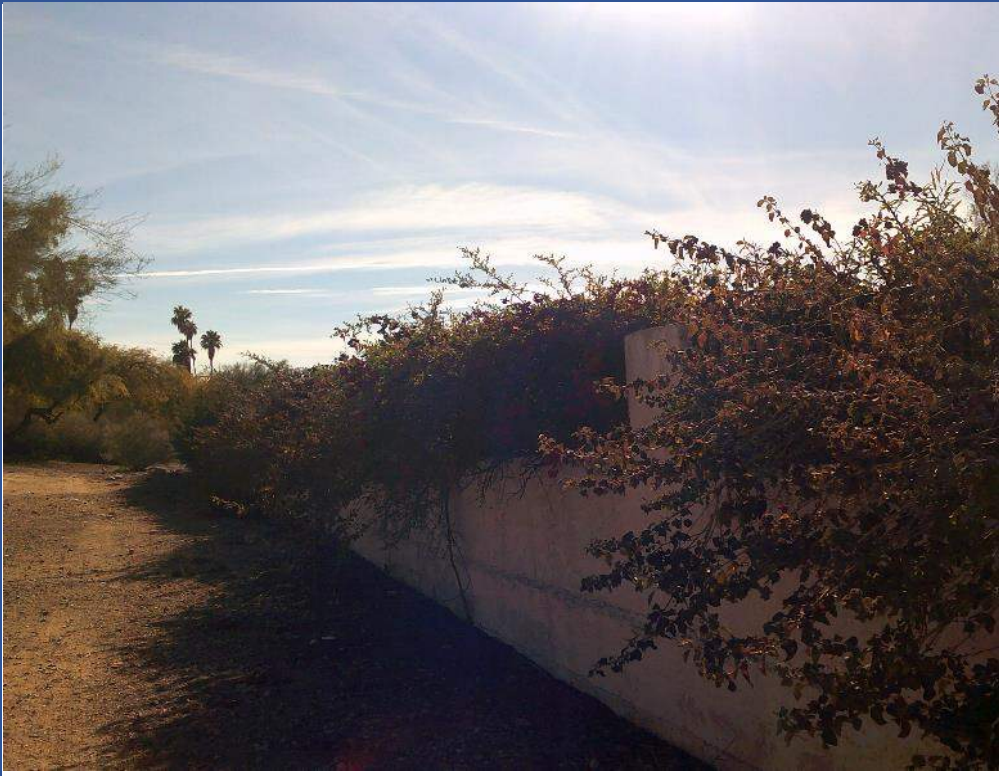
83

Lot 43 - Delamination. Overgrowth.

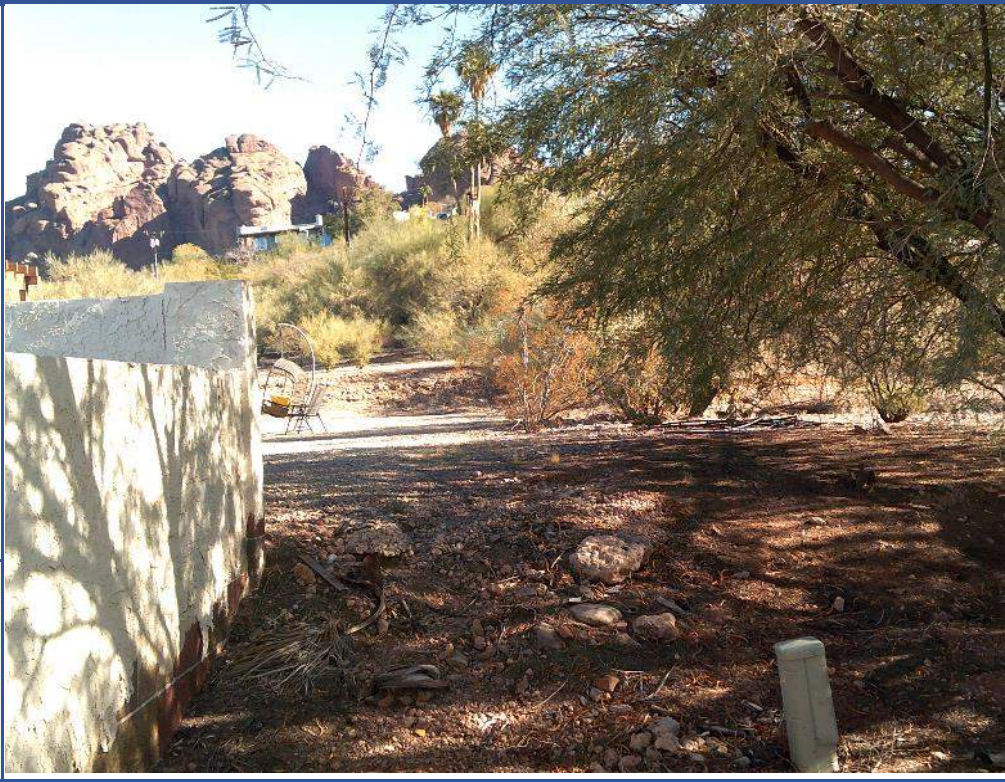
88

Lot 45 - Delamination.
