CAMELBACK CANYON ESTATES BLOCK WALL EVALUATION

Final Submittal: January 31, 2024

PROPERTY: CAMELBACK CANYON ESTATES COMMUNITY
PHOENIX, ARIZONA

SERVICE: 23-0433 – BLOCK WALL STRUCTURAL EVALUATION

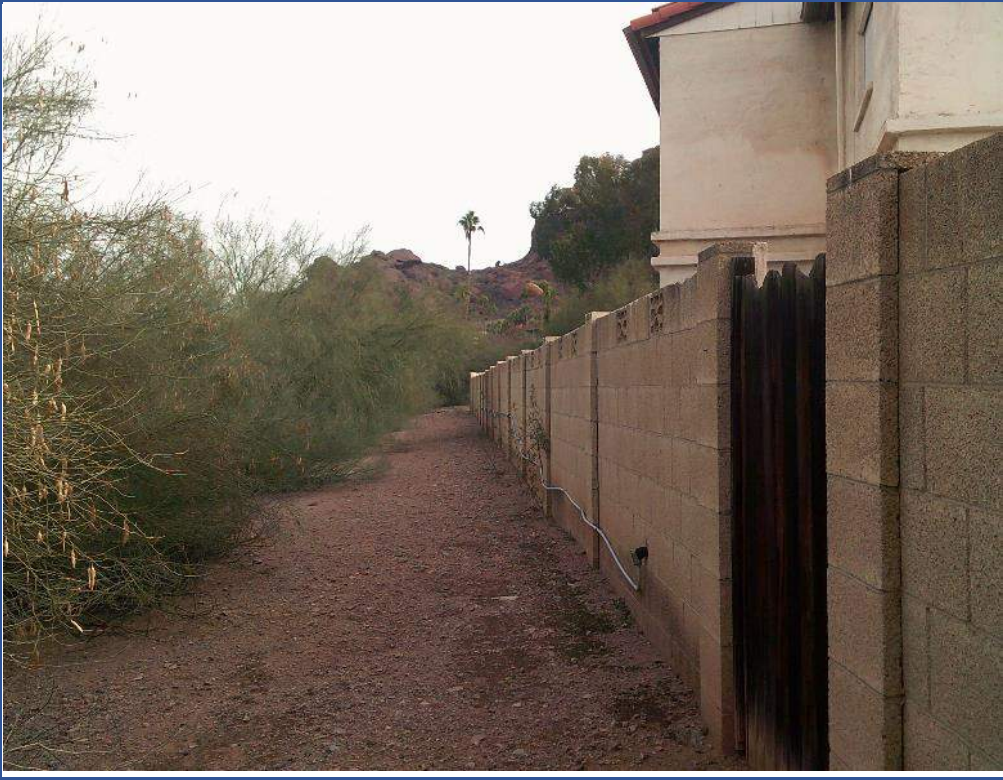
95

Lot 51 - Elevation.

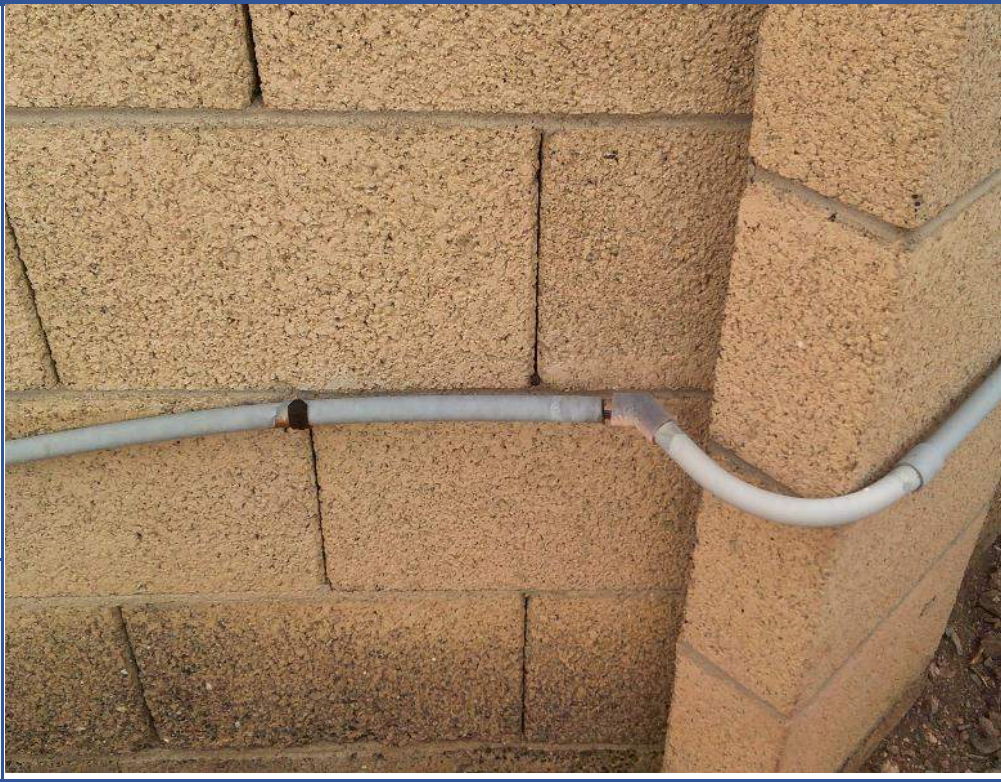
97

Lot 51 - Exposed electrical wires from debonded conduit..

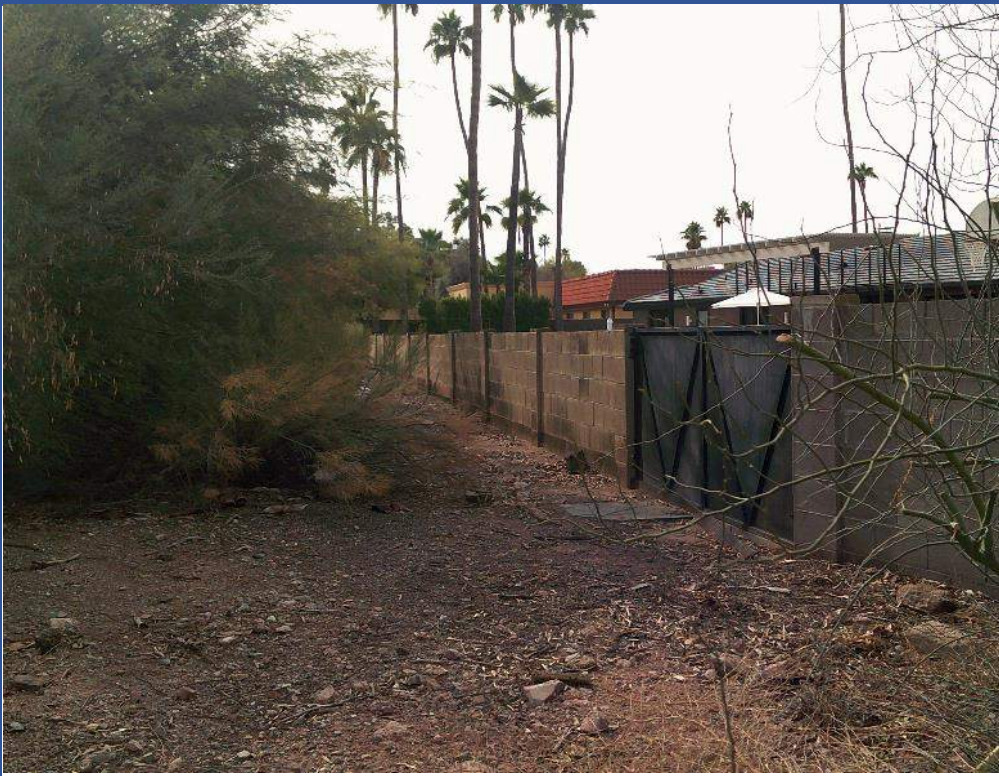
99

Lot 52 - Elevation Moderate delamination.

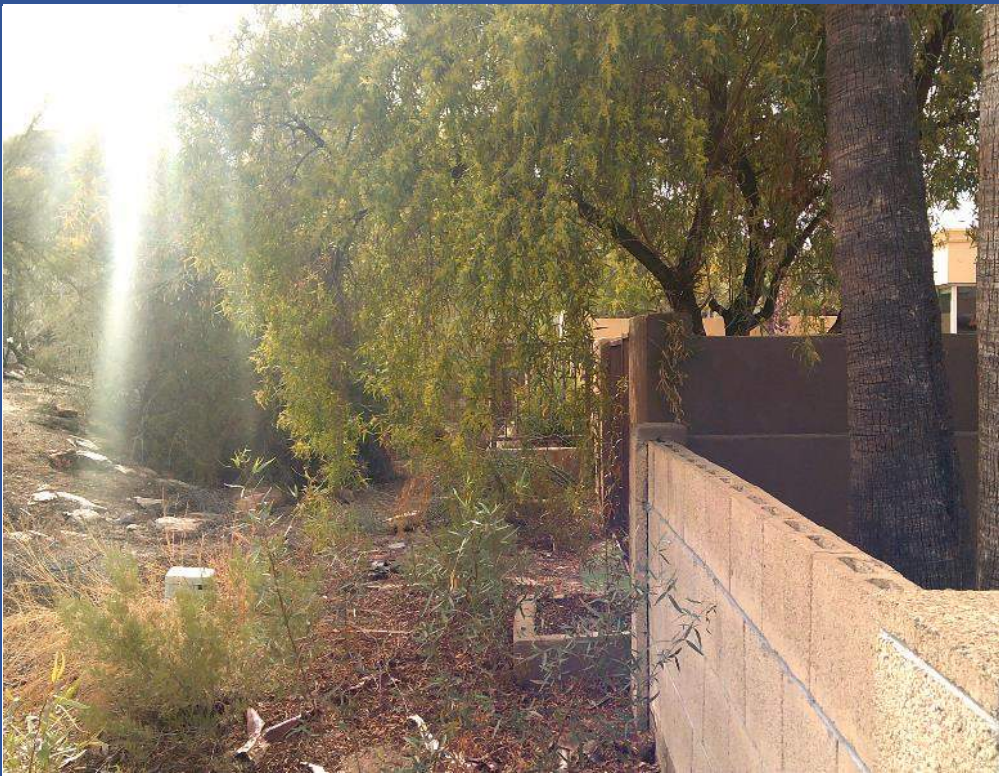
100

Lot 53 - Column rotation up to approximately 3" on a 5-foot wall. Negative slope towards wall. Multiple panel with exposed courses.

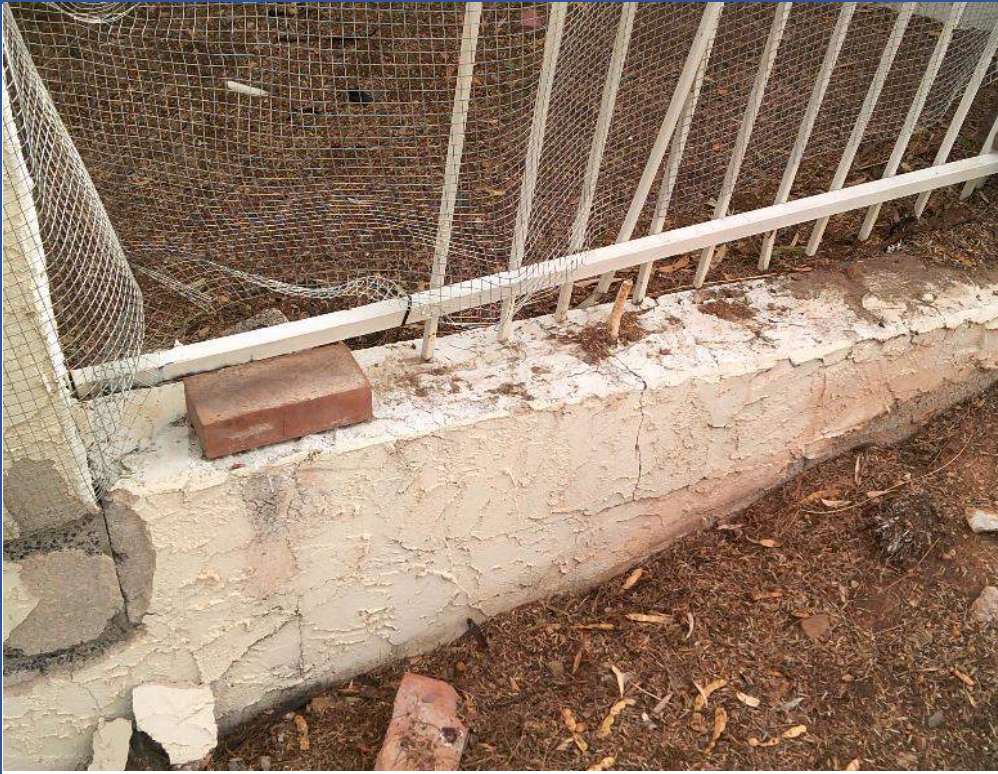
107

Lot 63 - Exposed rebar.

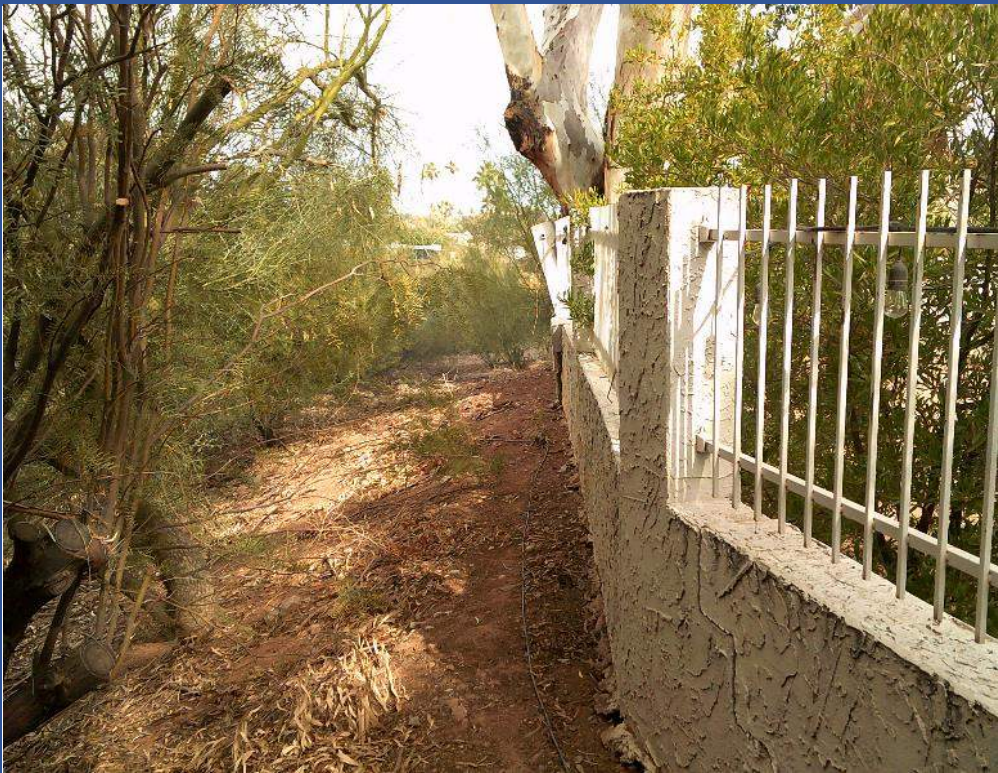
108

Lot 63 - Column
rotation elevation.

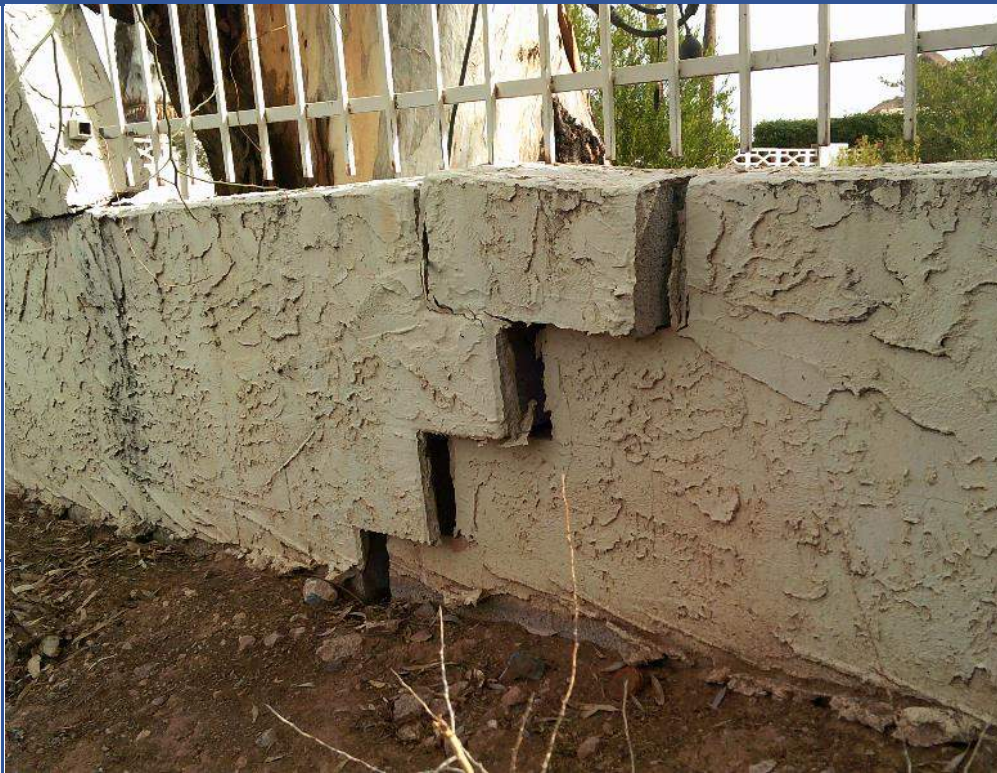
110

Lot 63 - Column rotation up to approximately 6" on a 5.5-foot wall. Wall is offset by approximately 3".

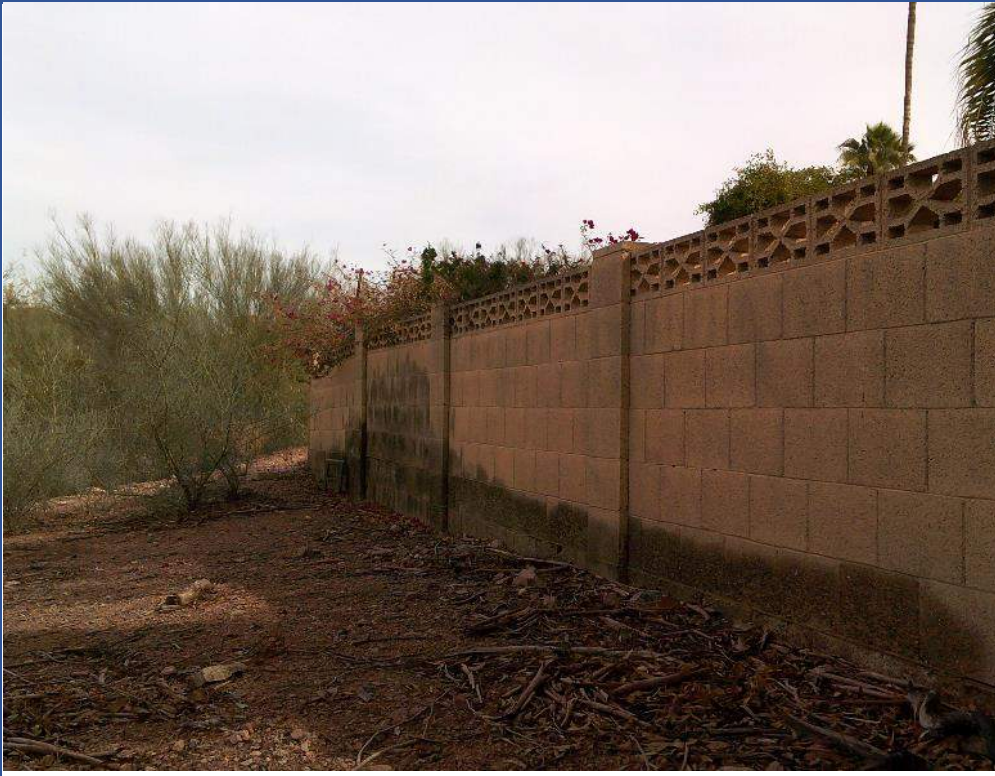
111

Lot 64 - Elevation.
Significant delamination.
Overgrowth.

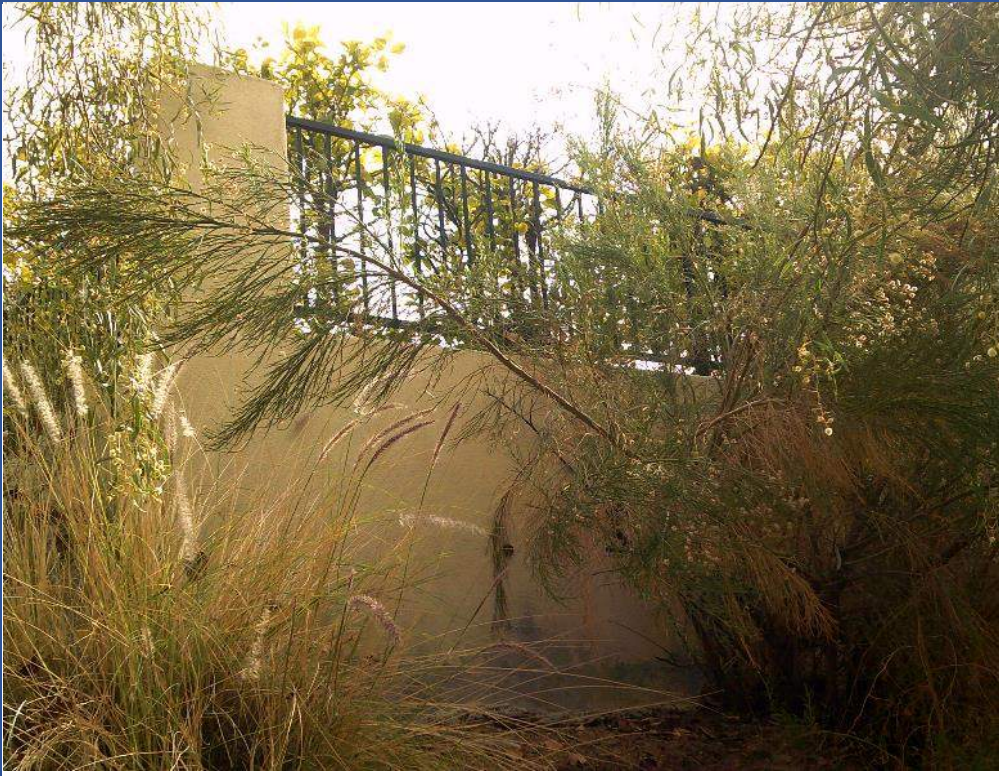
115

Lot 65 - Column rotation up to approximately up to approximately 1" on a 6-foot wall.

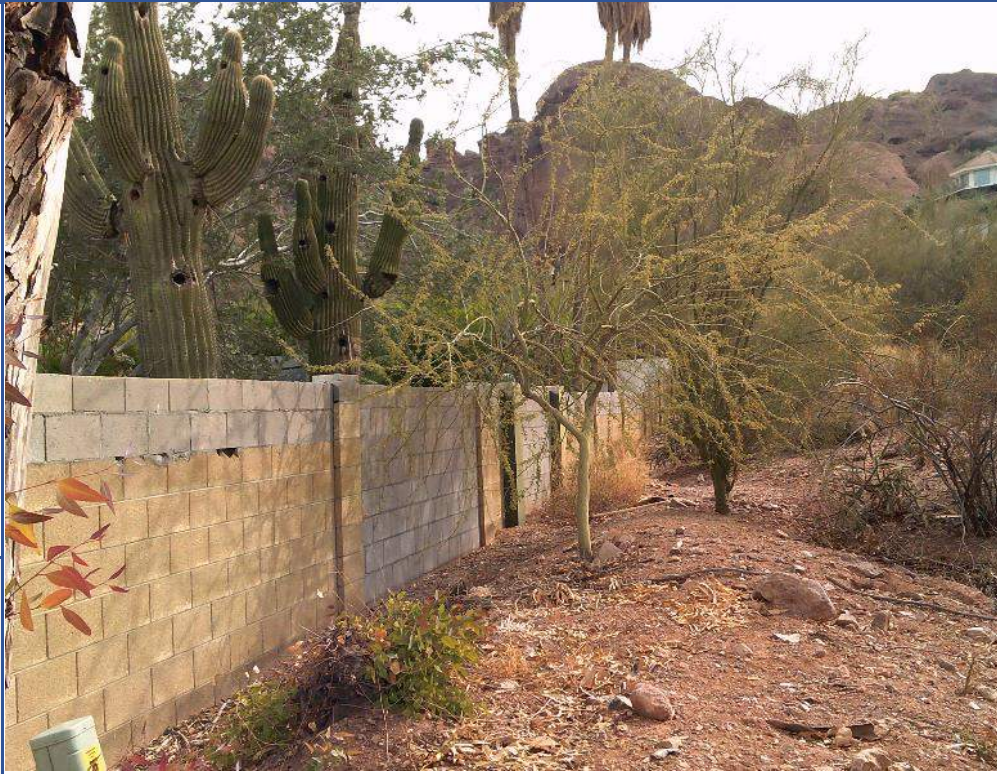
117

Lot 68 - Delamination. Negative slope towards wall. Built up wall with open cells.

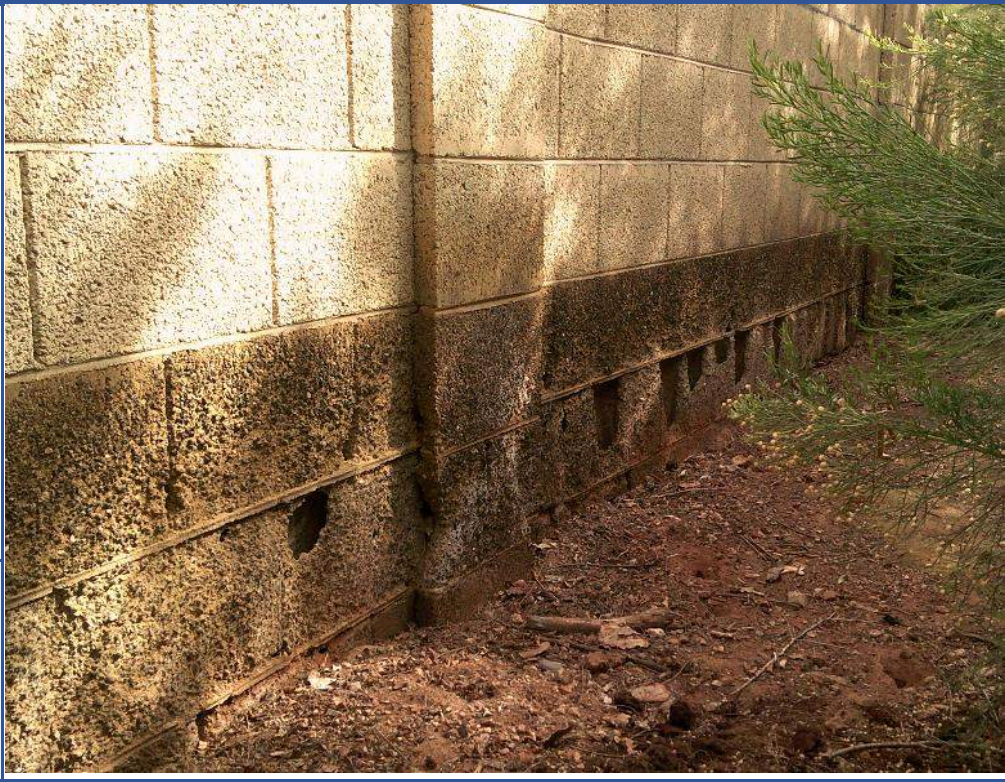
120

Lot 70 - Significant delamination. Multiple holes in course.

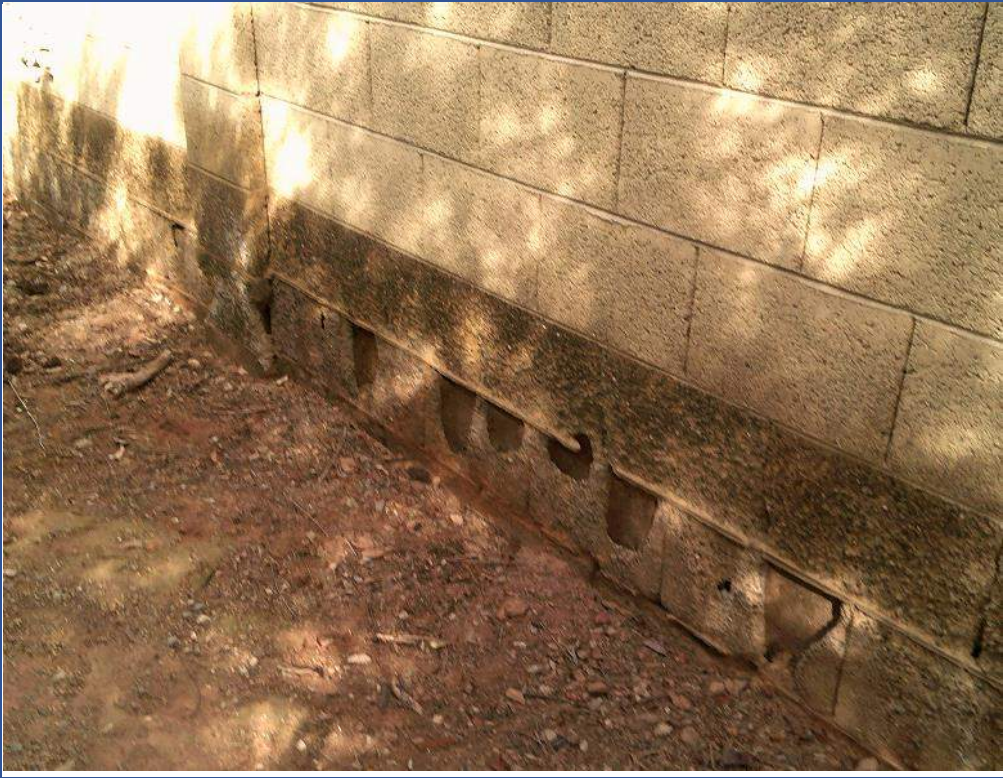
121

Lot 70 - Significant delamination. Multiple holes in course.

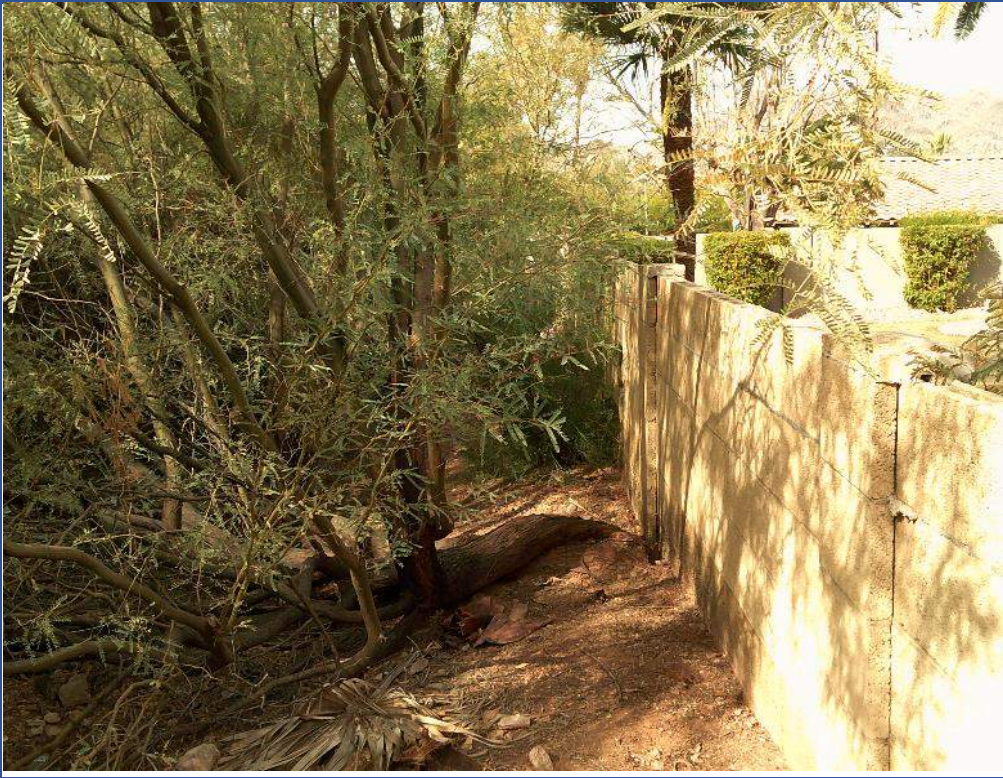
122

Lot 70 - Exposed top cell.

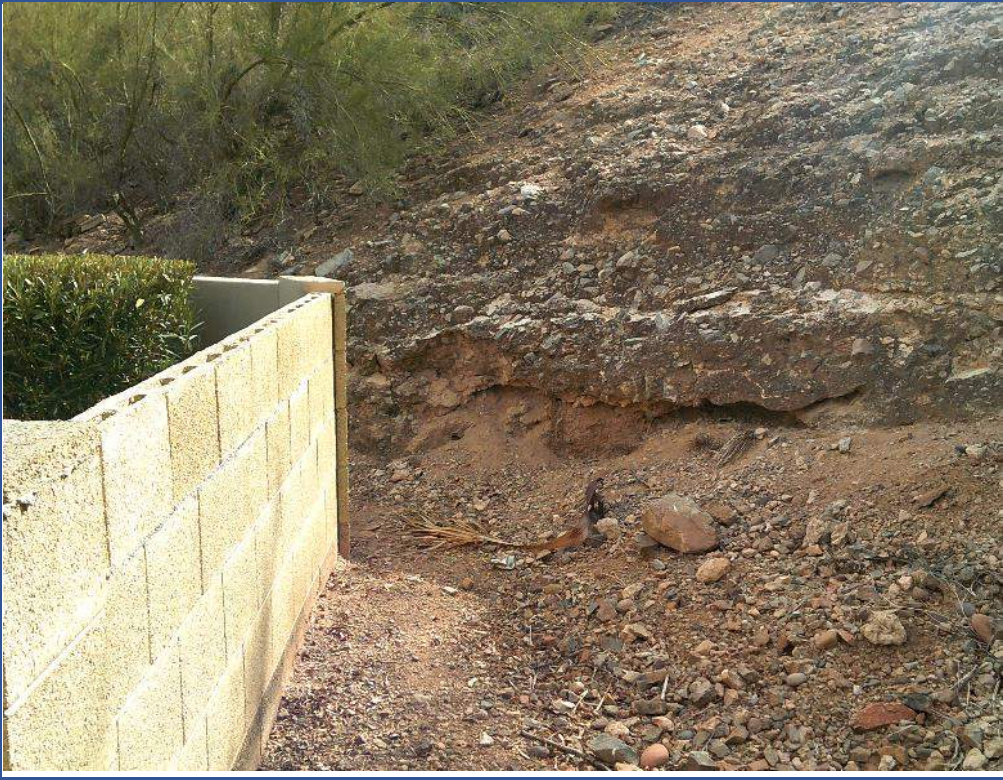
PHOTO NUMBER
123

Lot 70 - Exposed top cell.

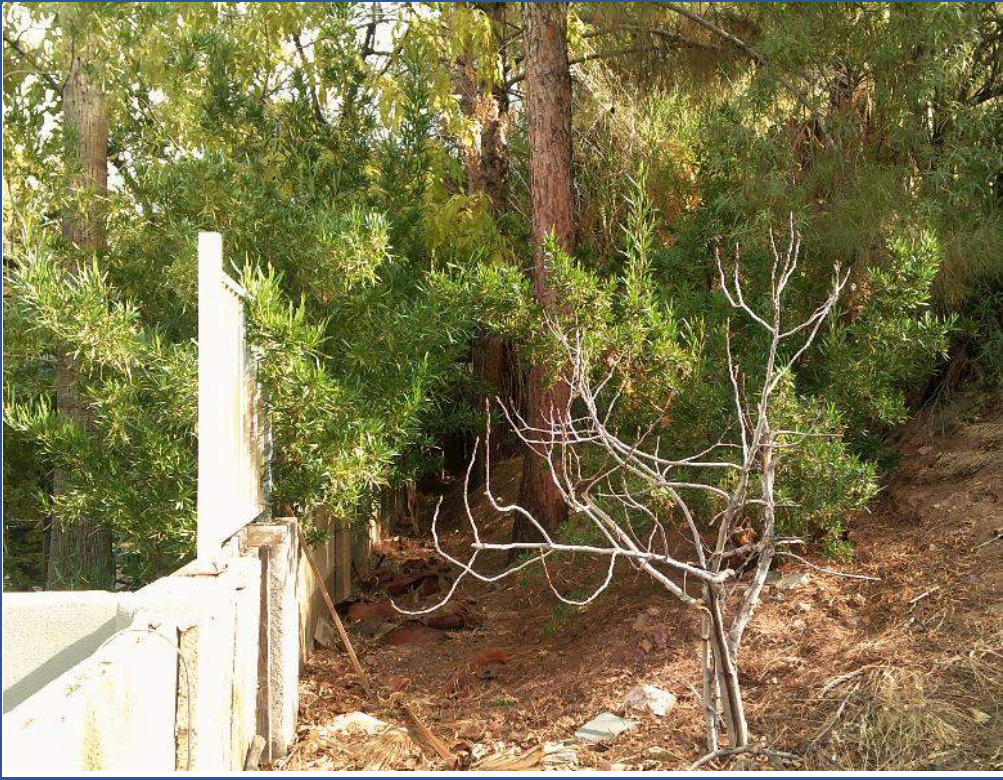
PHOTO NUMBER
124

Lot 71 - Elevation. Overgrowth.

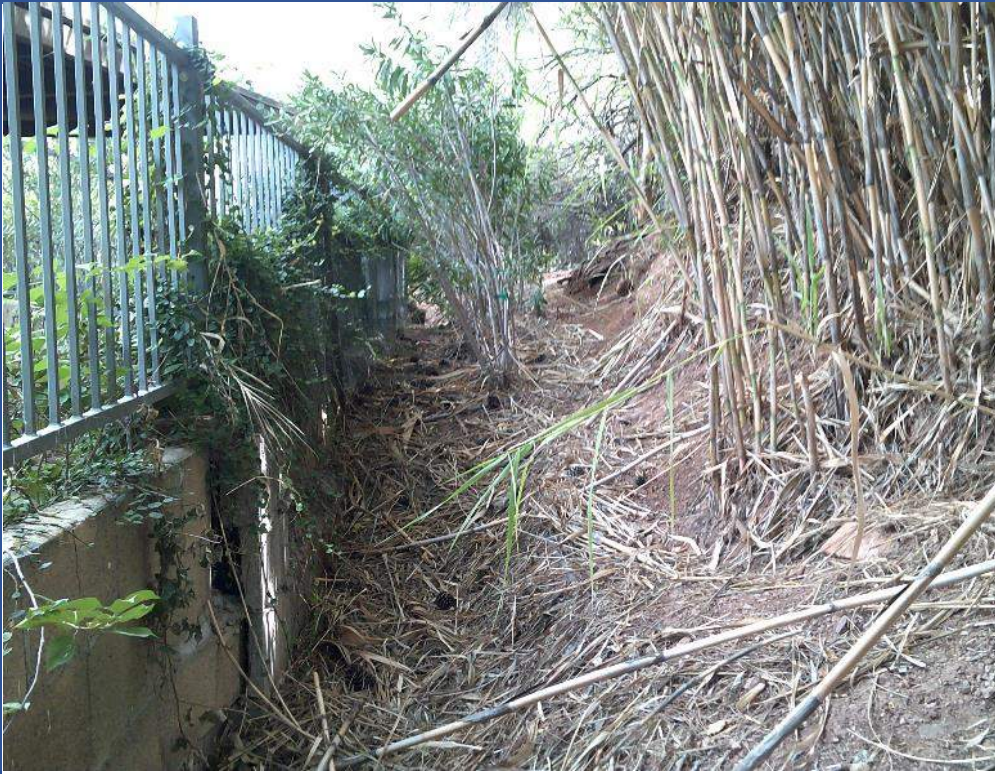
125

Lot 71 - Multiple locations of overgrowth. Negative slope towards wall. Very limited access in multiple locations.

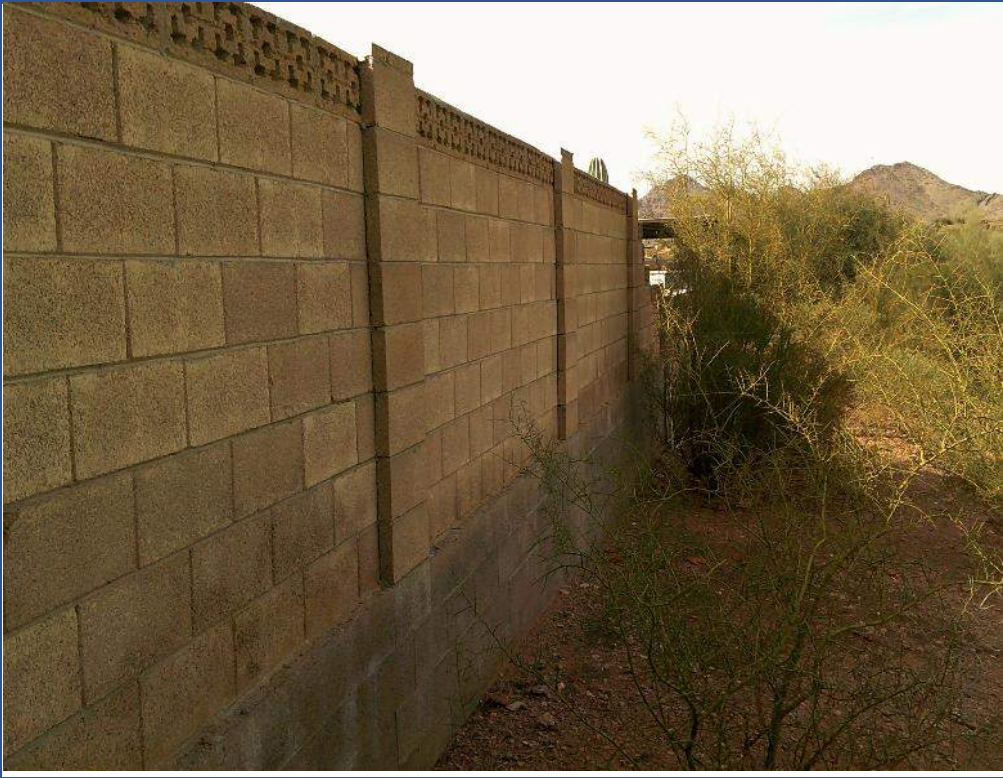
128

Lot 73 - Delamination and efflorescence. Wet grade while on site.

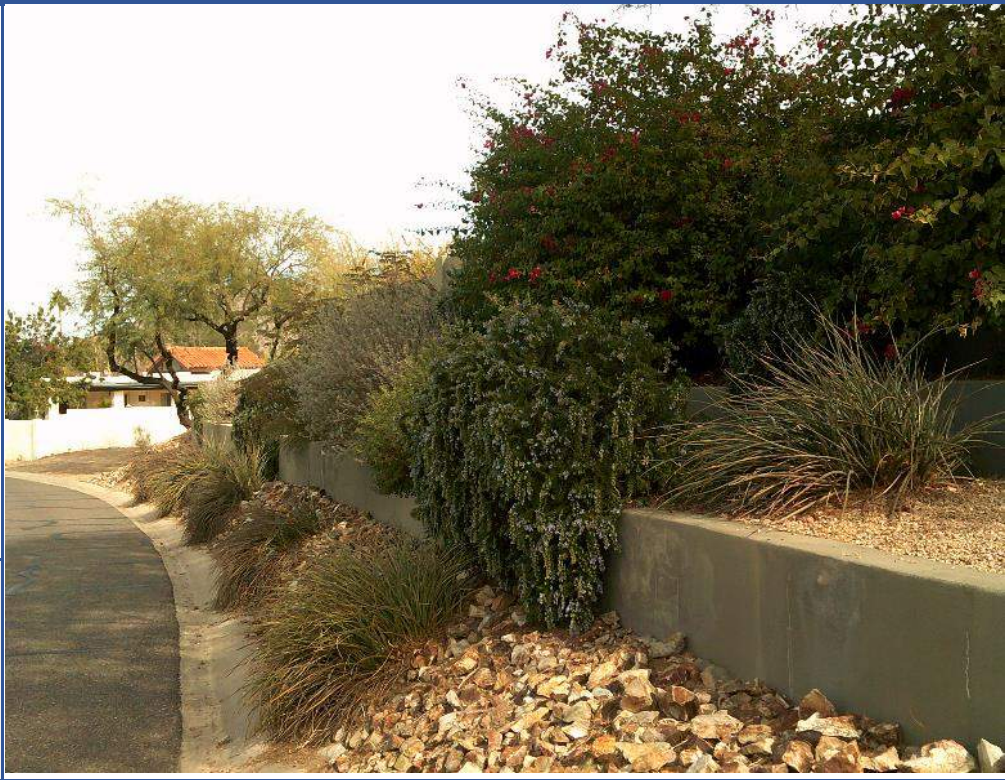
Lot 75S - Elevation.

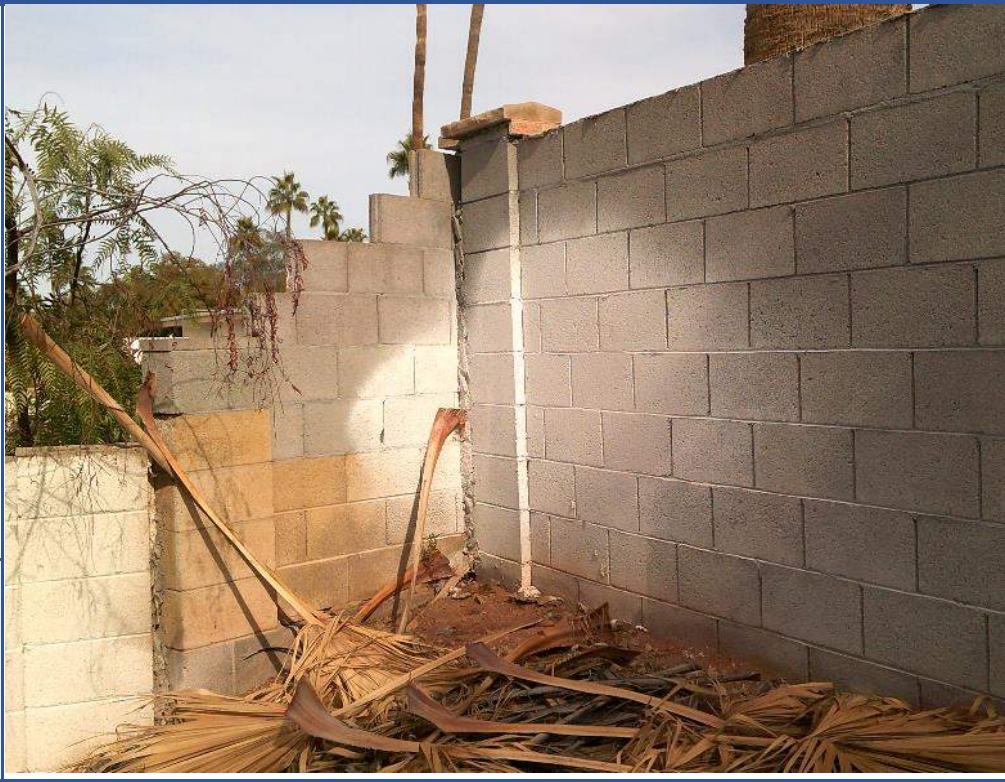
131

Lot 77 - Minimal wall with staggered elevation.

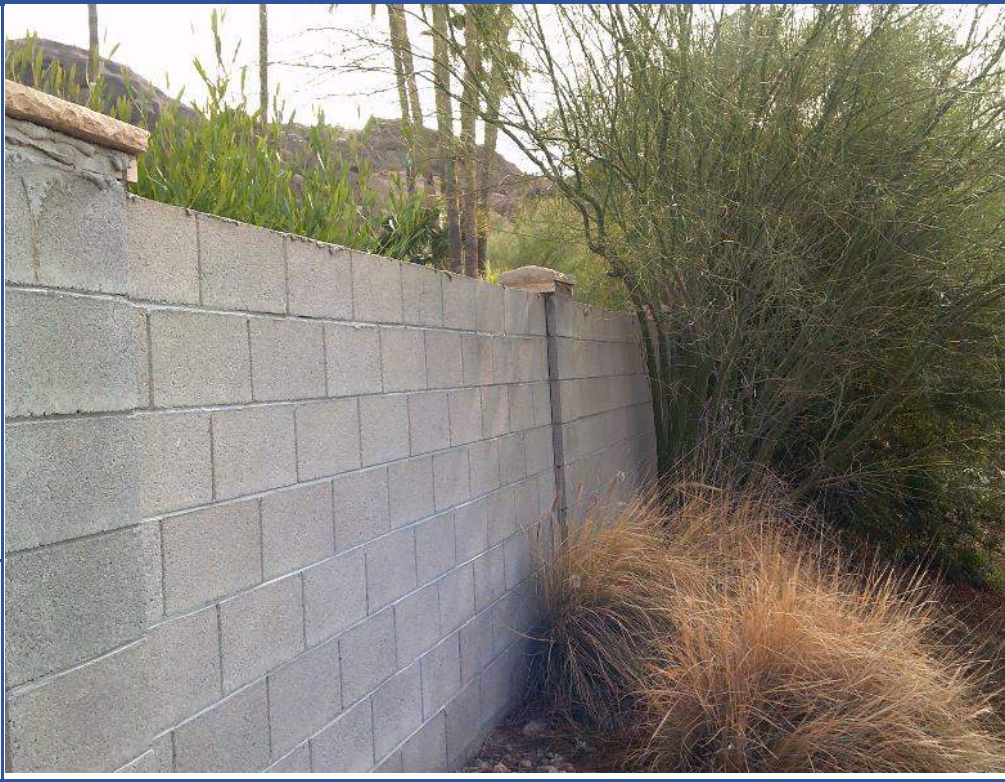
132

Lot 78 - Elevation. Overgrowth.

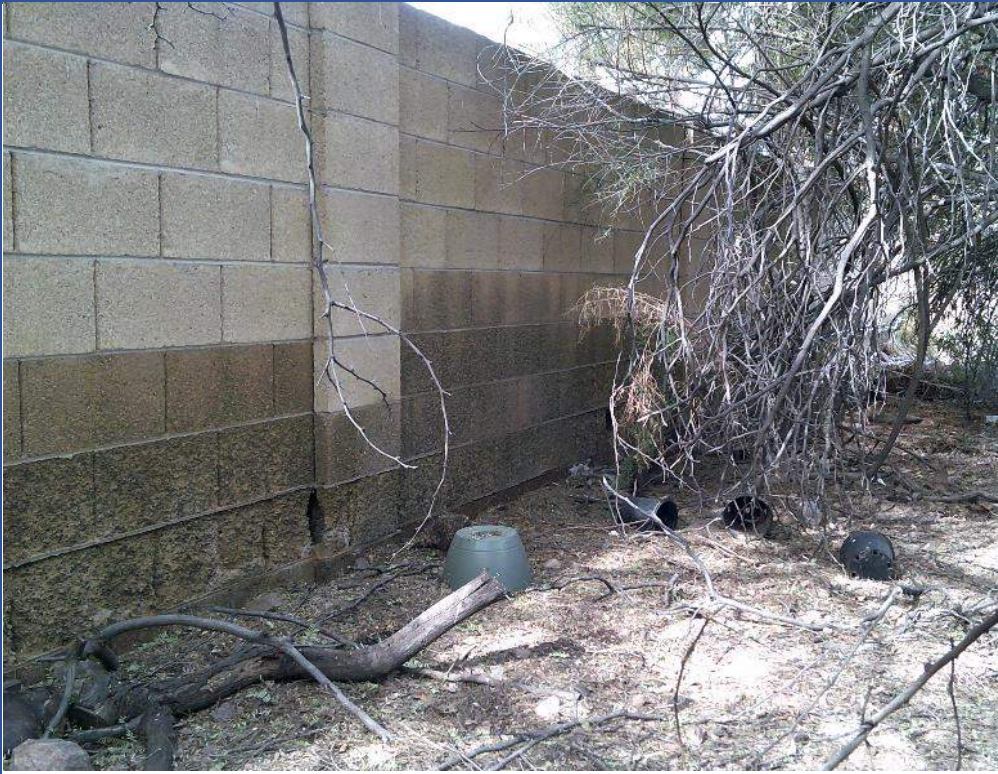
137

Lot 81 - Moderate delamination. Efflorescence. Column rotation up to approximately 1" on three 5.5-foot columns. Overgrowth.

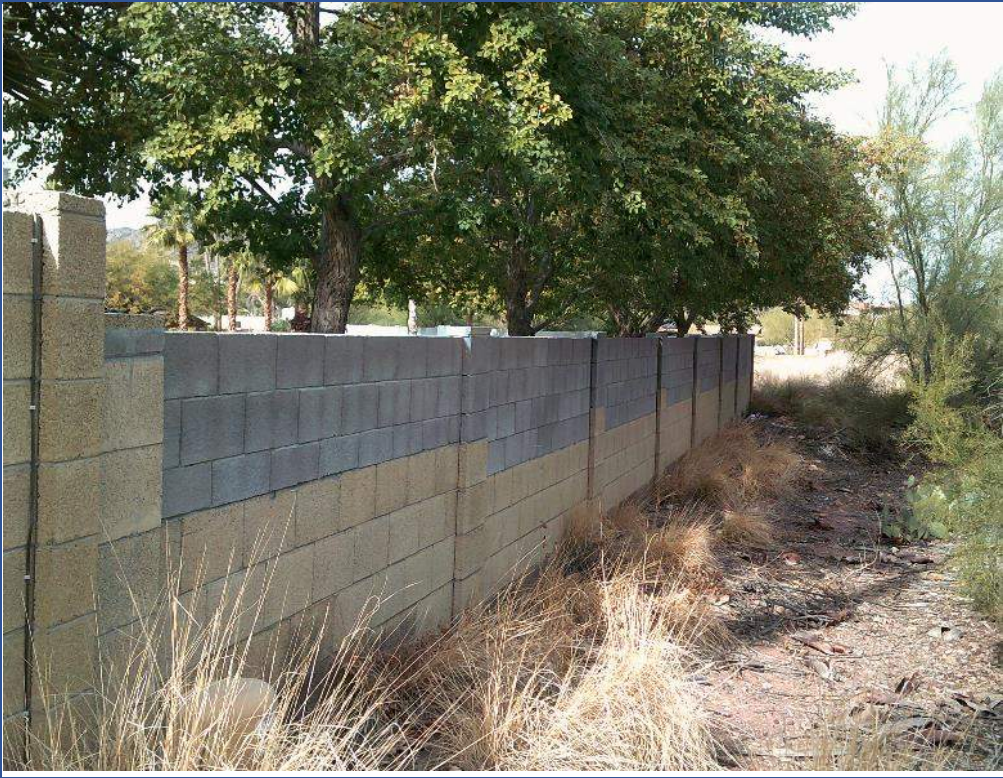
139

Lot 82 - Elevation. Built up wall.

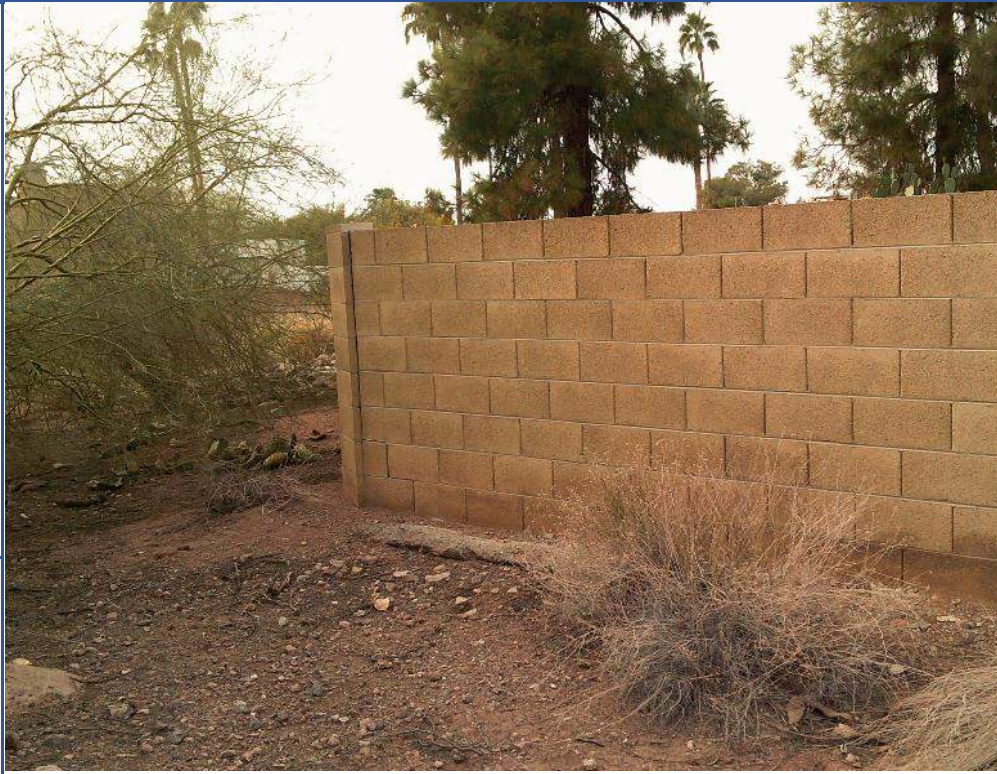
143

Lot 90 - Delamination.
Exposed footing.

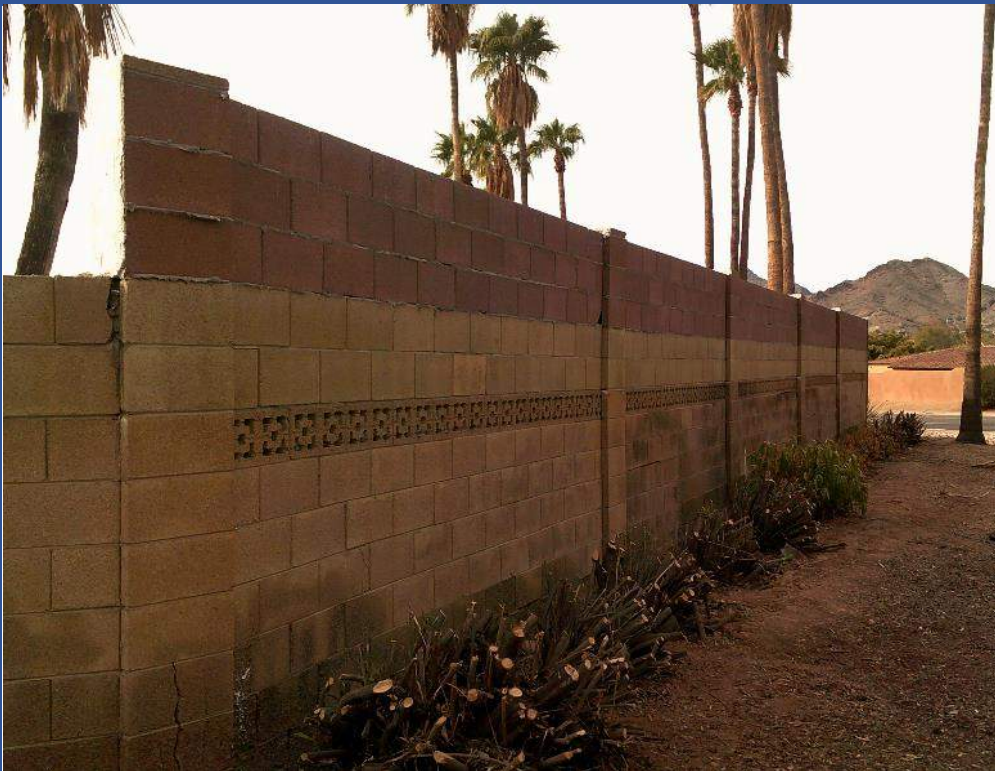
146

Lot 91 - Built up wall.

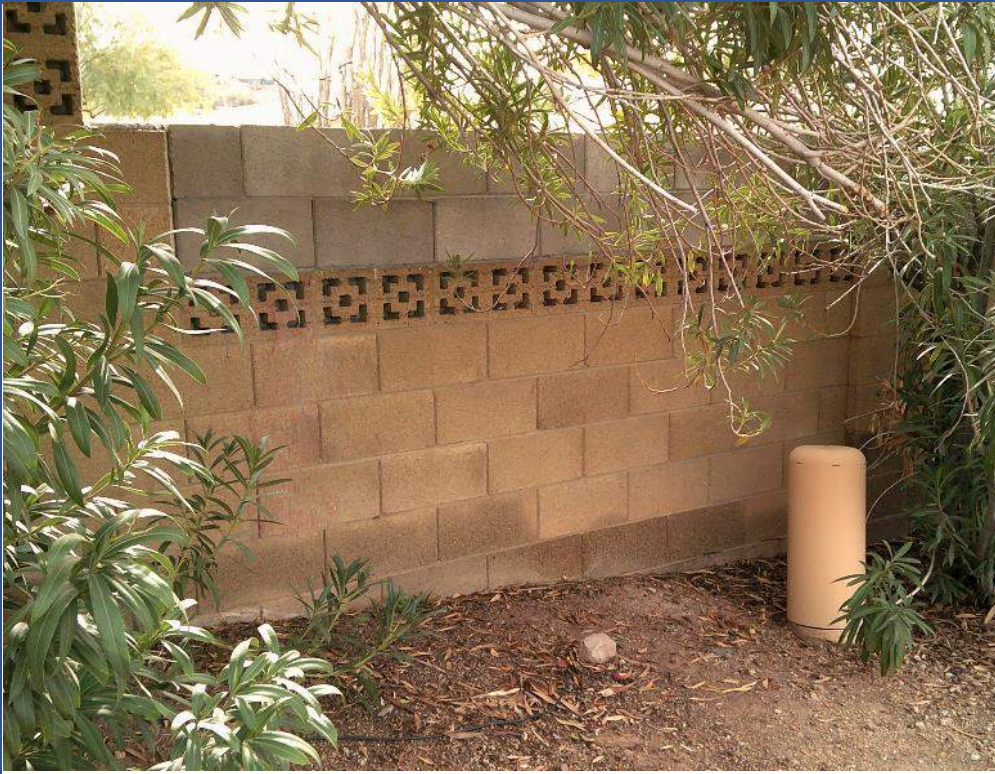
149

Lot 93 - Built up wall.

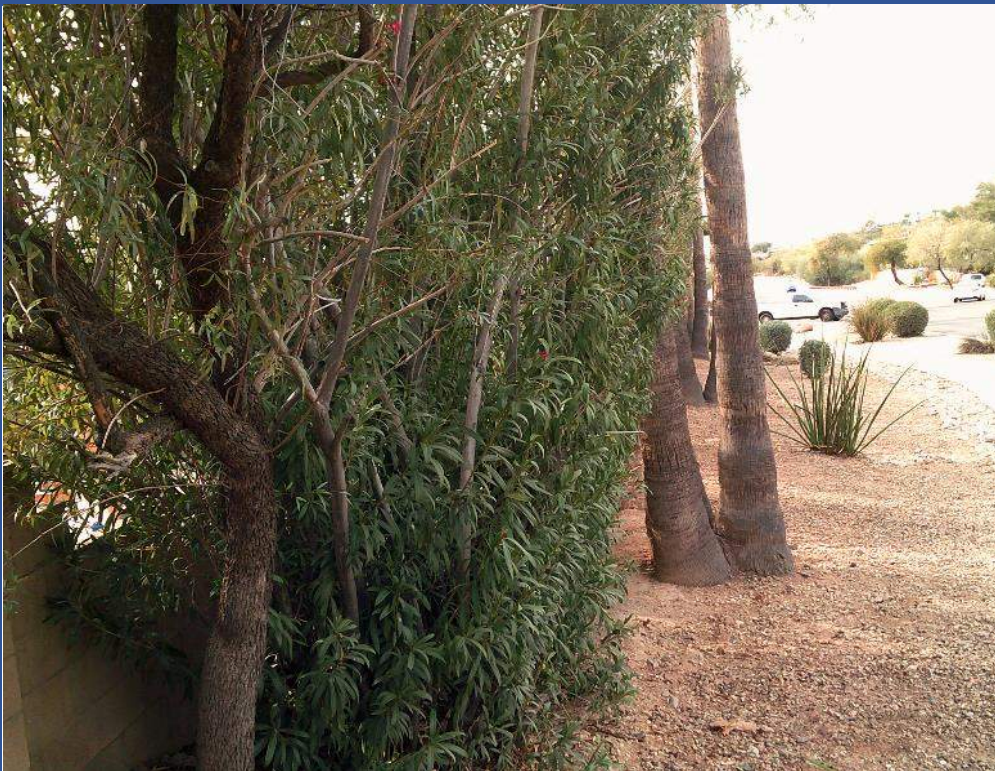
150

Lot 94 - Delamination.
Overgrowth. Negative
slope towards wall.

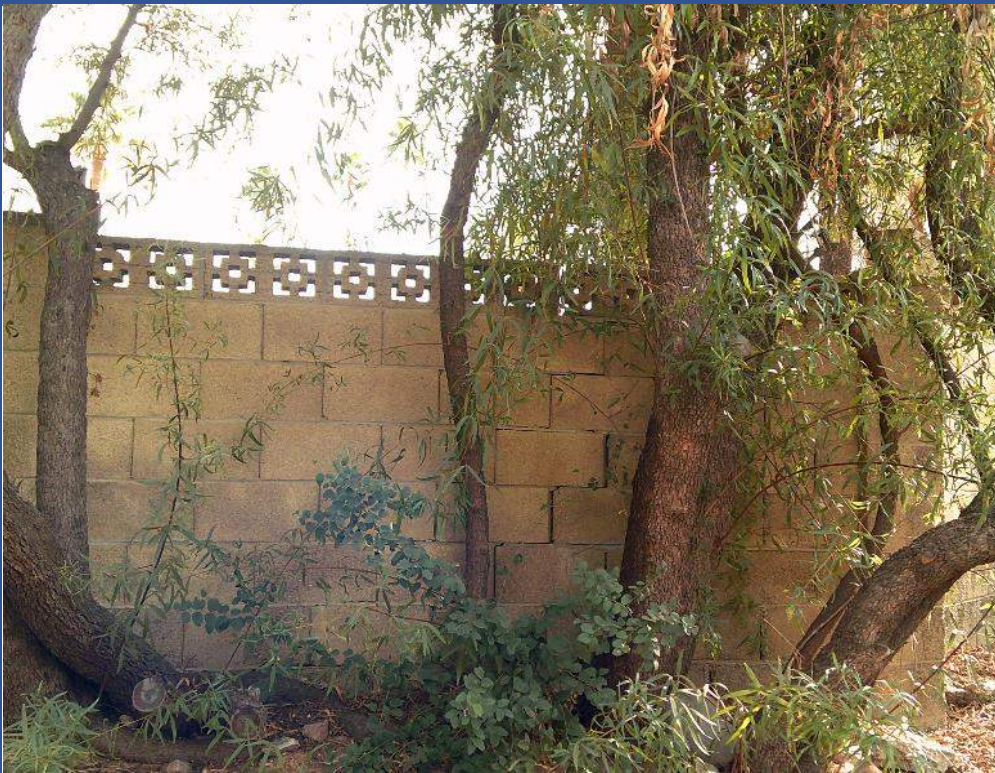
160

Lot 101 - Panel offset
up to approximately
1/2". Holes in course.

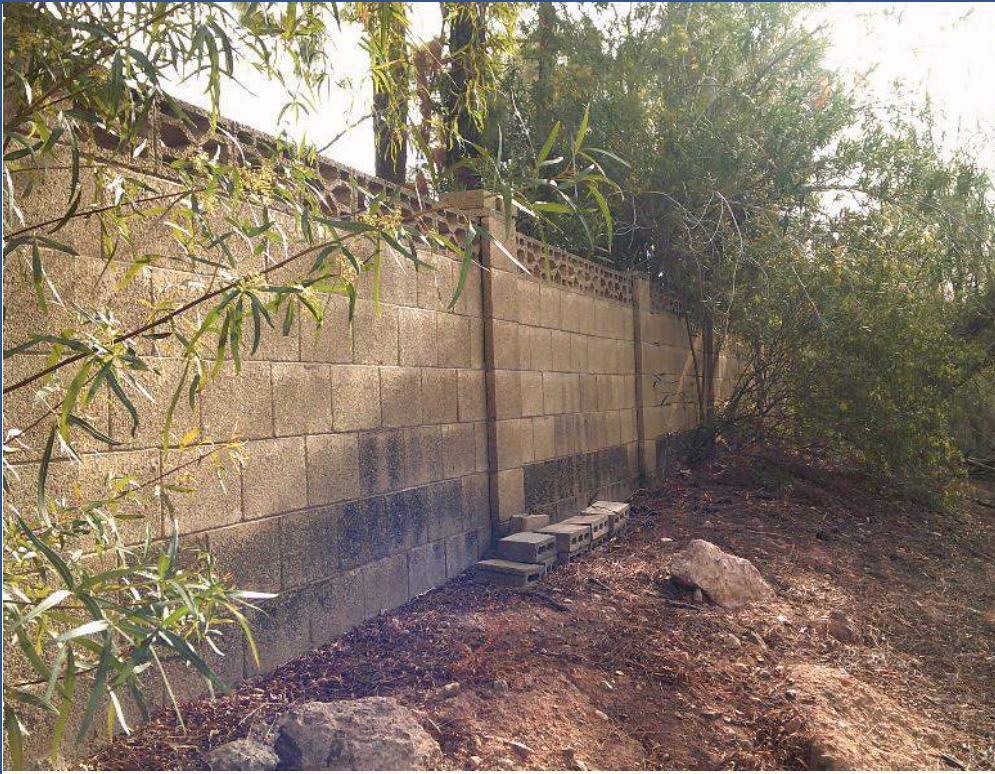
161

Lot 101 - Significant delamination. Holes in course.

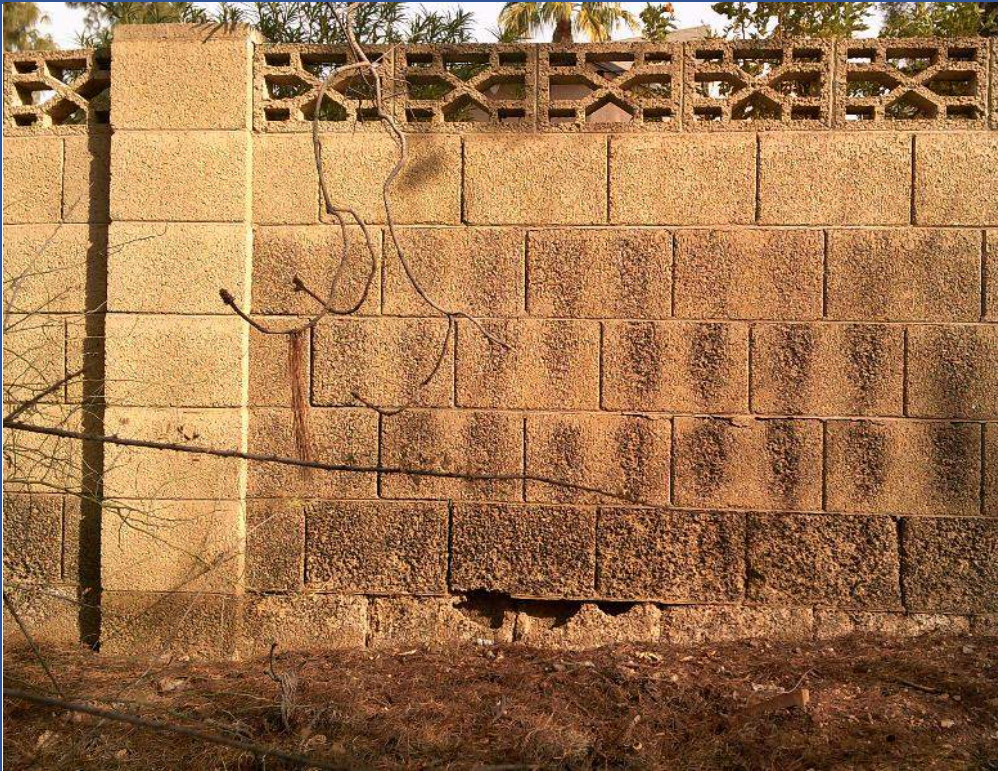
164

Lot 101 - Significant delamination. Holes in course.
