CAMELBACK CANYON ESTATES BLOCK WALL EVALUATION

Final Submittal: January 31, 2024

PROPERTY: CAMELBACK CANYON ESTATES COMMUNITY
PHOENIX, ARIZONA

SERVICE: 23-0433 – BLOCK WALL STRUCTURAL EVALUATION

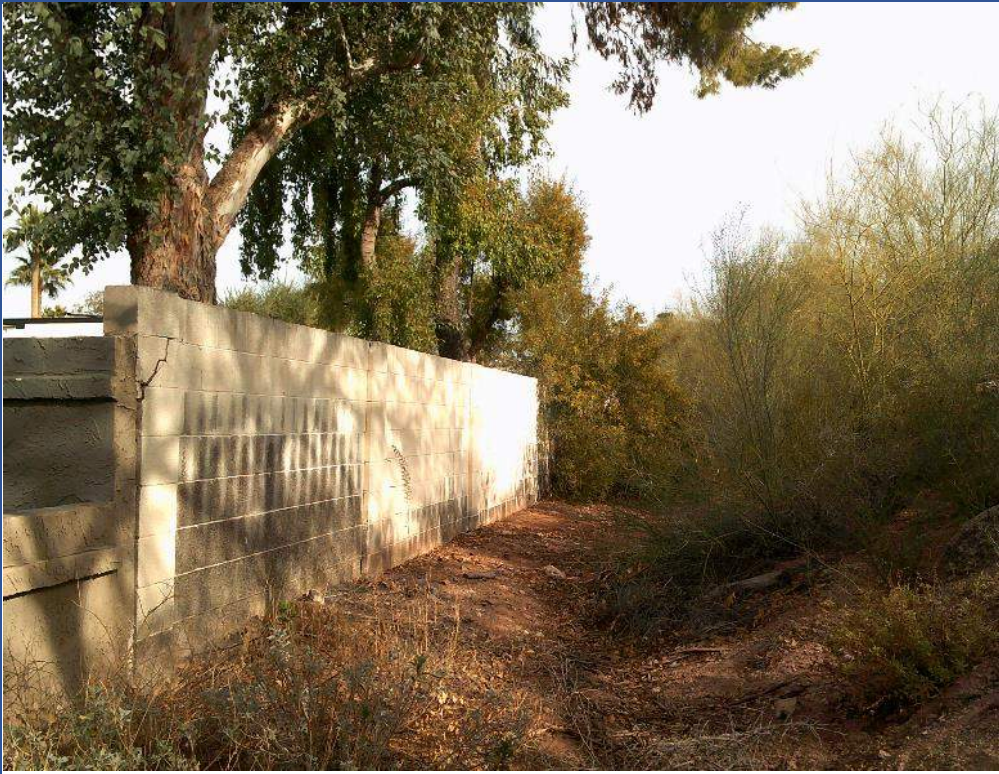
168

Lot 104 - Elevation.

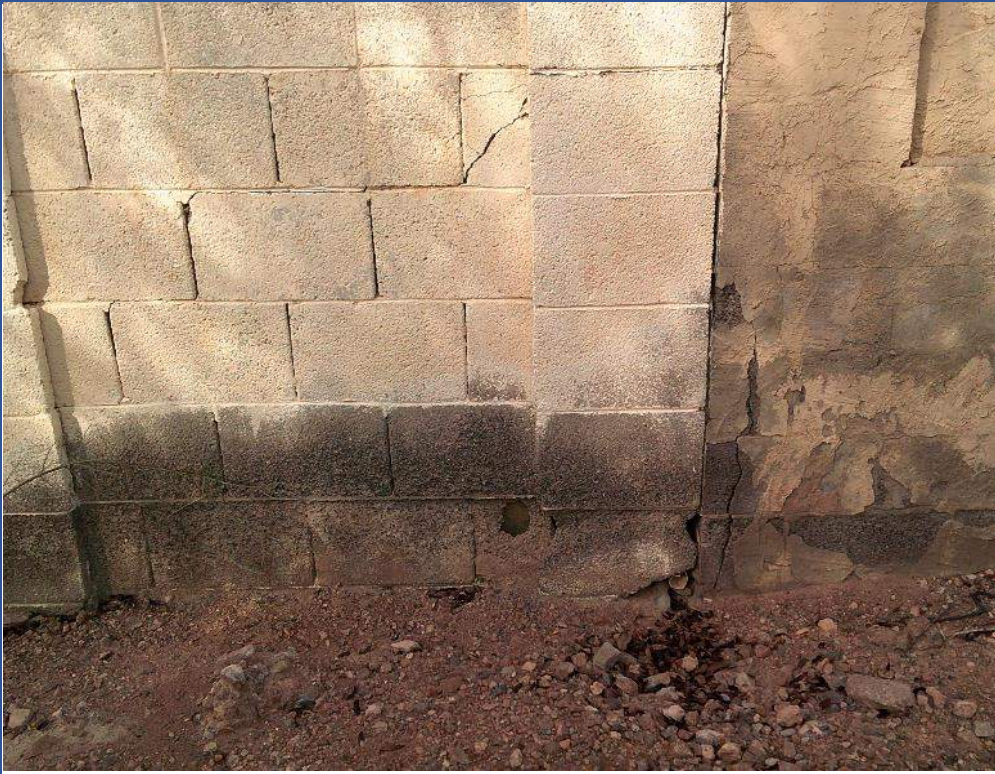
173

Lot 104 - Significant delamination.

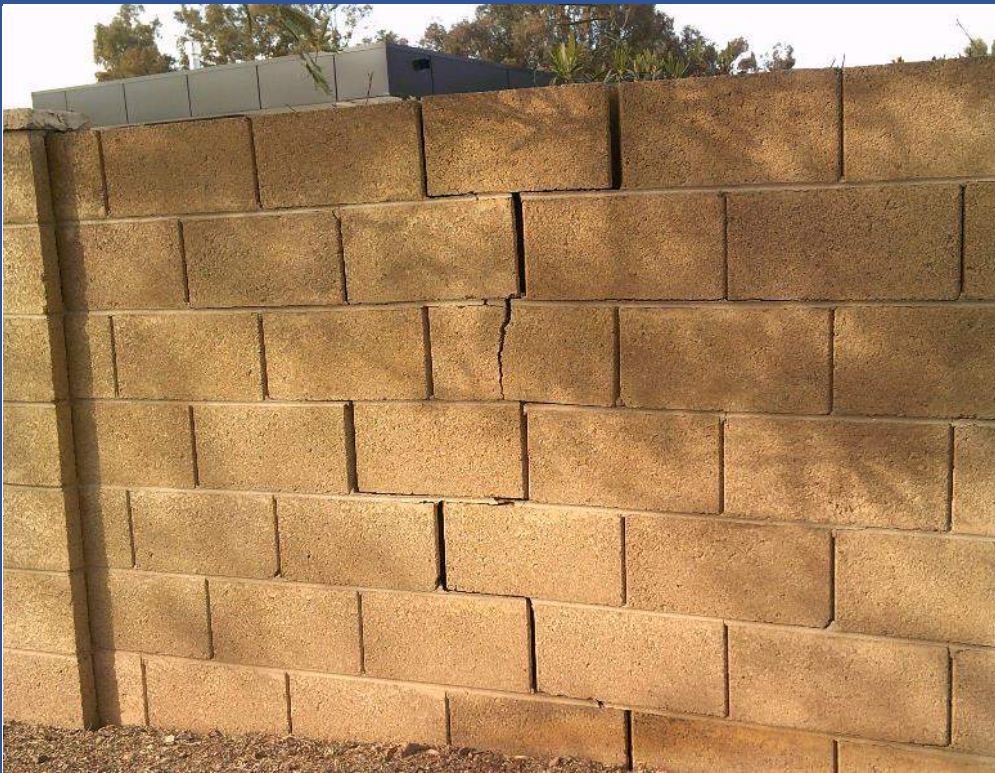
174

Lot 105 - Column rotation up to approximately 3/4" on a 5-foot column. Uplift up to approximately 1/2".
